Additional
information/witness
for our "hearing" on
5/1/24.

BOARD OF REVISION HEARING NOTICE TO
ASHTABULA COUNTY PROPERTY OWNER OR HIS/HER
AGENT

B.O.R. CASE NUMBER: 2023-0037

- 1) 07-021-10-009-21 located at 1170 GREENBRIER DR, the market value is \$356,600. The market value sought is \$200,000.

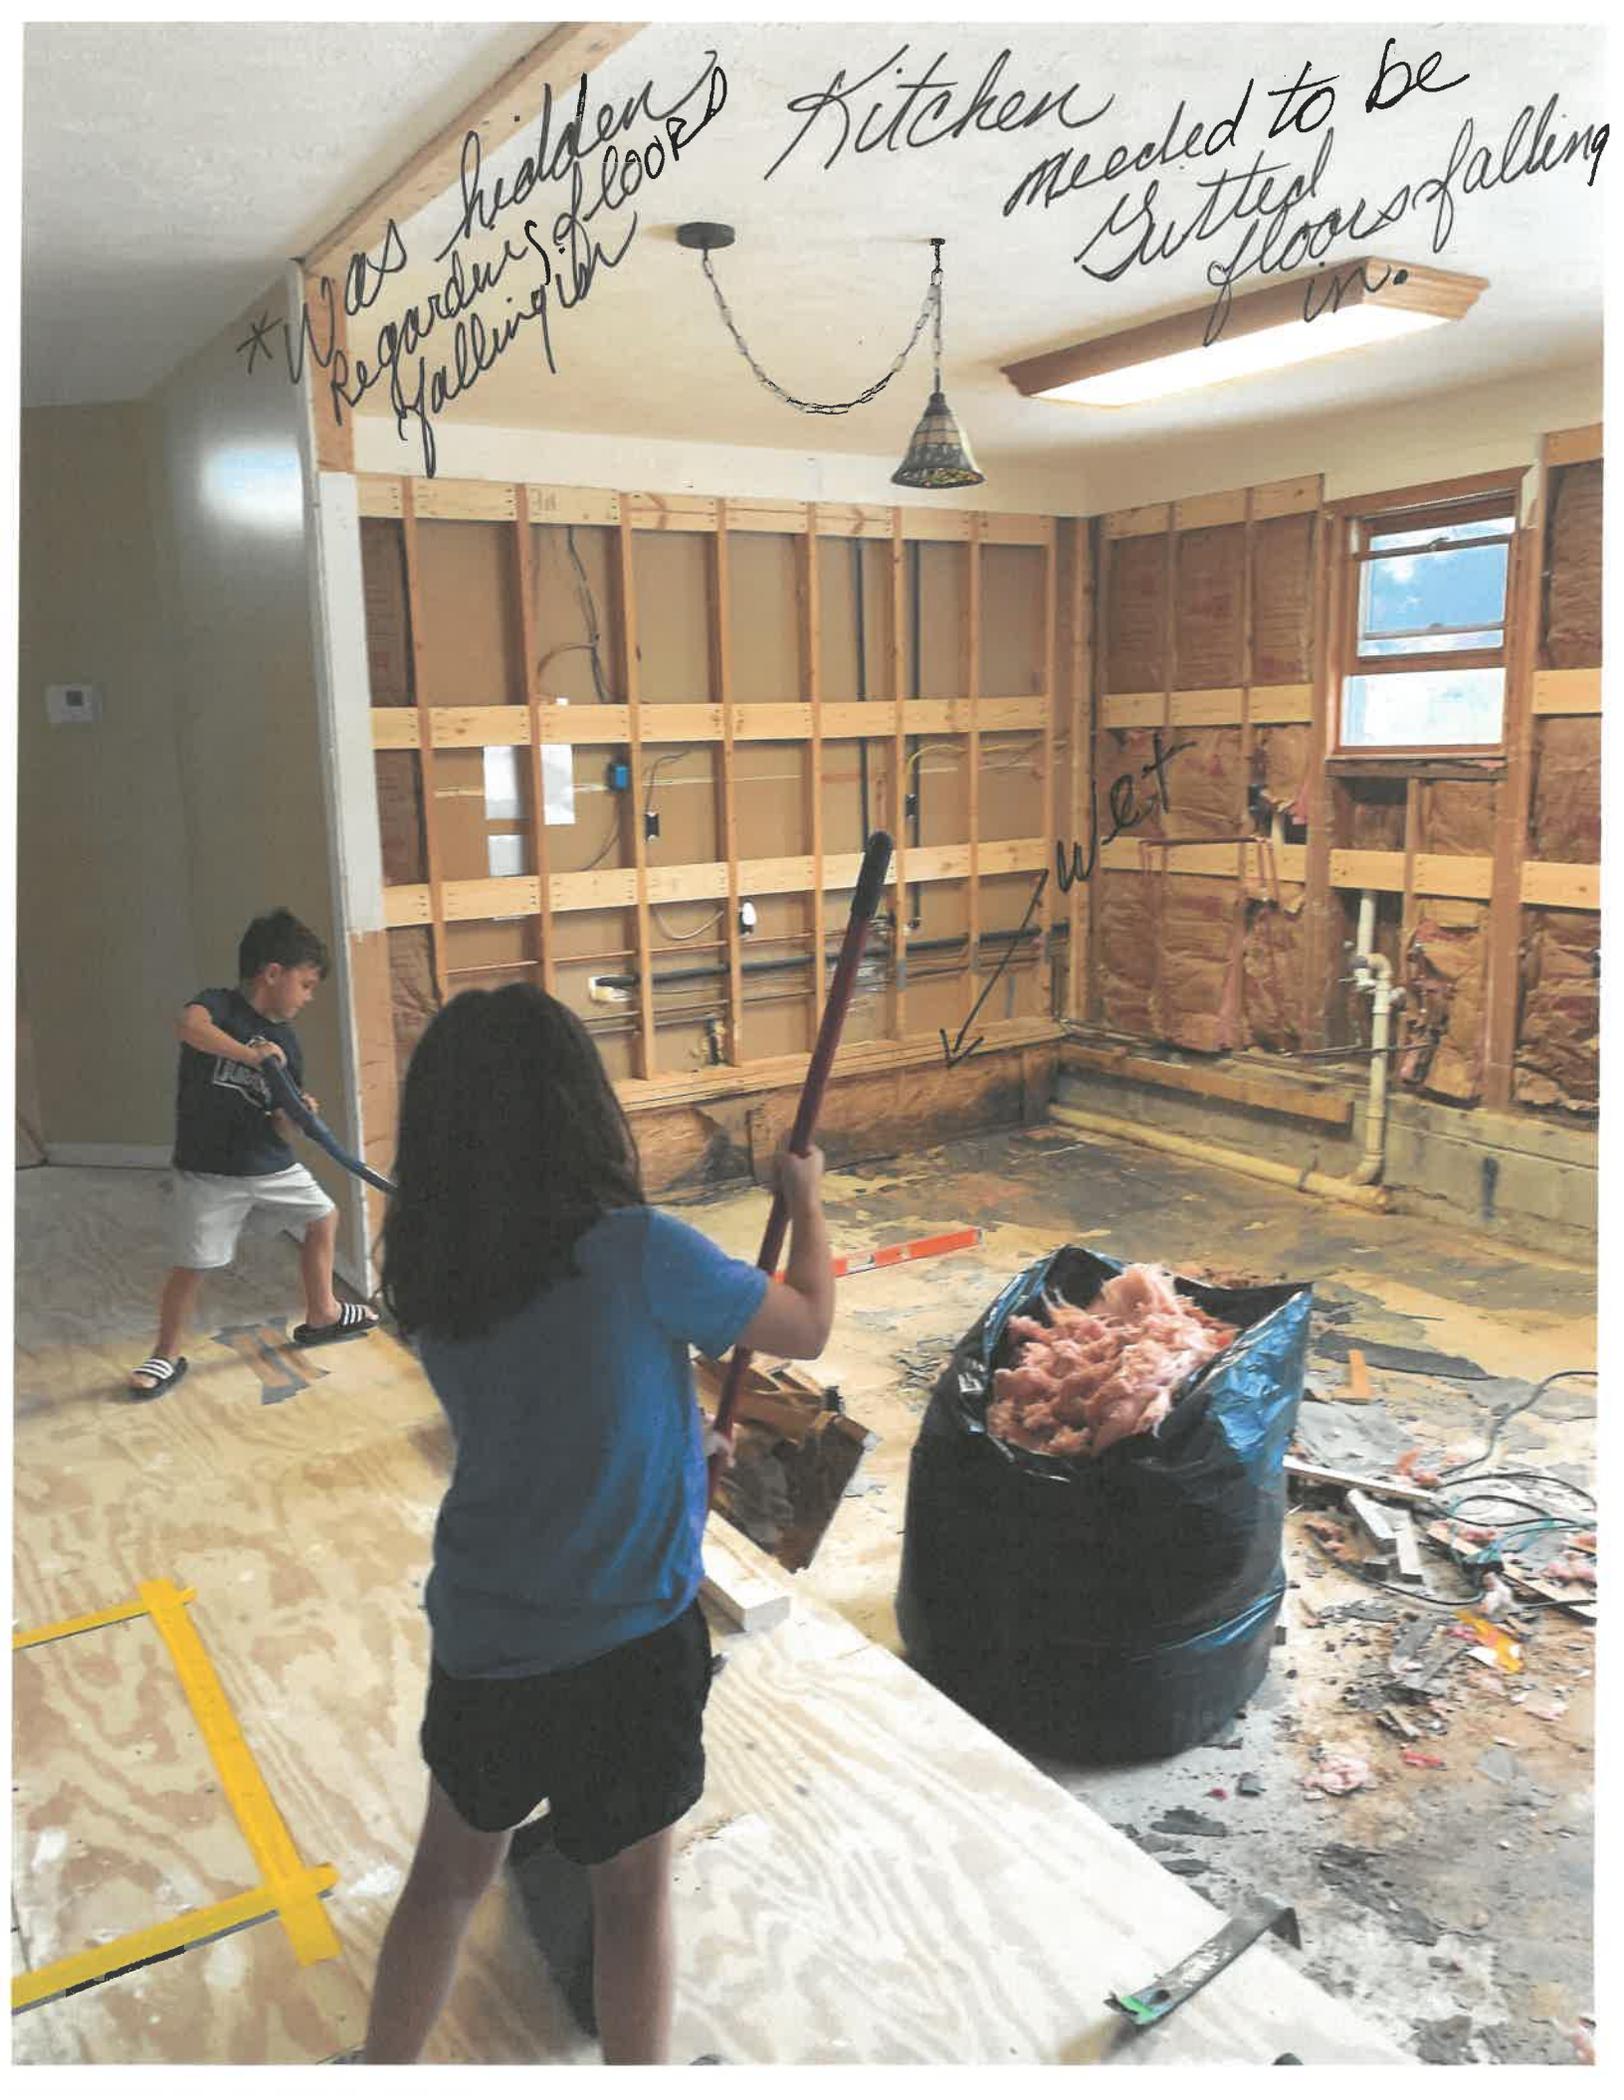
Kitchen
needed to be
Gutted
floors falling
in.

wet

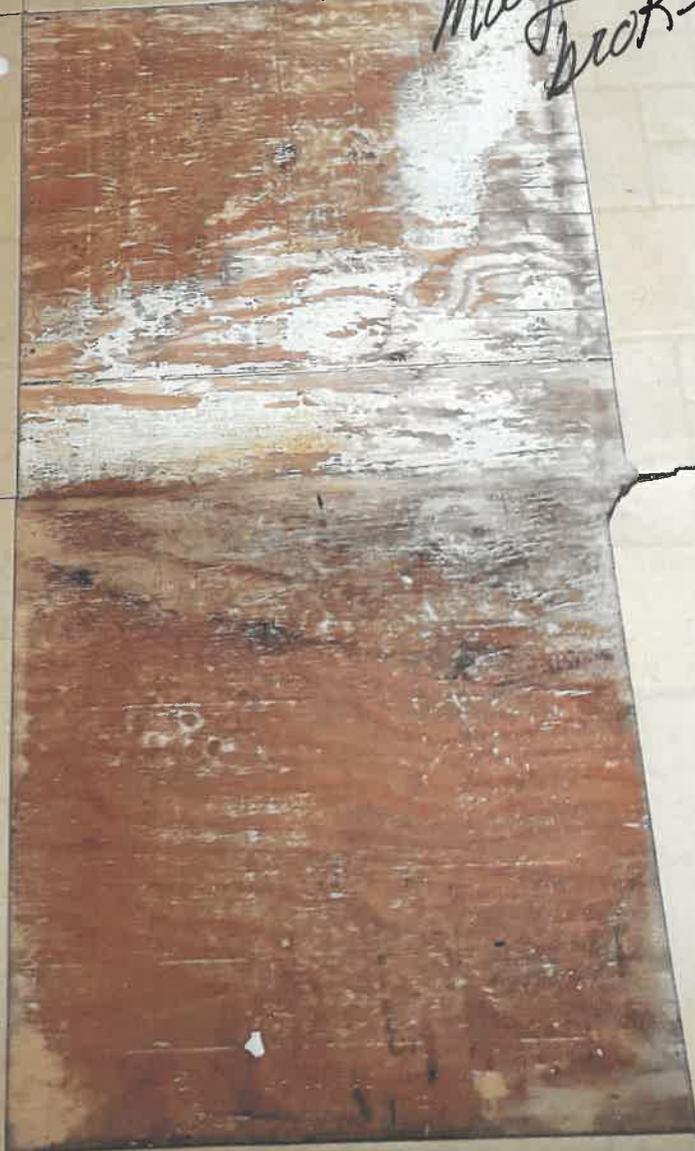
floor example
Hidden under Rugs
Laundry Room
Due to water damage
previous pipes
and hot water tank
may have
leaked

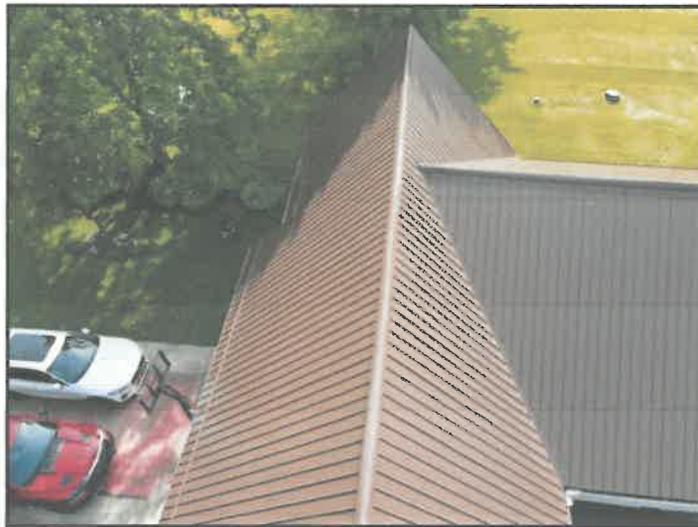
Metal roofing appeared in overall good condition at the time of inspection.

1. Roofing appeared in overall good condition.

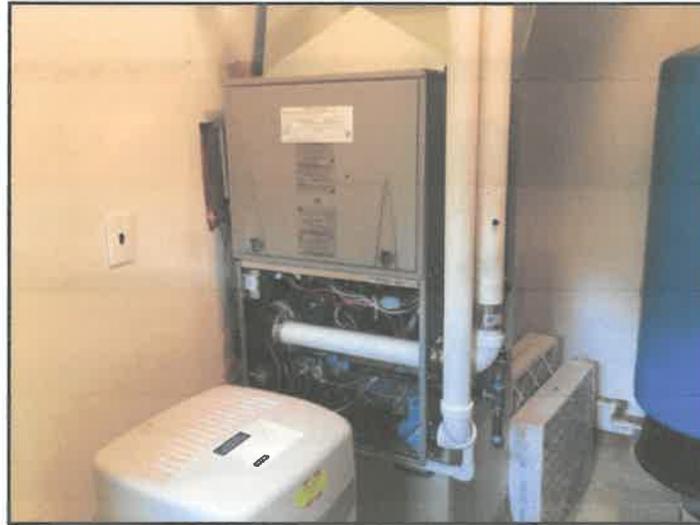
11. No heating recommendations are offered as a...

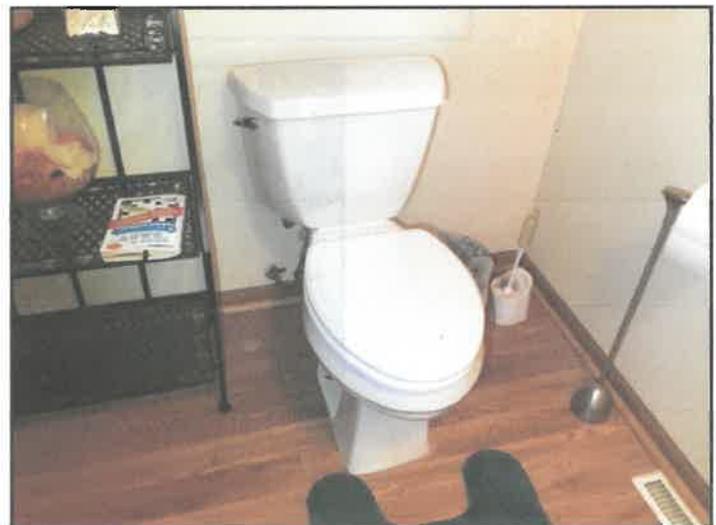
Both toilets were very loose at the base. Recommend properly securing both toilets to prevent the toilets from leaking.

15. Loose

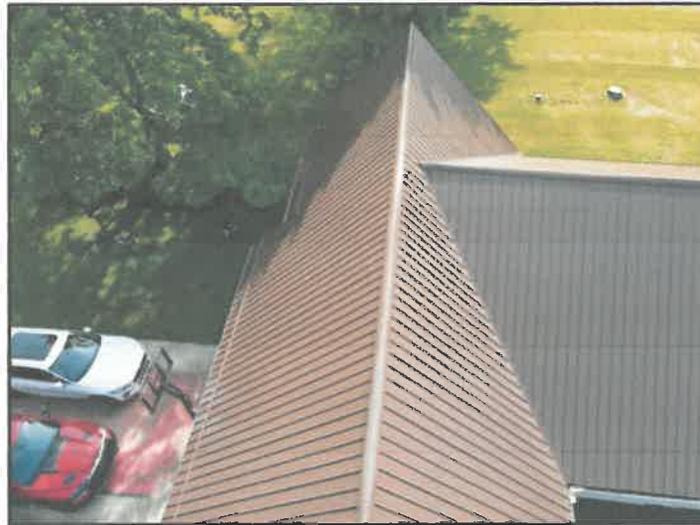
Metal roofing appeared in overall good condition at the time of inspection.

23. Roofing appeared in overall good condition.

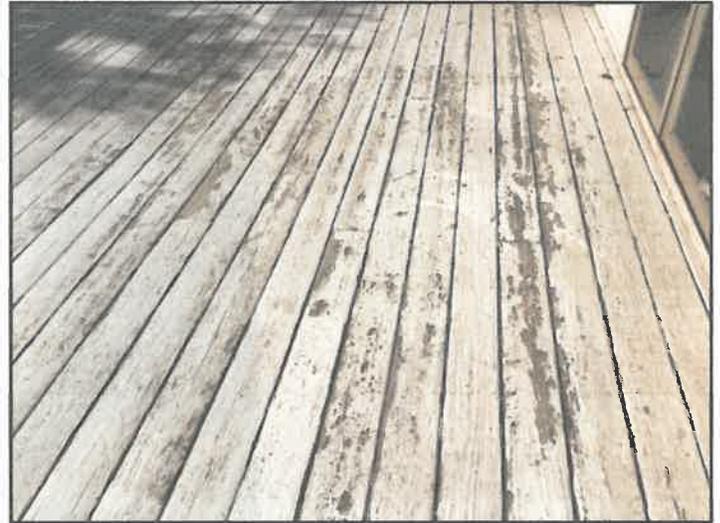
67. Seal or stain decking

Recommend power washing and sealing / staining decking.

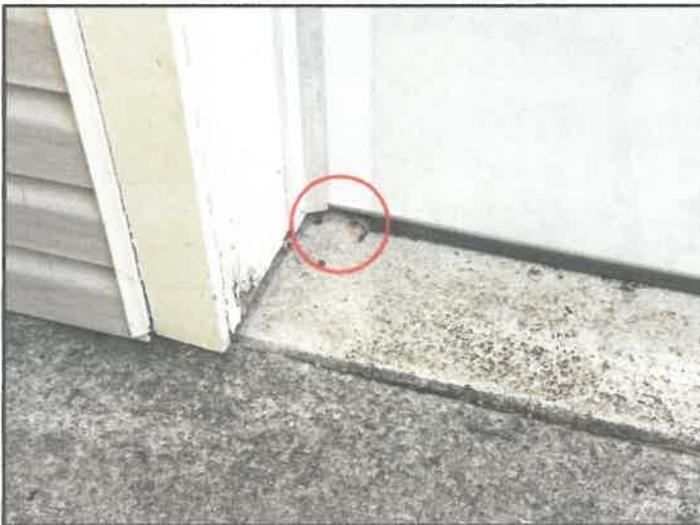
82. Missing / Damaged Weatherstripping

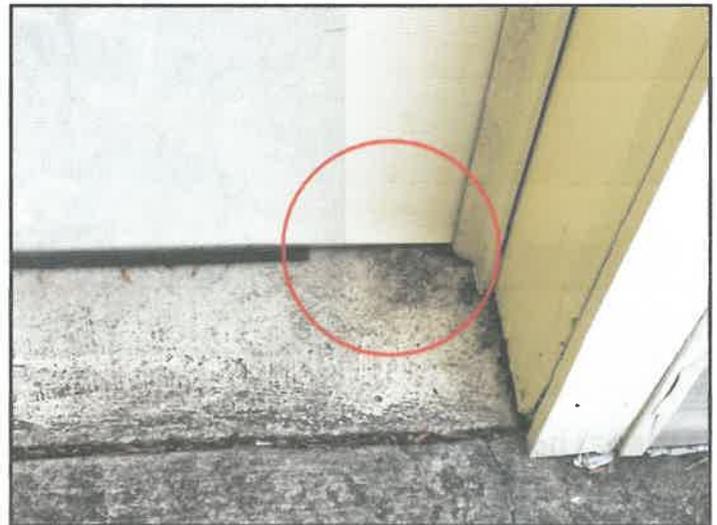
83. Missing / Damaged Weatherstripping

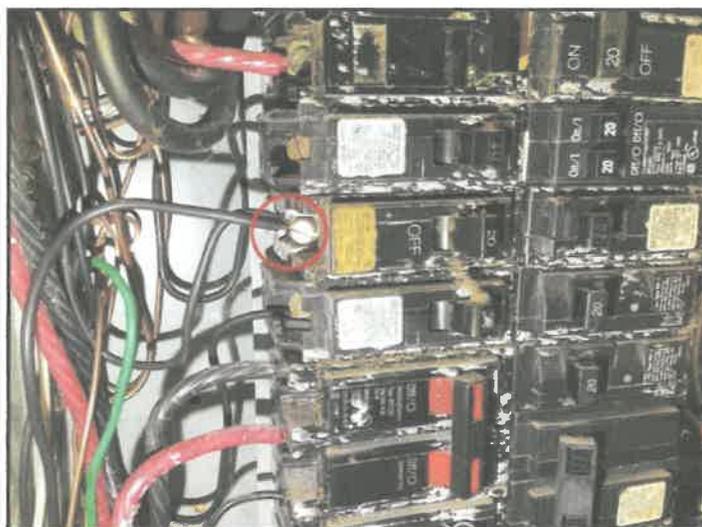
103. Double taps

Recommend having a licensed electrician correct double taps in panel.

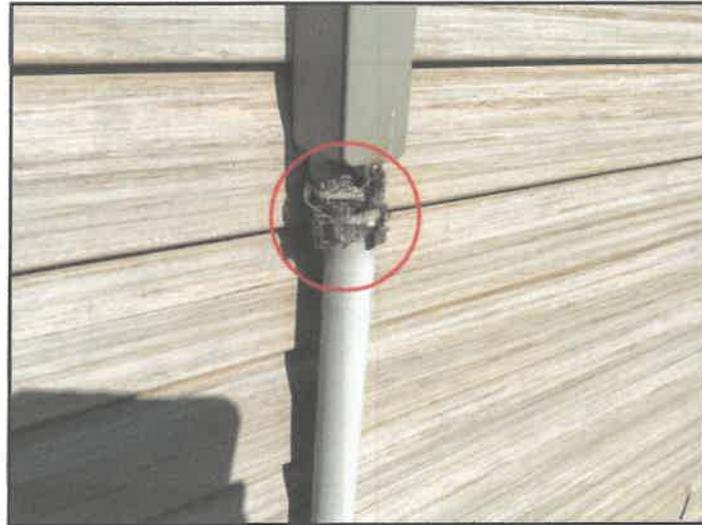
108. Exposed

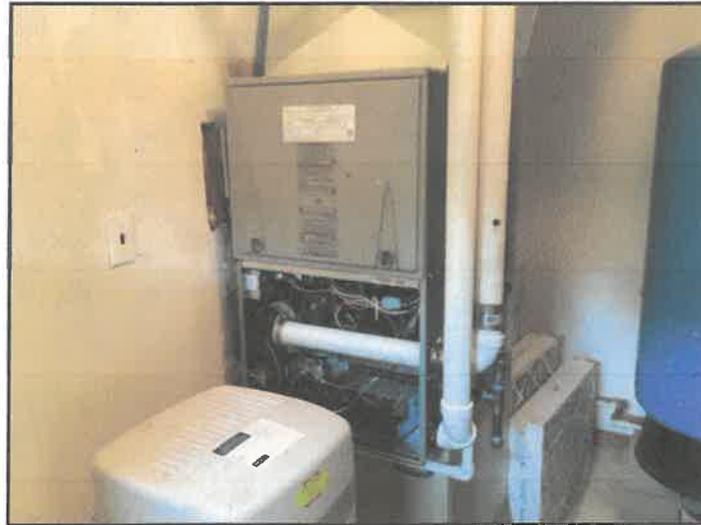
130. No heating recommendations are offered as a...

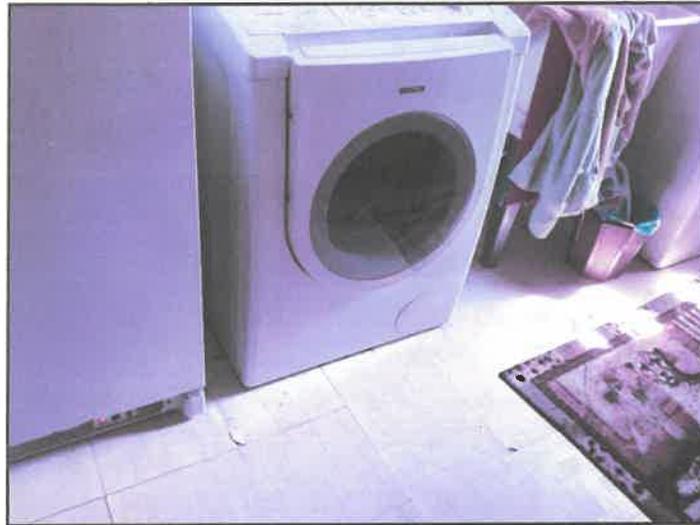
It is recommended that laundry areas located in or near a finished area should have a safety pan under washing machine that is plumbed to a drain or a floor drain present.

152. Missing safety pan for washing machine

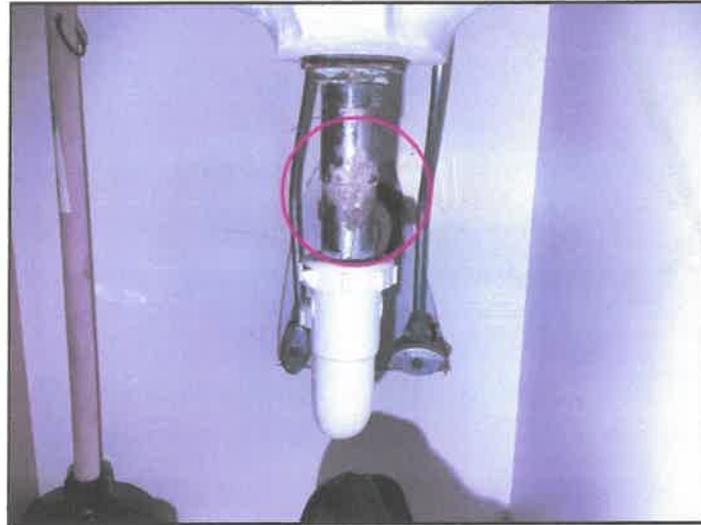
155. Corroded

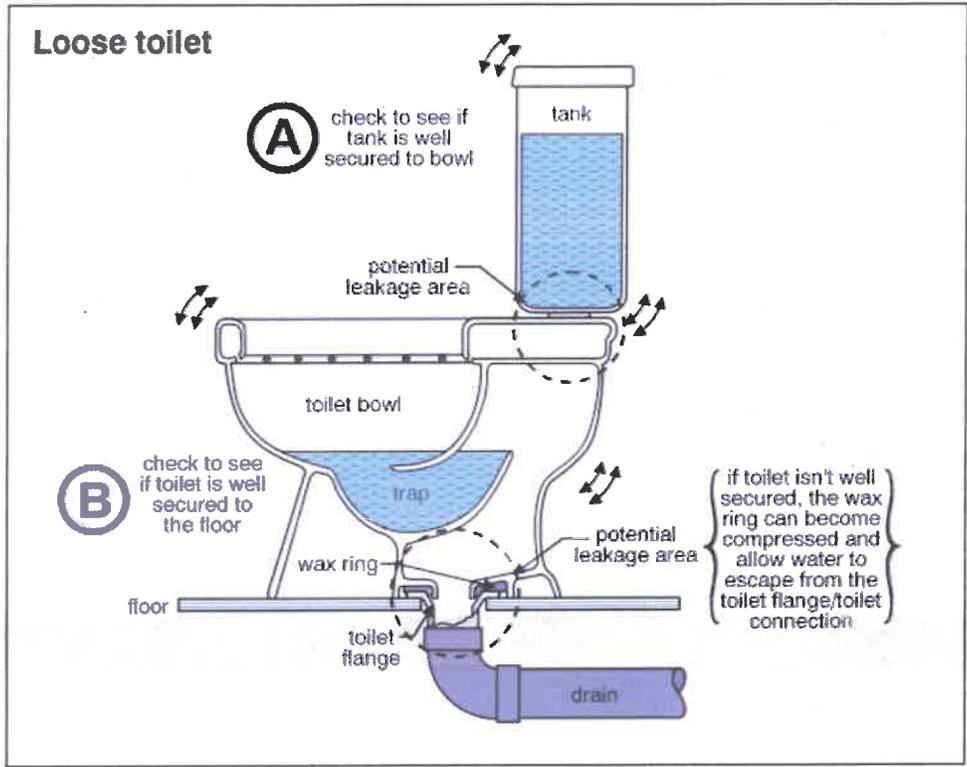
159. Loose

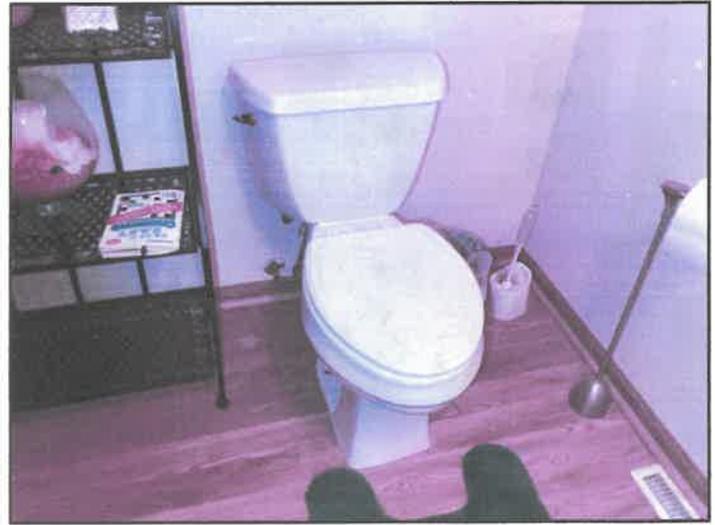
160. Loose

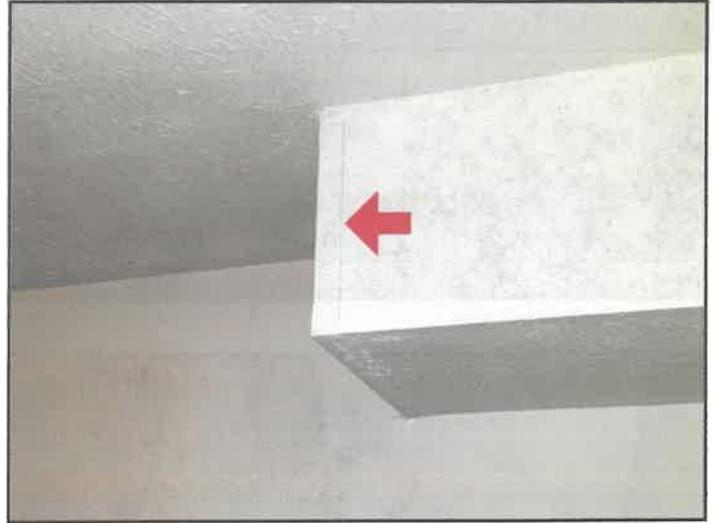
169. Cracks

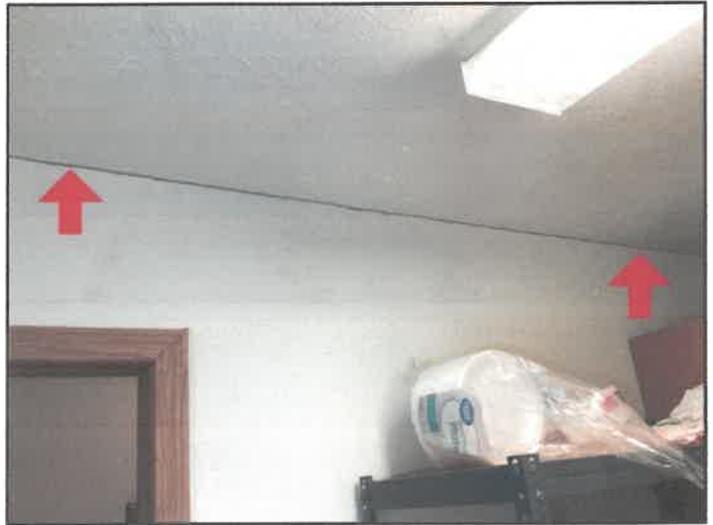
171. Cracks

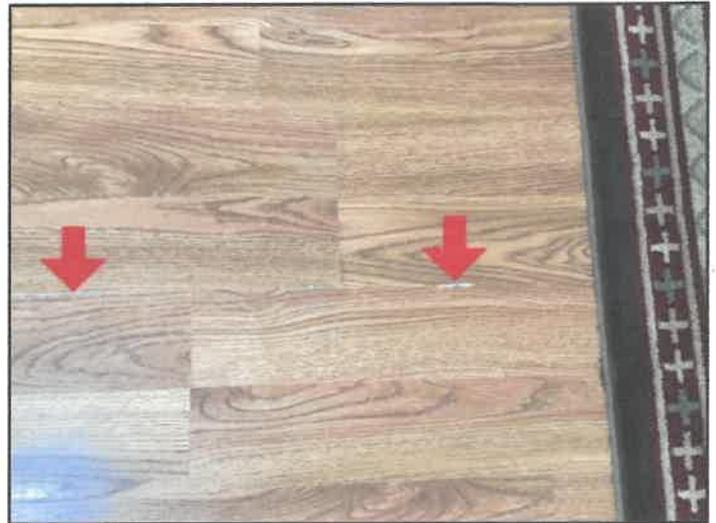
178. Damaged

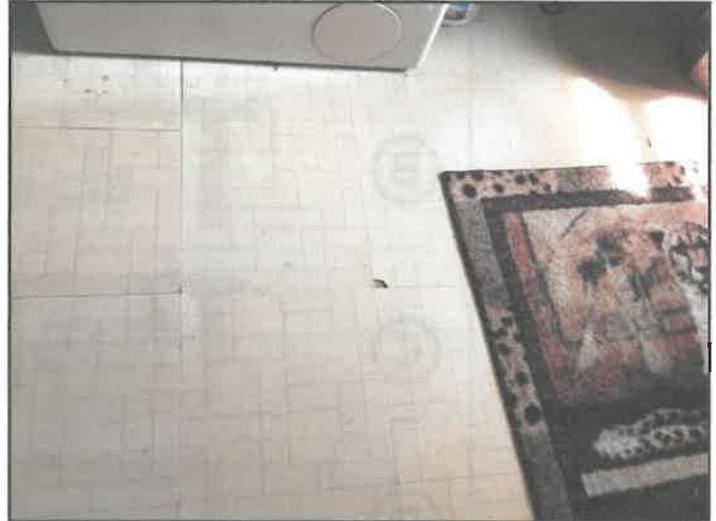
184. Damage
