### Complaint Against the Valuation of Real Property

6. Parcel numbers from tax bill	Address of property
<u>07-021-10-009-21</u>	<u>1170 Greenbriar DR. Rock Creek, Ohio 44084 (Austinburg TWP)</u>

1170 Greenbriar Dr, Rock Creek, OH June 19, 2023

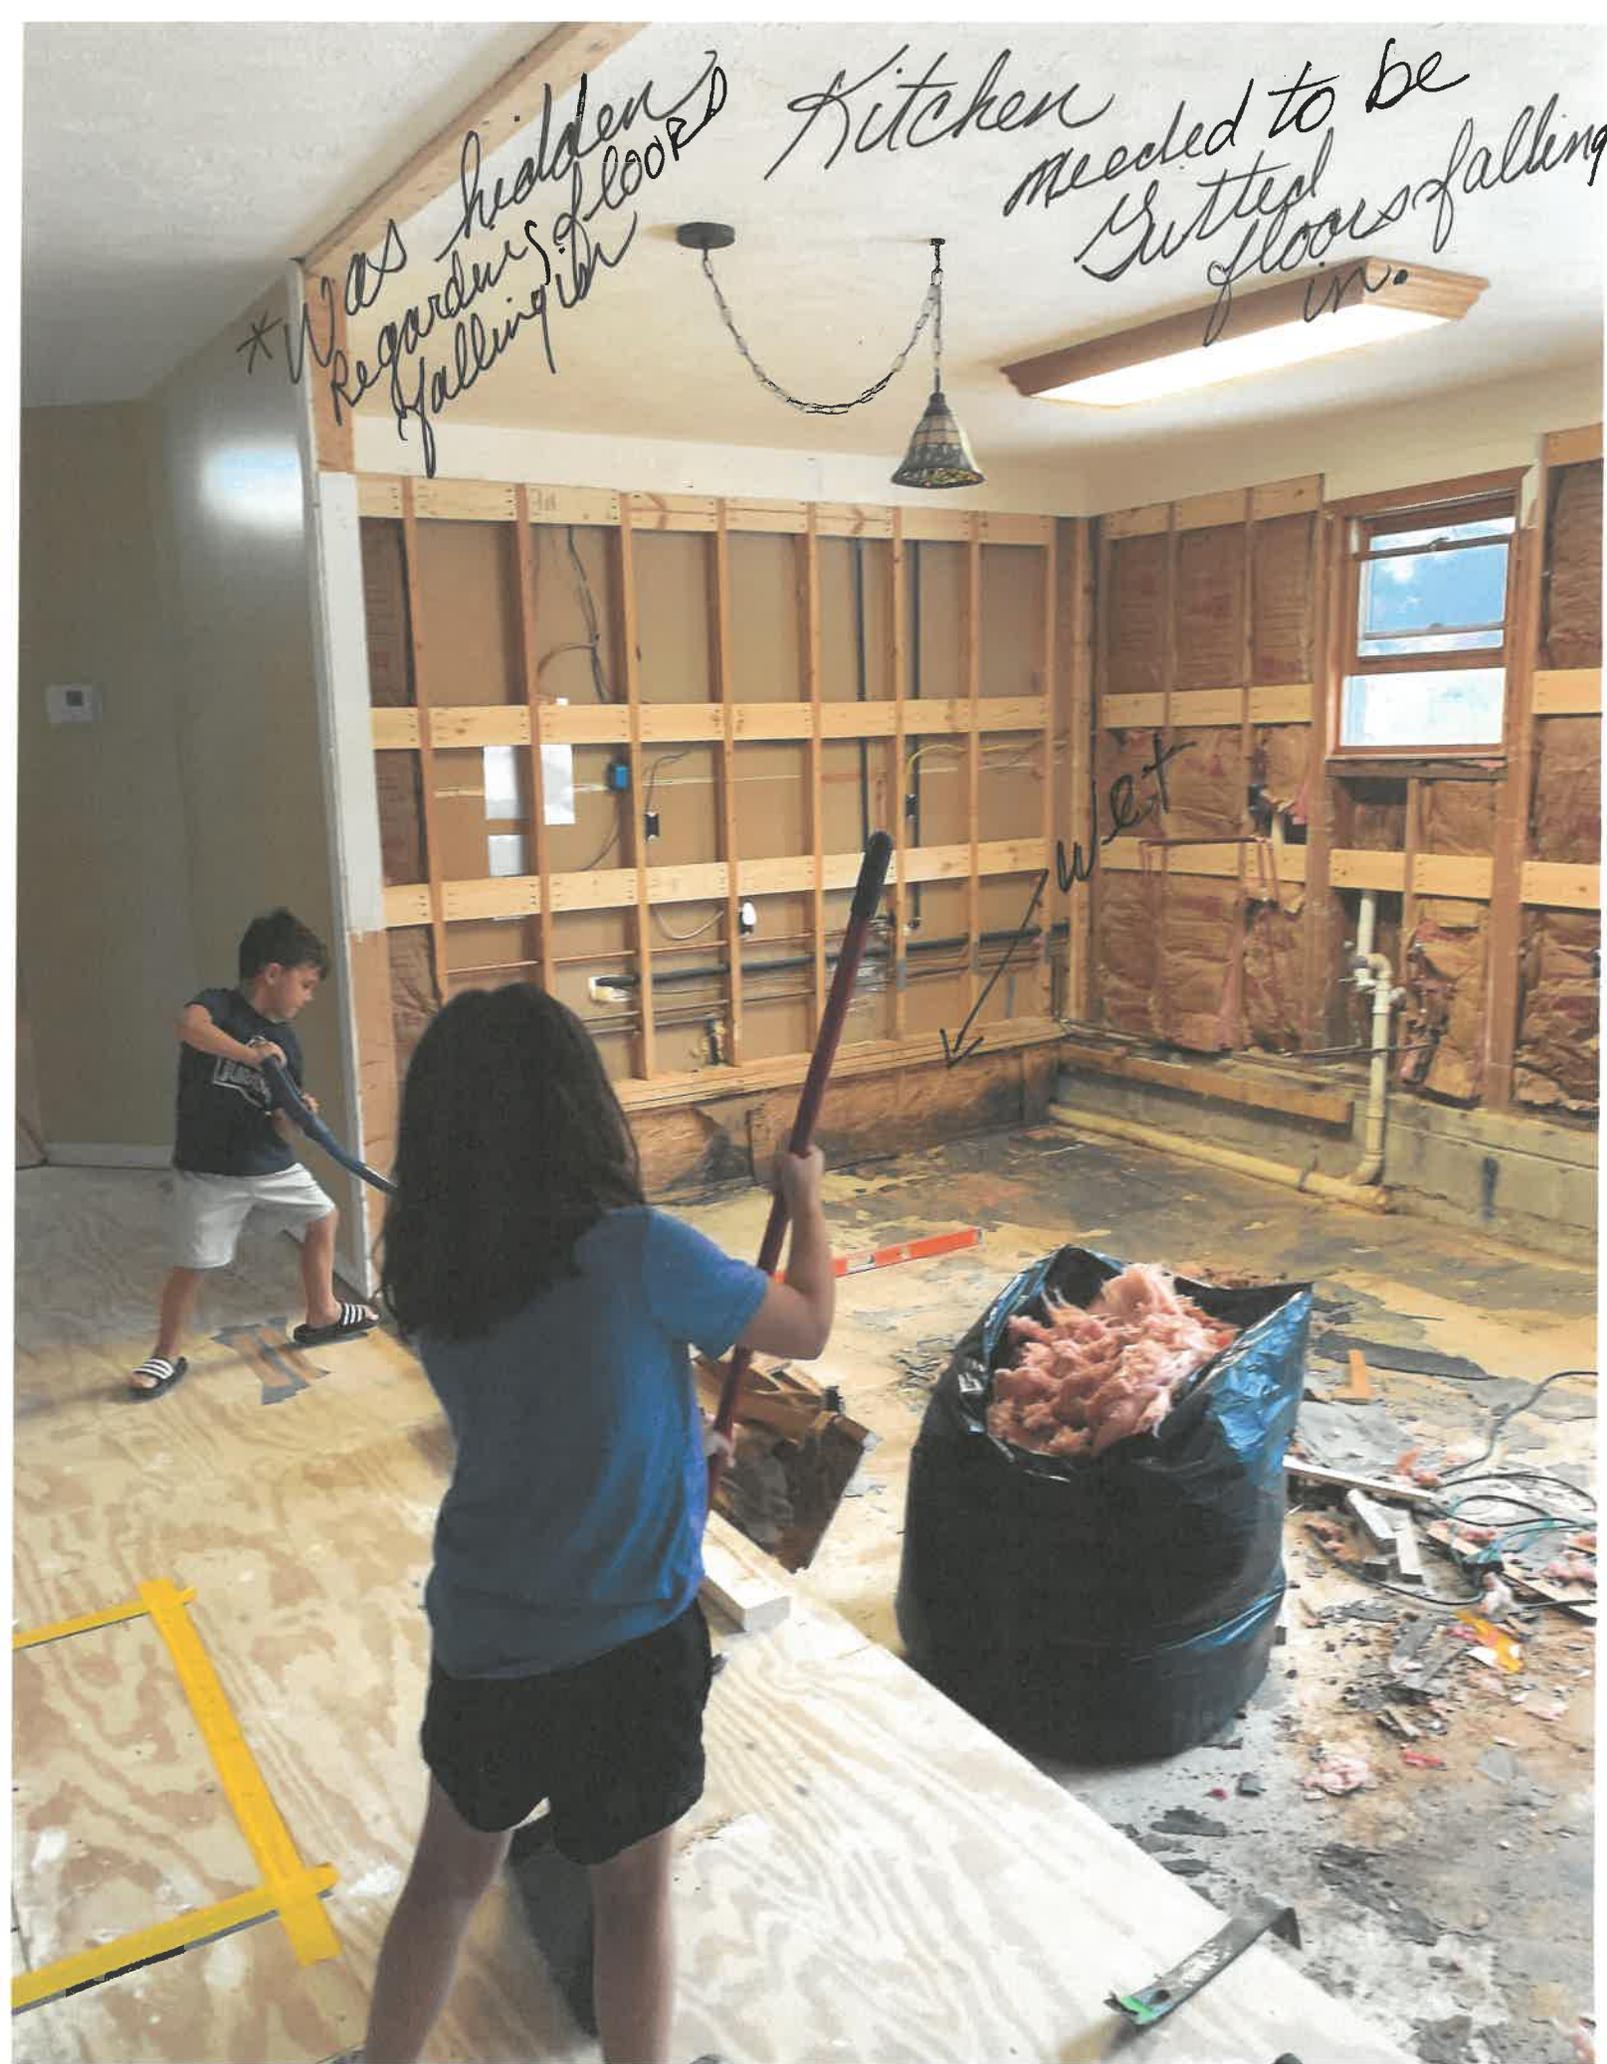
Kitchen  
needed to be  
cutted  
floors falling  
in.

wet

floor example  
Hidden under Rugs  
Laundry Room  
Due to water damage  
previous pipes  
and hot water tank  
may have  
leaked

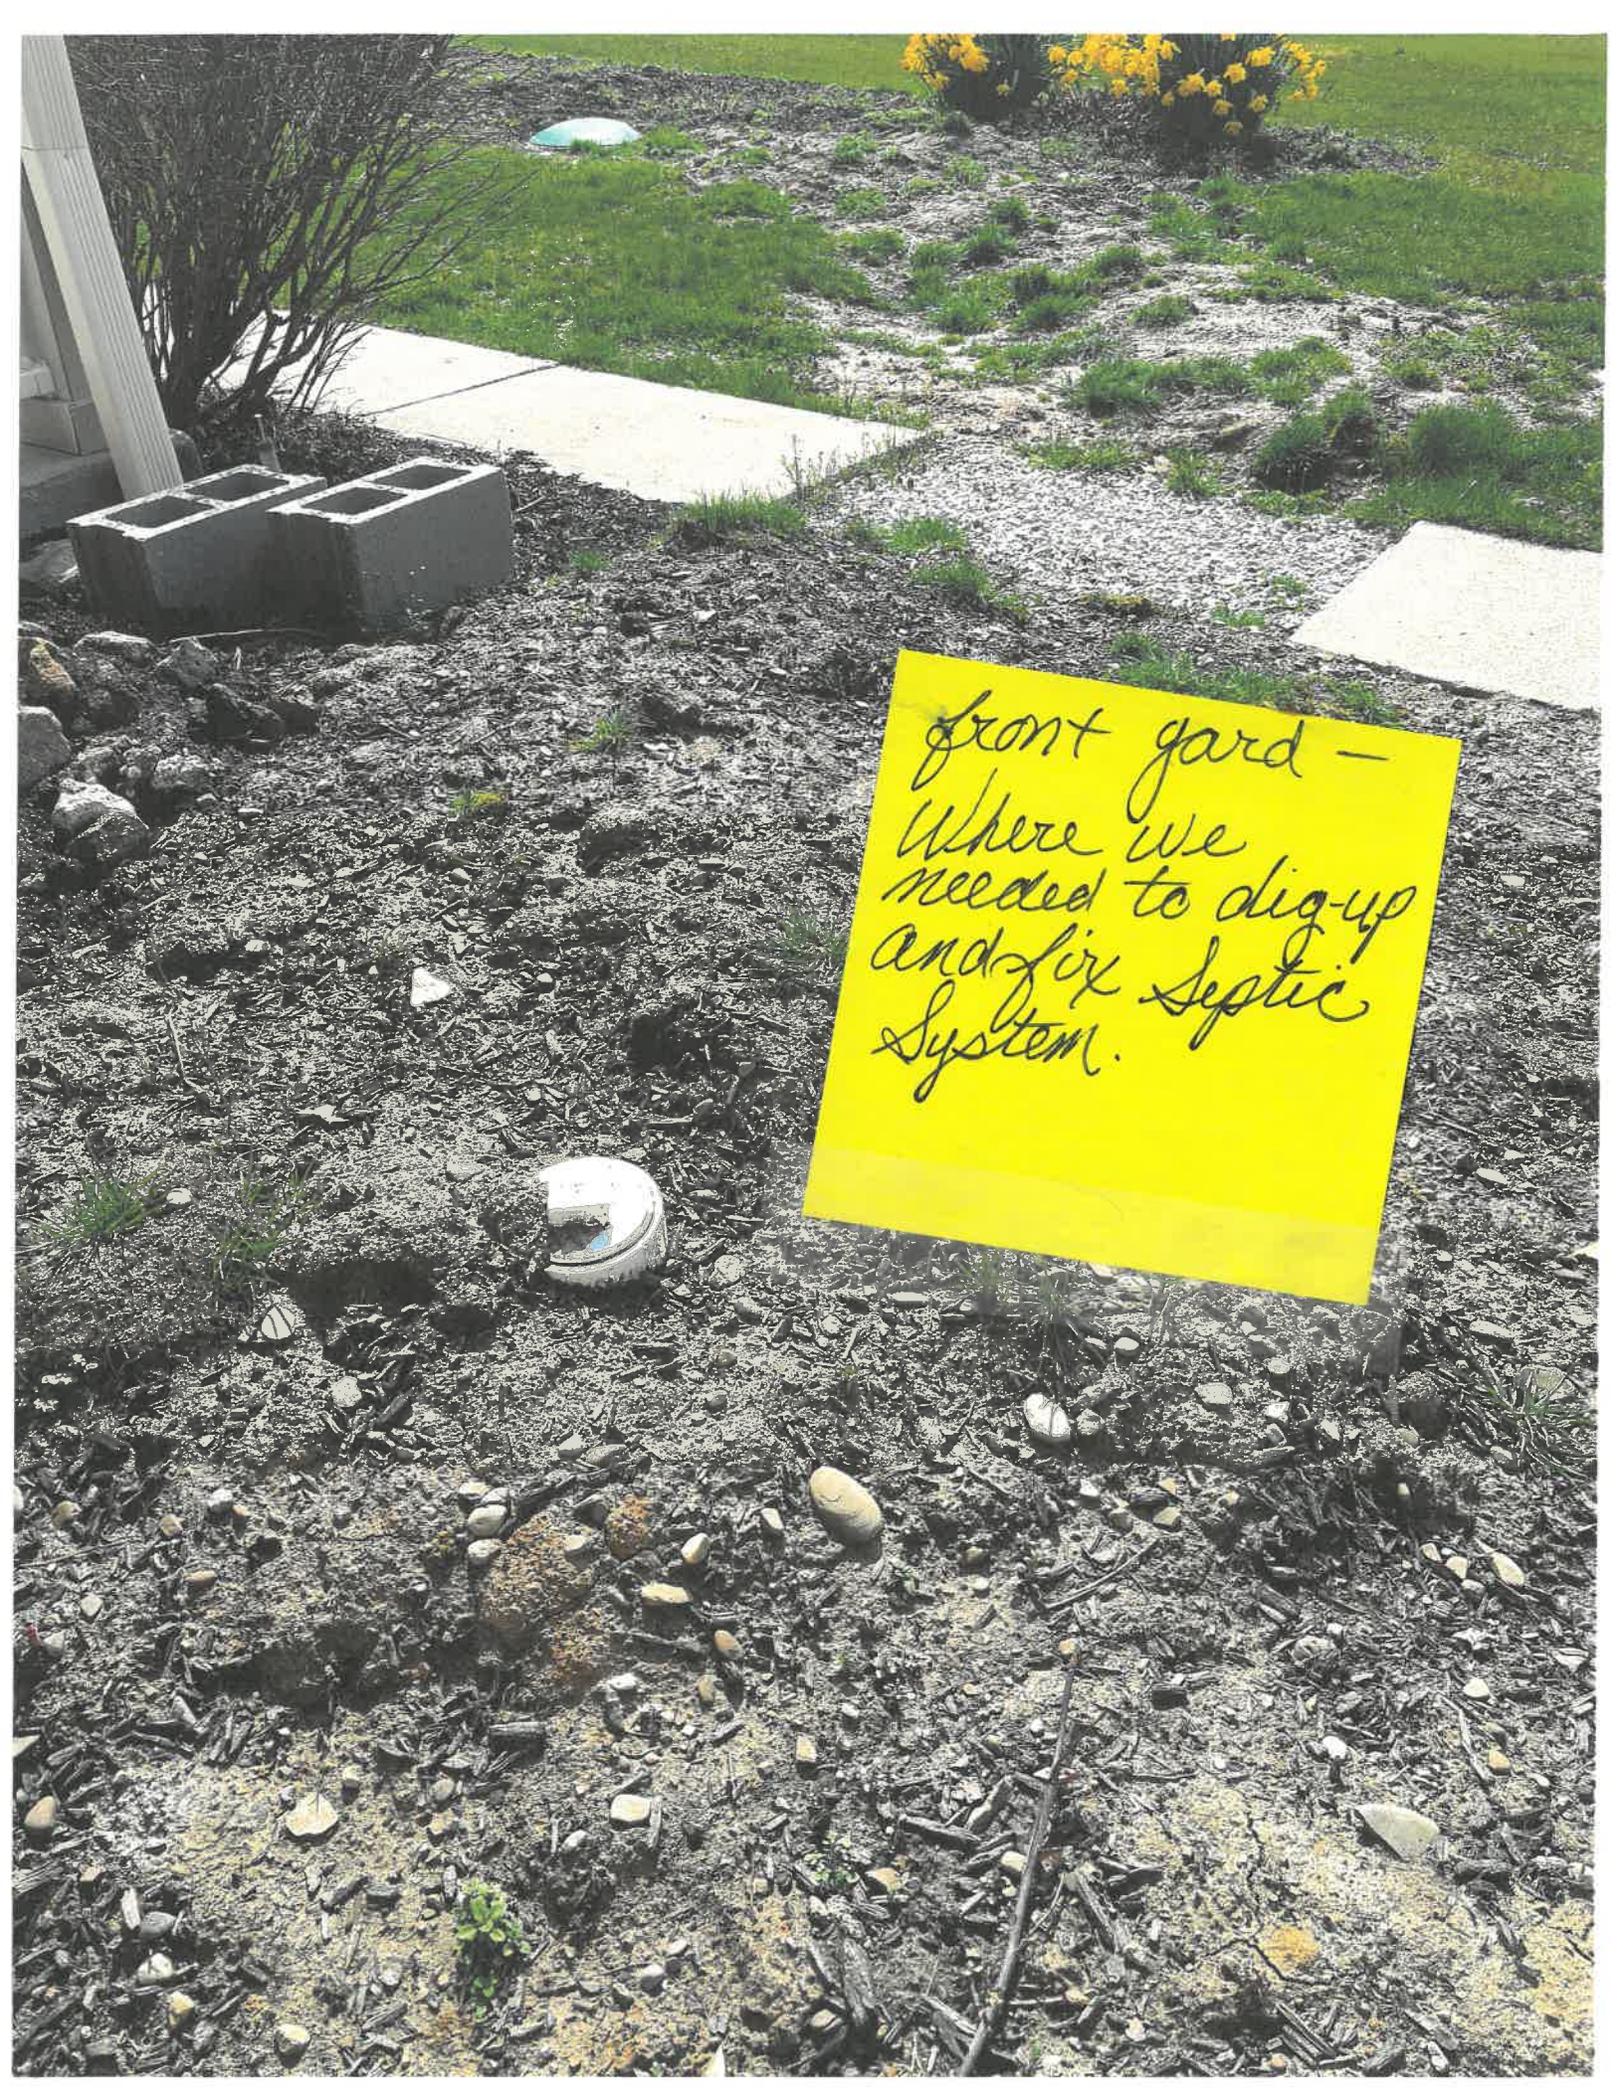
front yard -  
Where we  
needed to dig-up  
and fix Septic  
System.

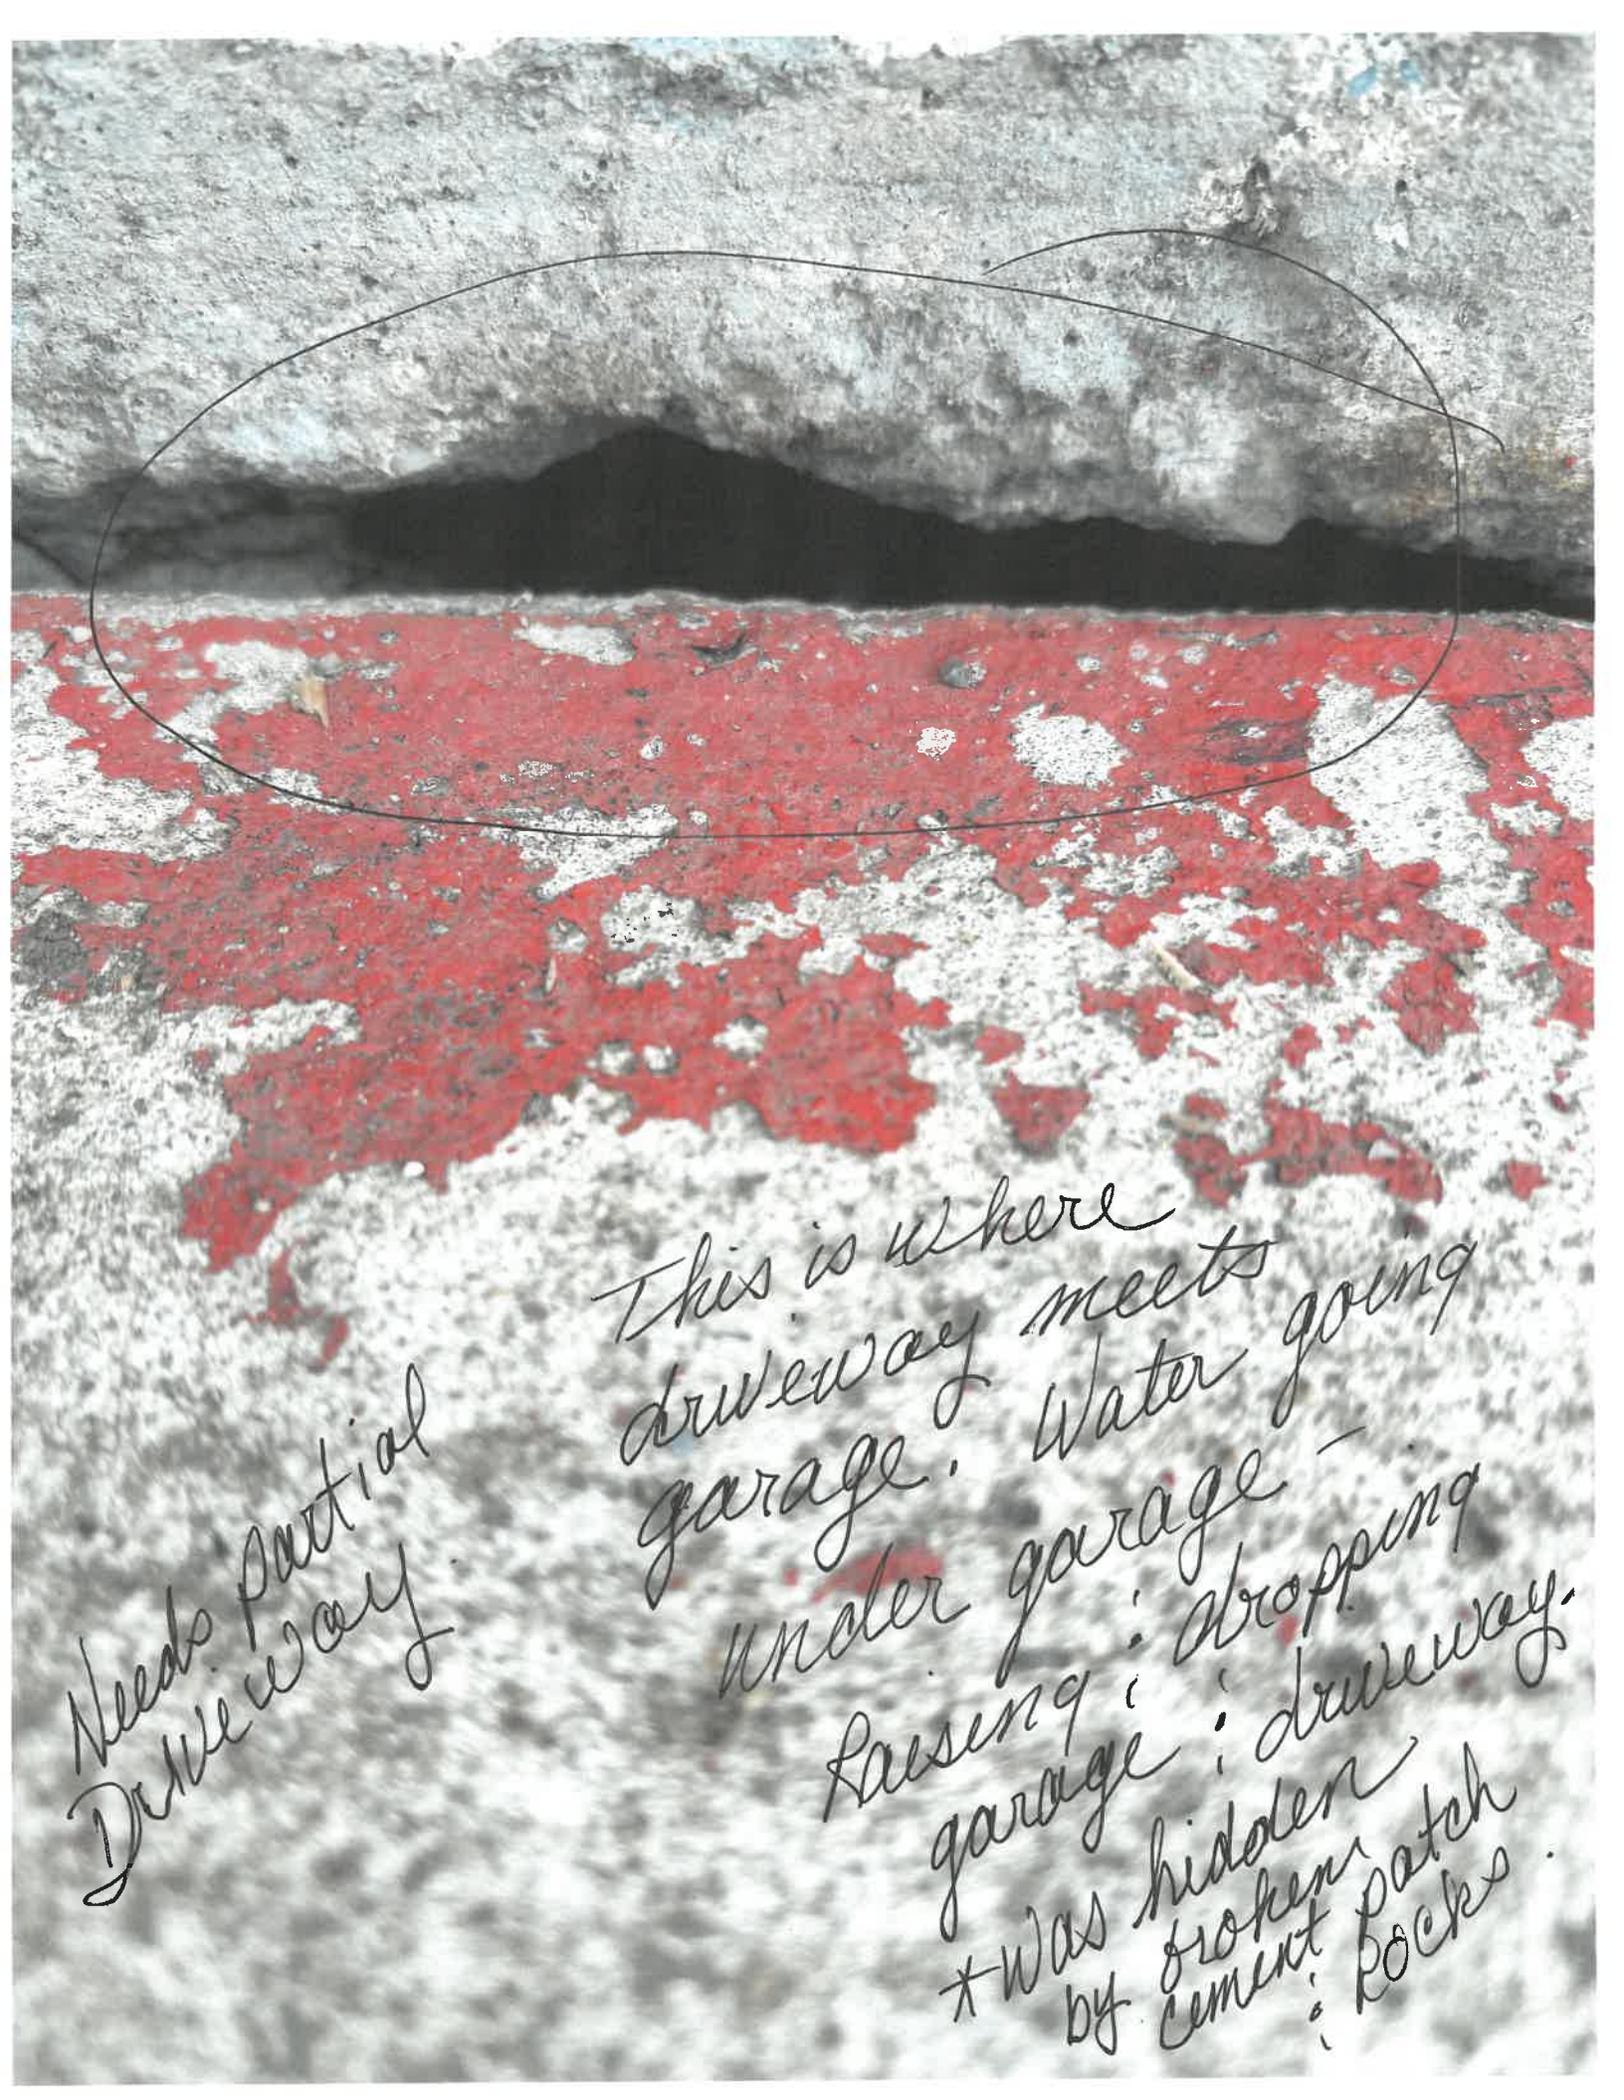
Needs partial  
Driveway

This is where  
driveway meets  
garage. Water going  
under garage -  
Raising; dropping  
garage; driveway.  
\* was hidden  
by cement patch  
& rocks.

Needed cement pad

\* Now needs replaced  
with new partial  
driveway

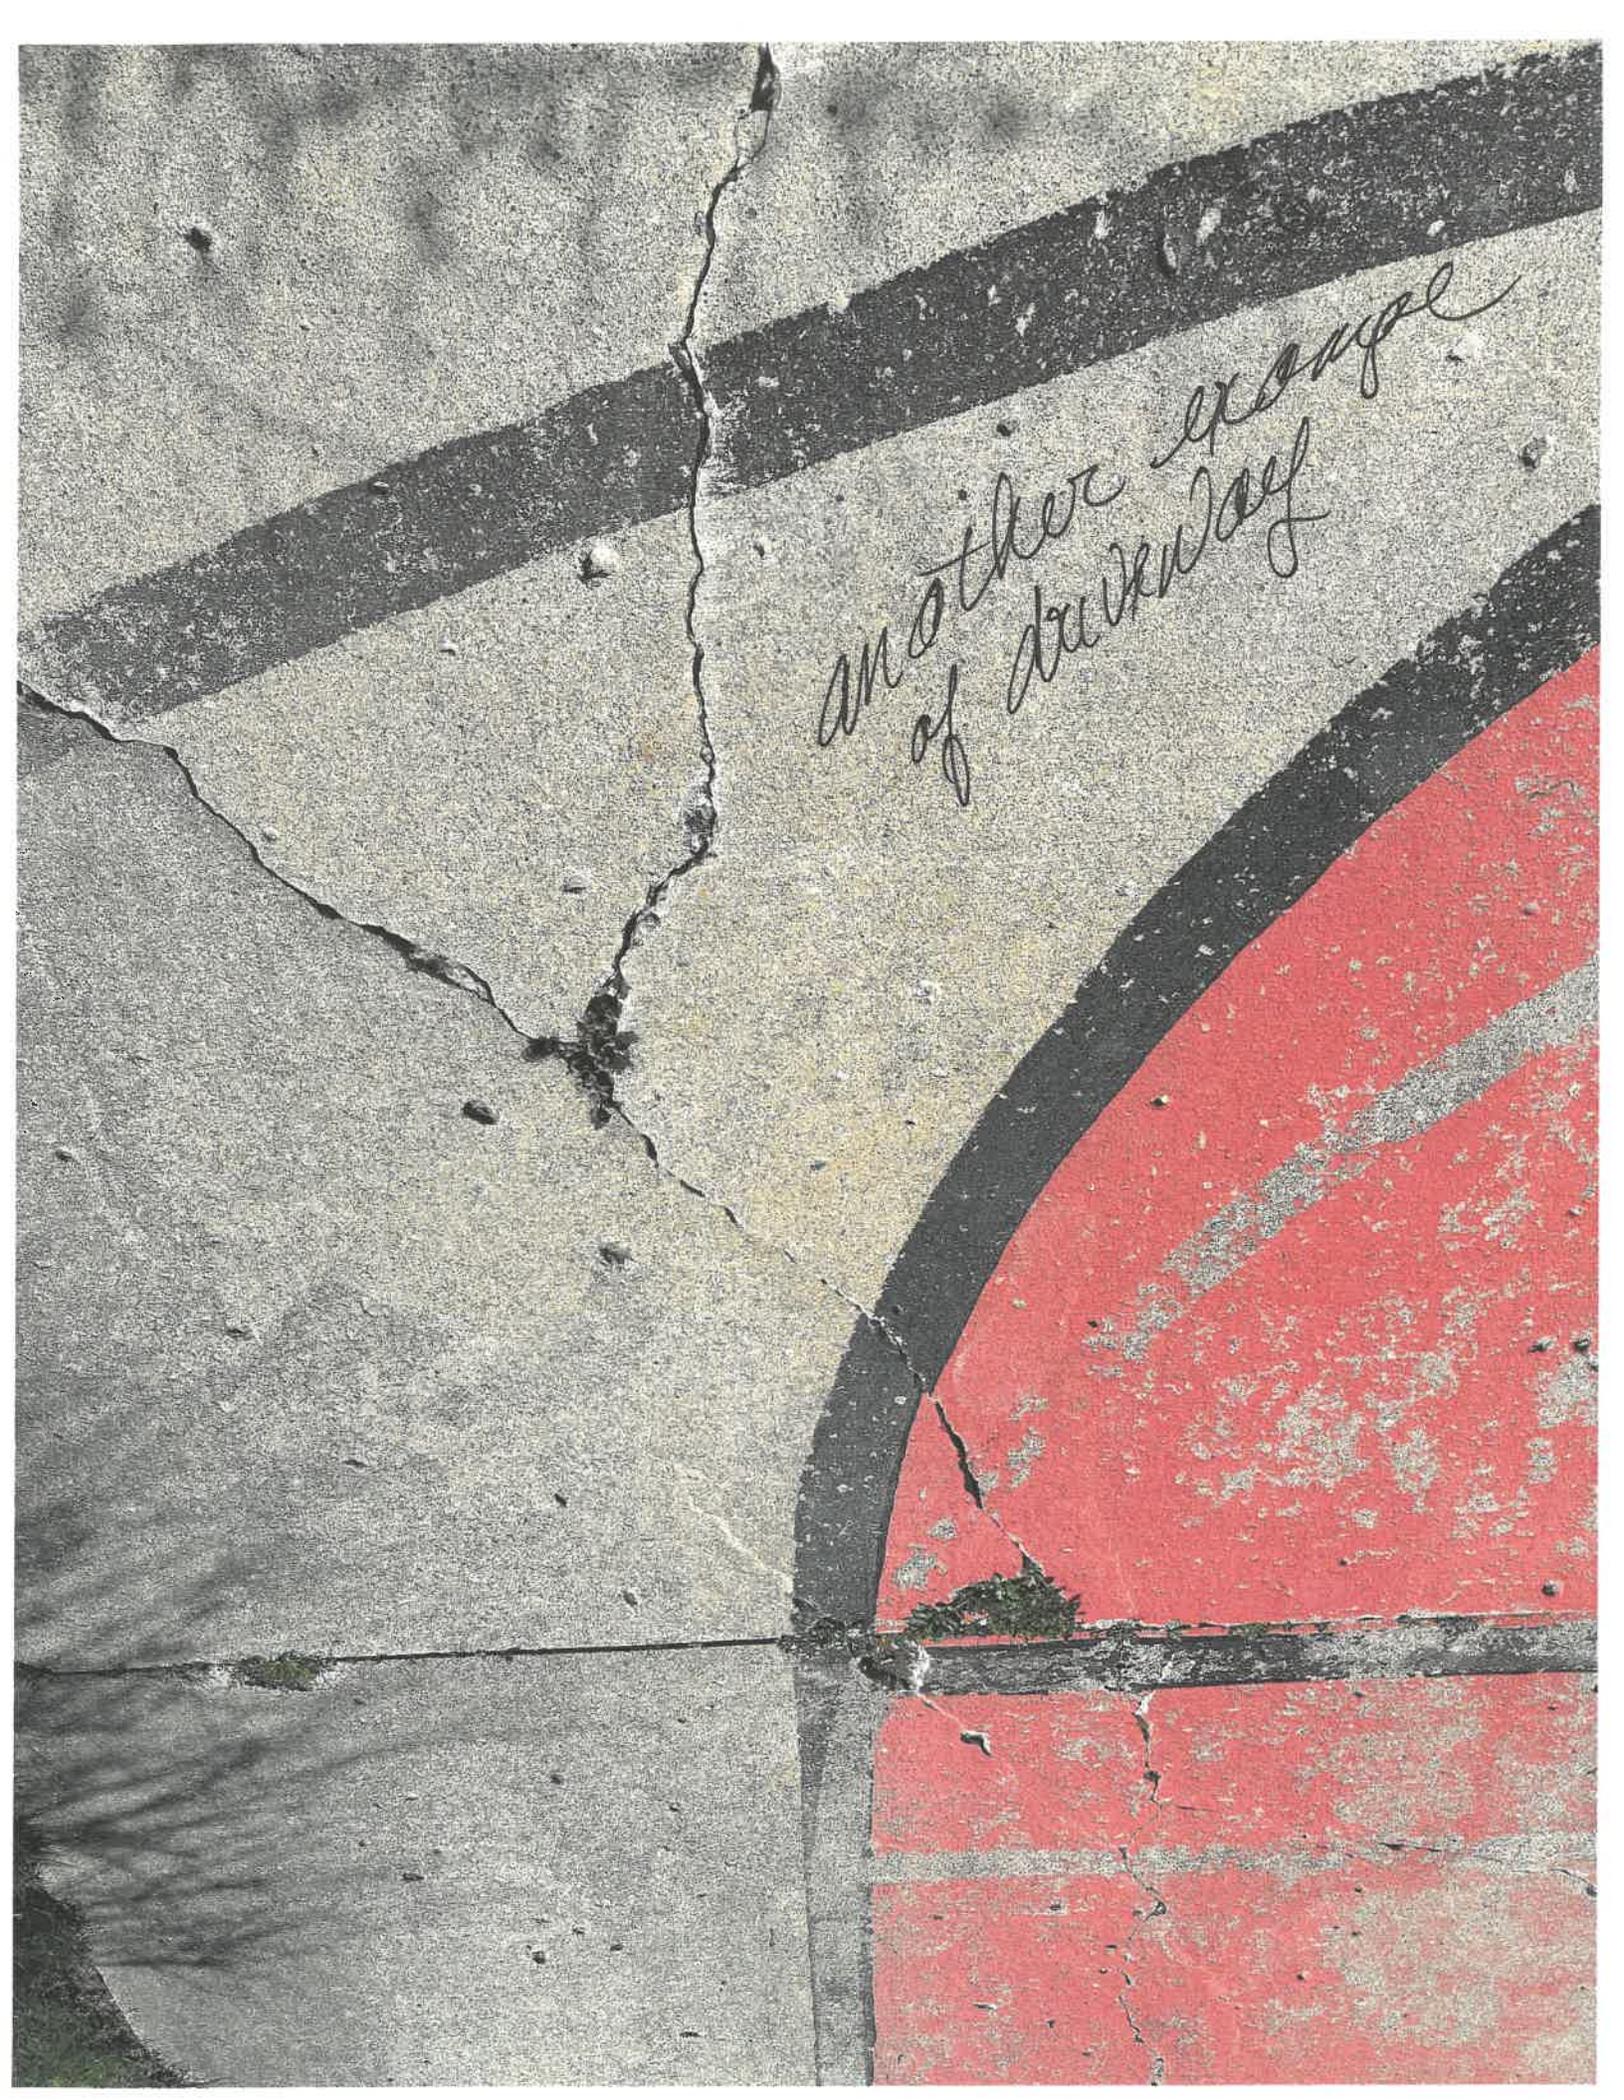
another example  
of damage

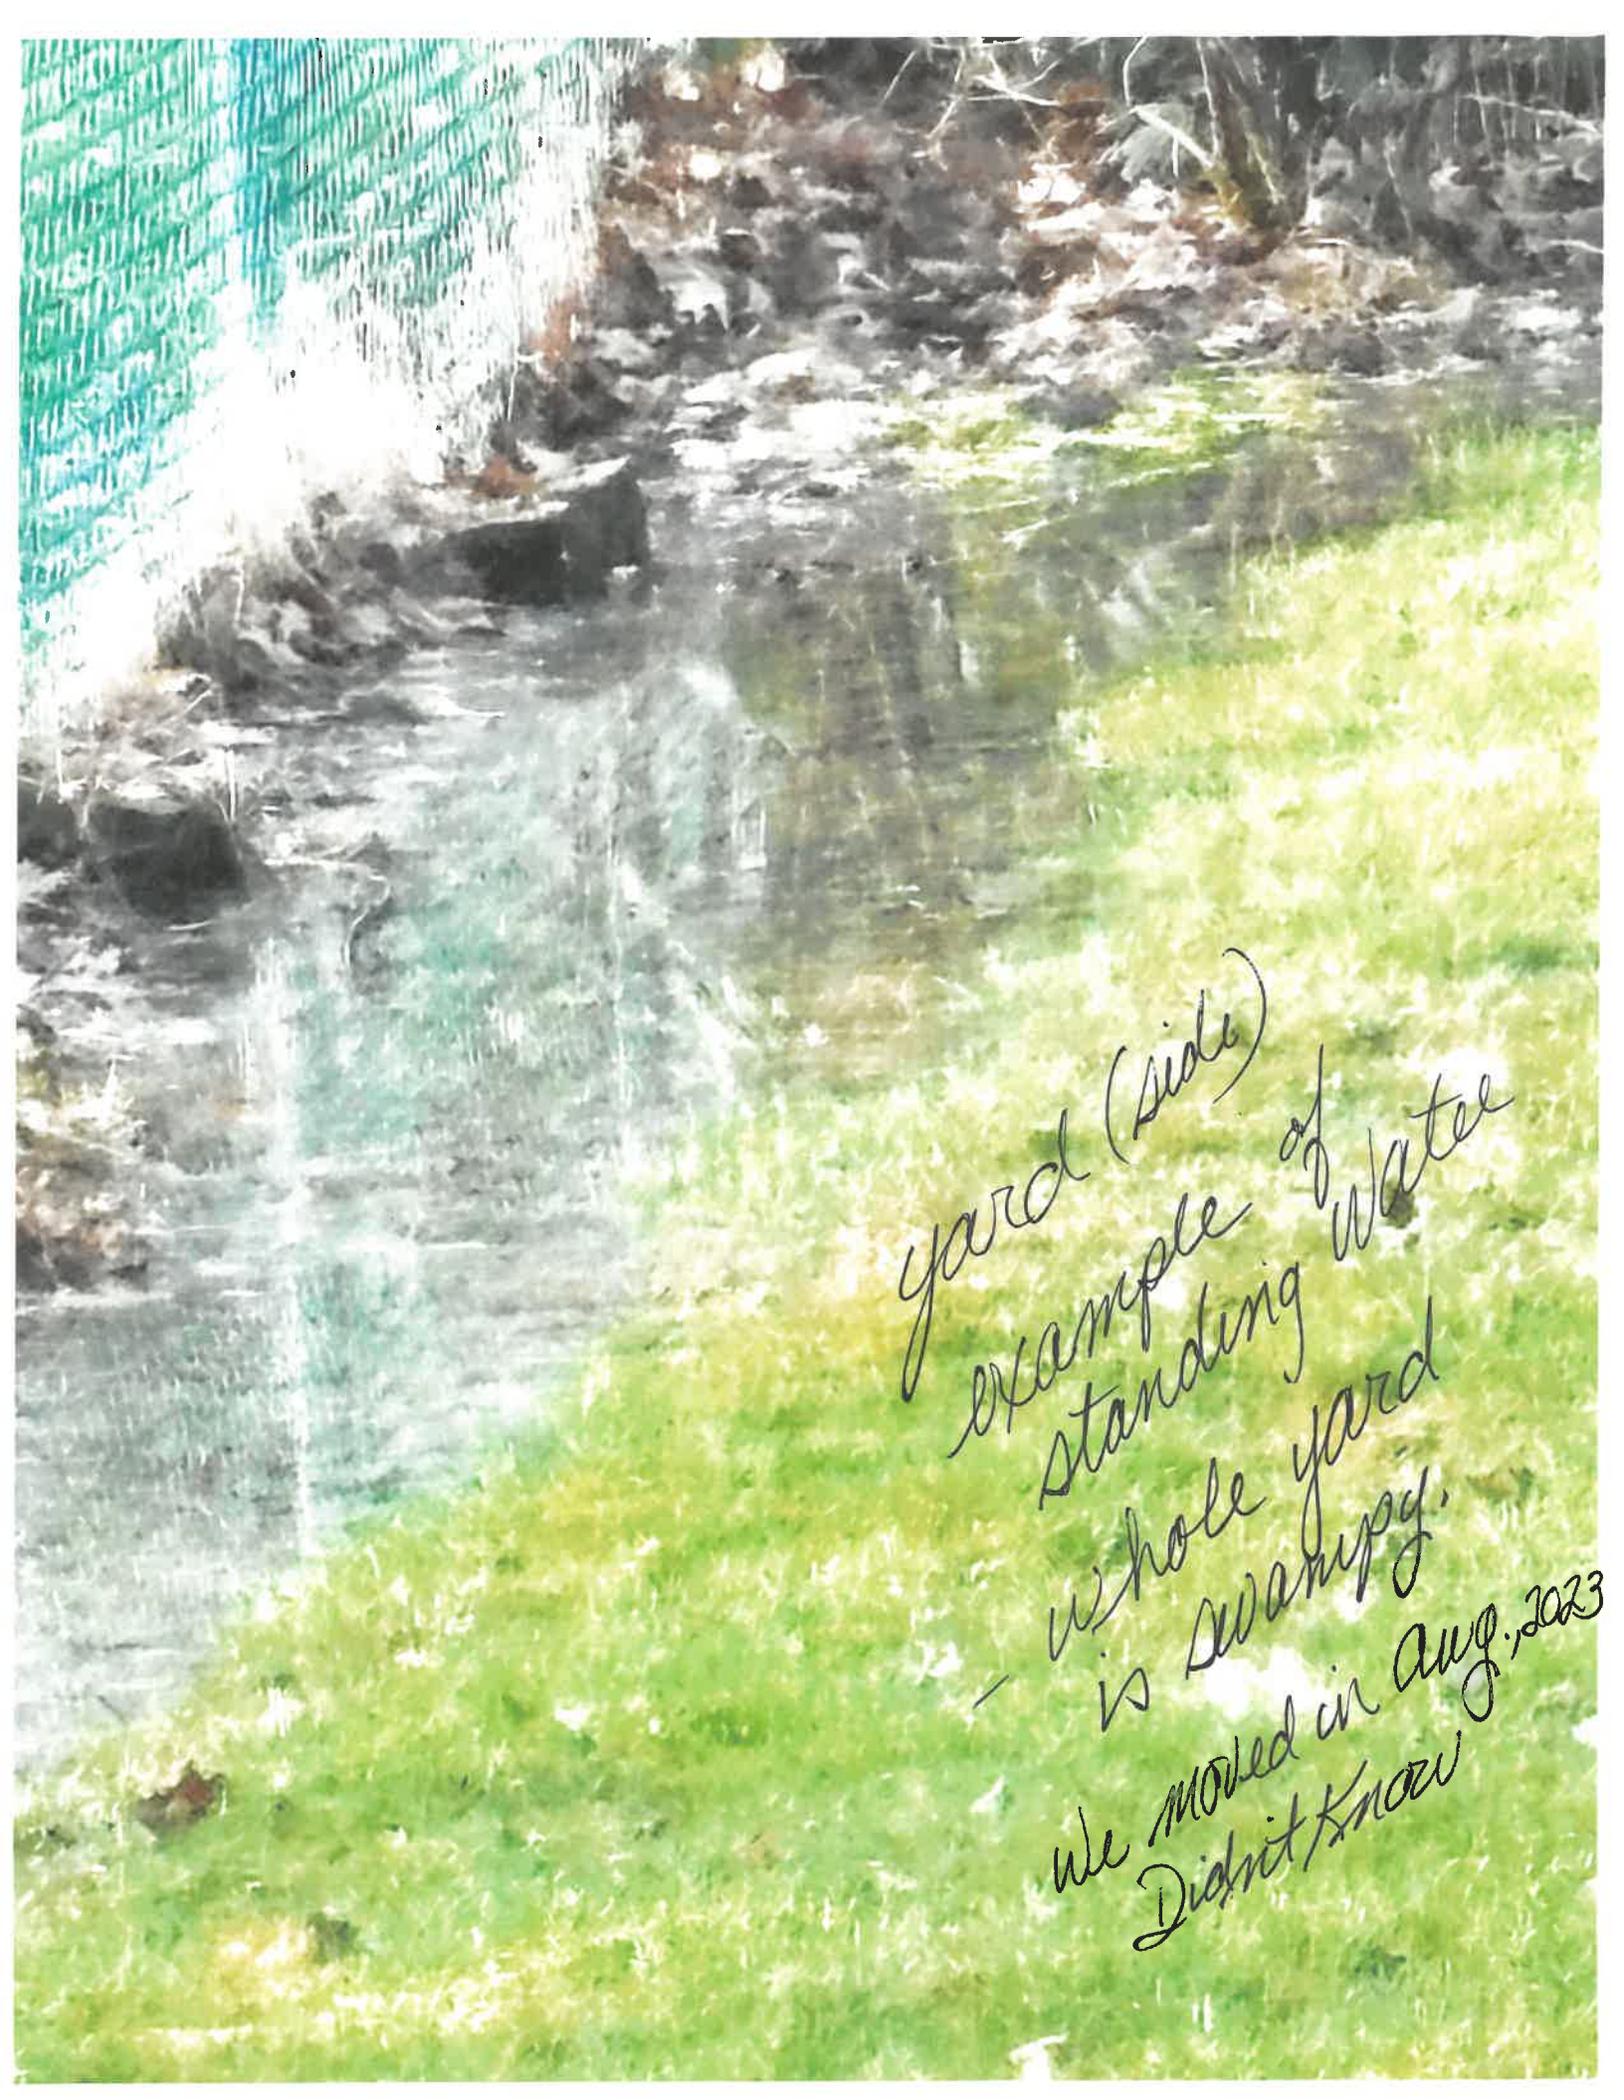
yard (side)  
example of  
standing water  
- whole yard  
is swampy.

We moved in Aug. 2023  
Didn't know

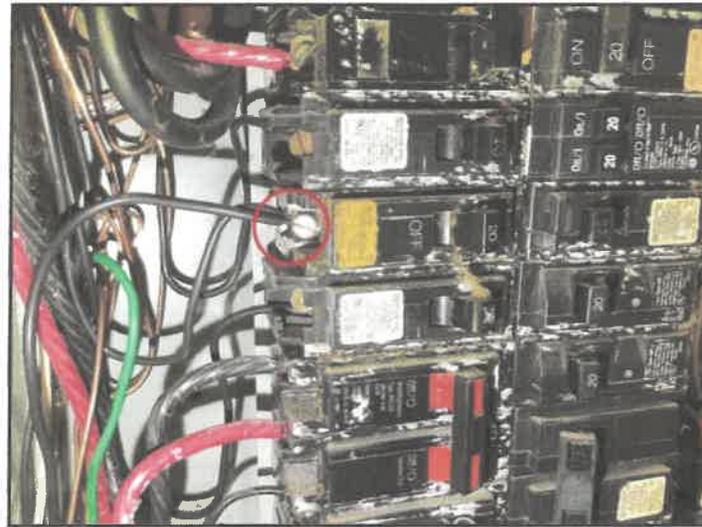
4. Double taps

**Condition:** • Double taps

Recommend having a licensed electrician correct double taps in panel.

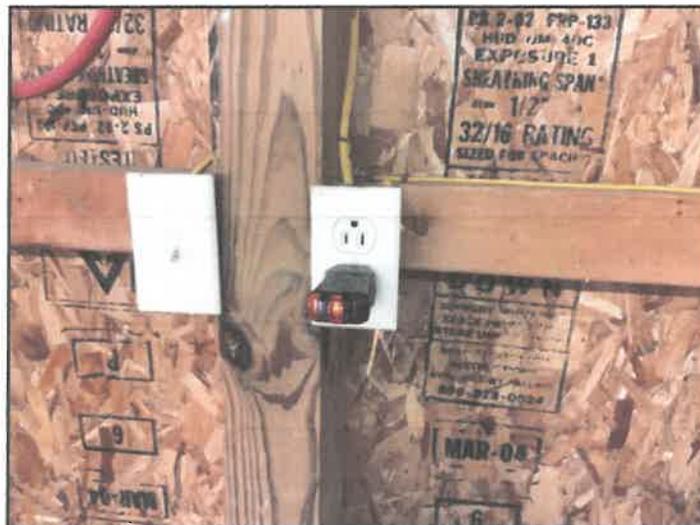
8. GFCI needed

**Condition:** • GFCI needed

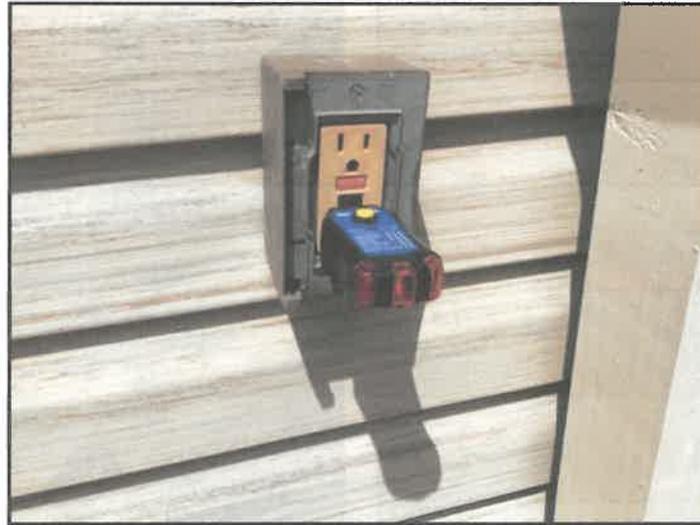
9. Test faulty on GFCI

**Condition:** • Test faulty on GFCI  
GFCI outlet failed to trip and or reset.

**Task:** Replace

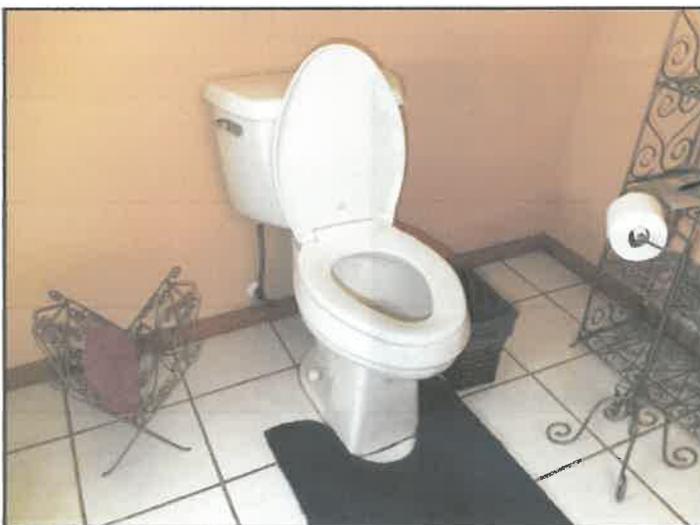
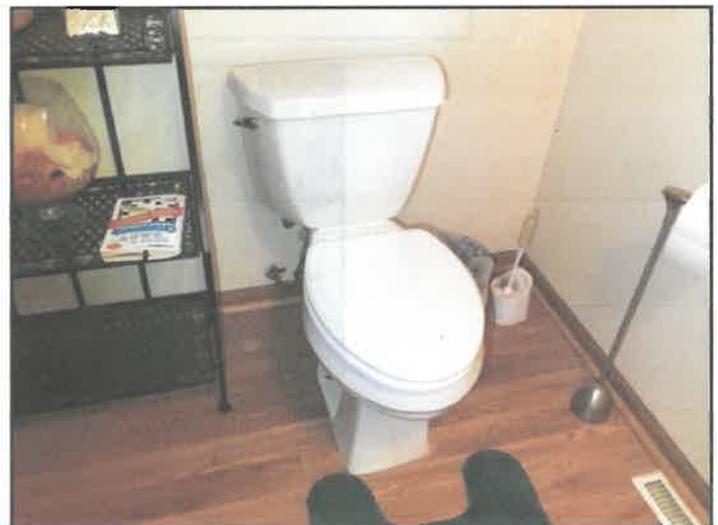
**Condition:** • [Loose](#)

Both toilets were very loose at the base. Recommend properly securing both toilets to prevent the toilets from leaking.

**Implication(s):** Chance of water damage to structure, finishes and contents | Sewage entering the building | Possible hidden damage

**Task:** Correct

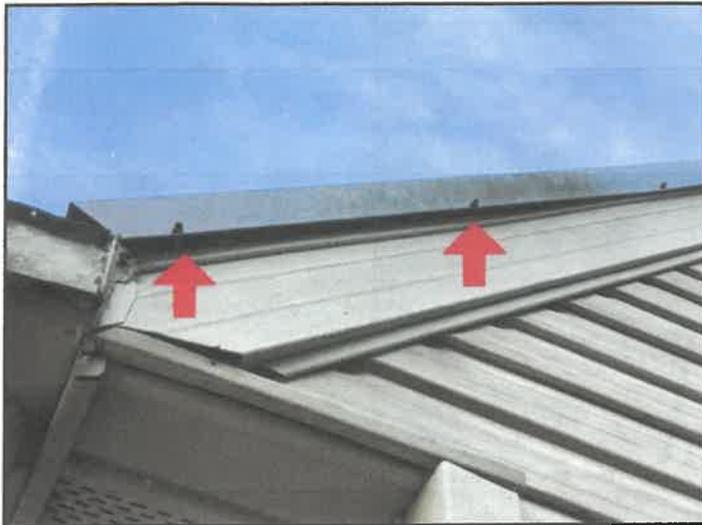
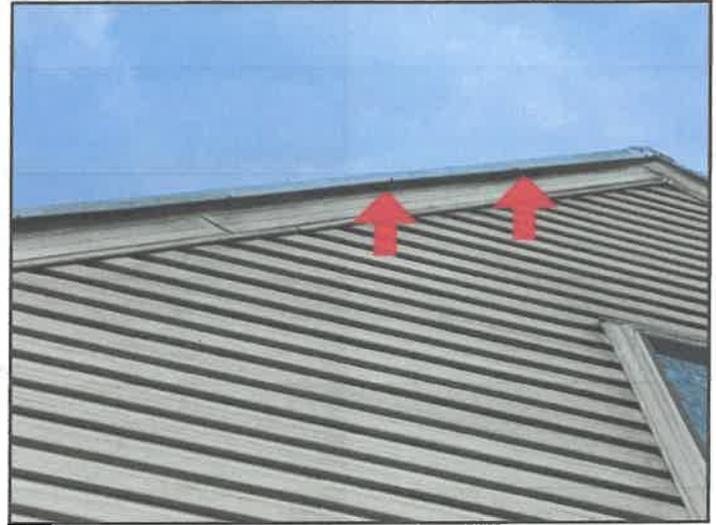
**3. Condition:** • [Missing, loose or broken pieces](#)

Screws came loose in the trim piece.

**Implication(s):** Chance of water damage to structure, finishes and contents

**Task:** Repair

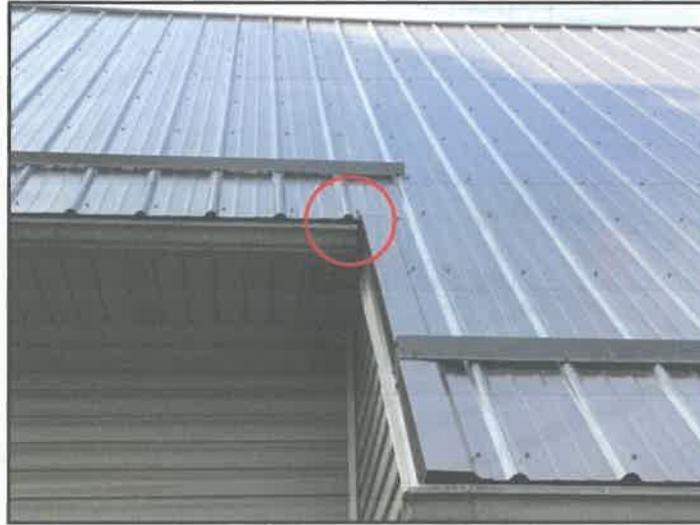
26. Kickout flashing - missing

4. Condition: • Kickout flashing - missing

Implication(s): Chance of water damage to structure, finishes and contents

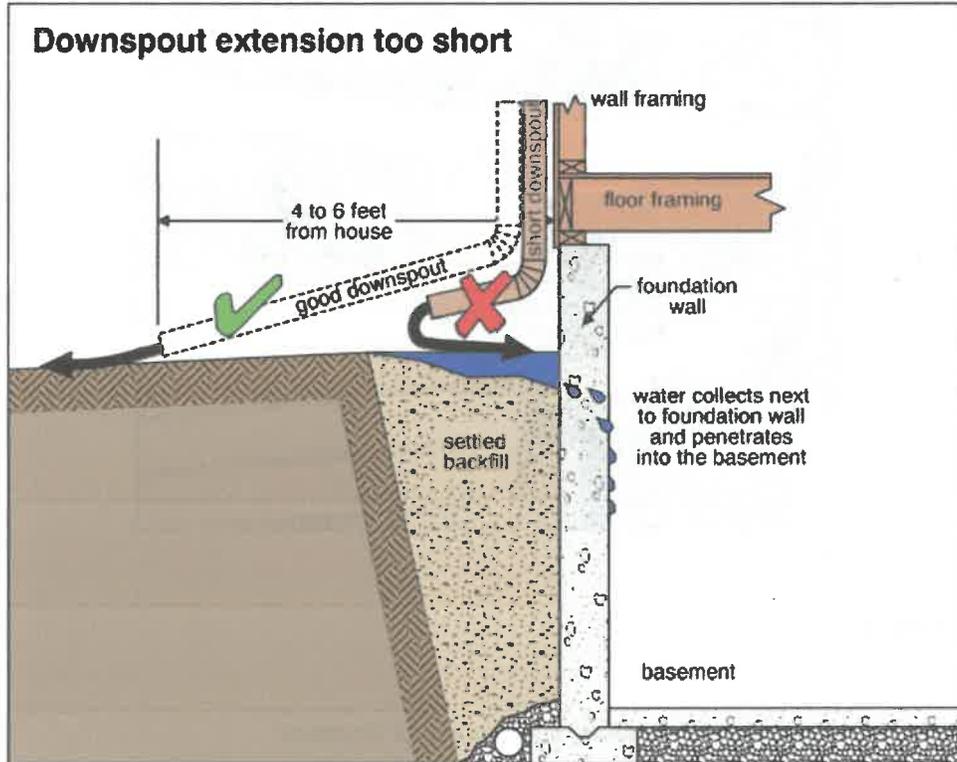
47. Discharge too close to building

**9. Condition:** • Discharge too close to building

**Implication(s):** Chance of water damage to contents, finishes and/or structure

**Task:** improve

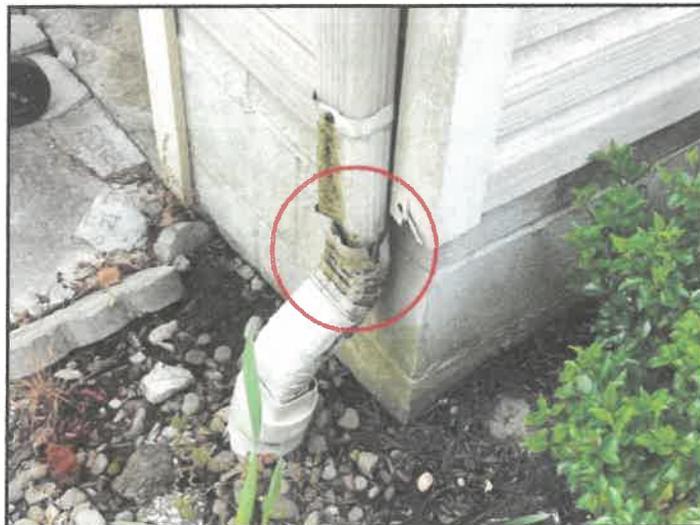
**48. Damaged / Crushed**

**10. Condition:** • Damaged / Crushed

**Implication(s):** Clogging / Leakage

**Task:** Replace

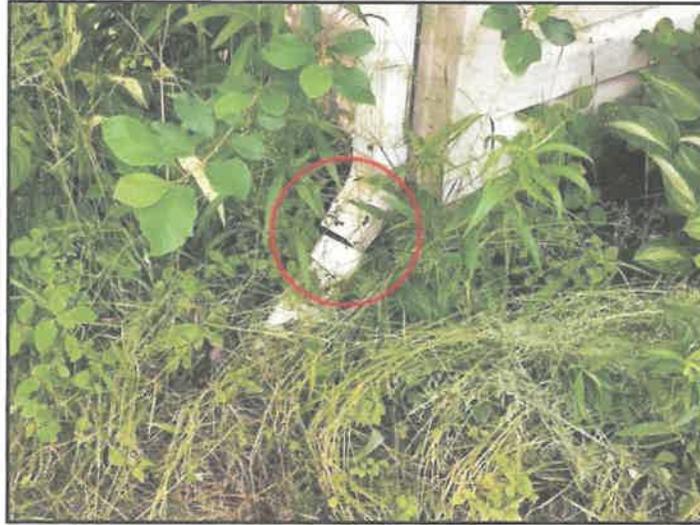
50. Connections loose

**12. Condition:** • Connections loose

**Implication(s):** Leakage

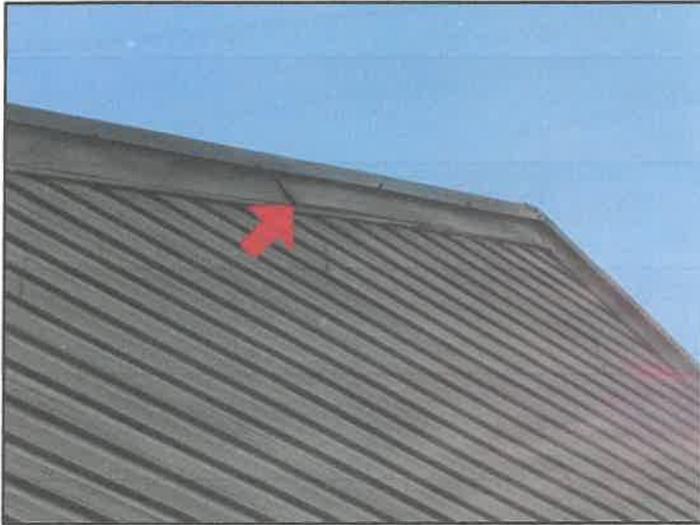
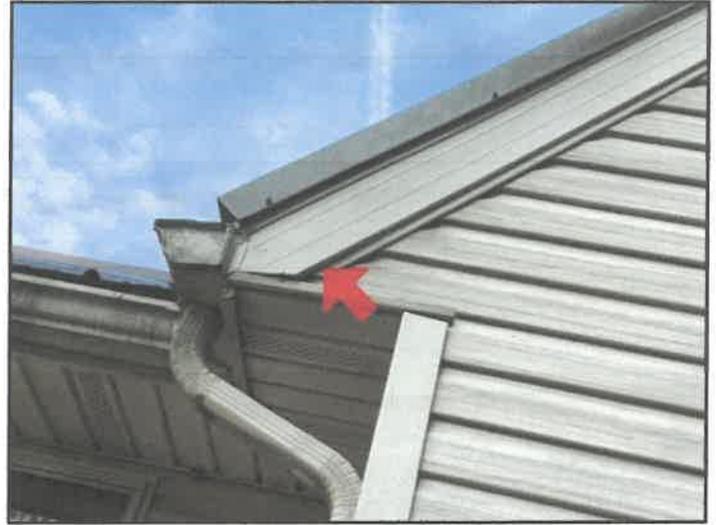
14. Condition: • Loose

Implication(s): Chance of water damage to contents, finishes and/or structure
