### Complaint Against the Valuation of Real Property

6. Parcel numbers from tax bill	Address of property
<u>07-021-10-009-21</u>	<u>1170 Greenbriar DR. Rock Creek, Ohio 44084 (Austinburg TWP)</u>

1170 Greenbriar Dr, Rock Creek, OH June 19, 2023

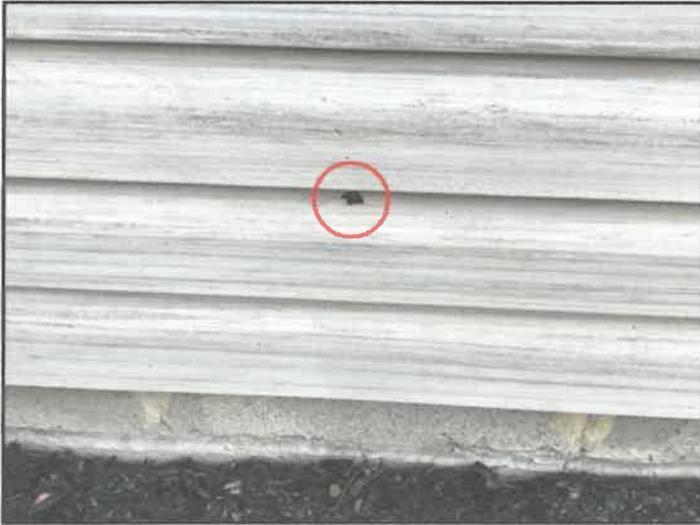
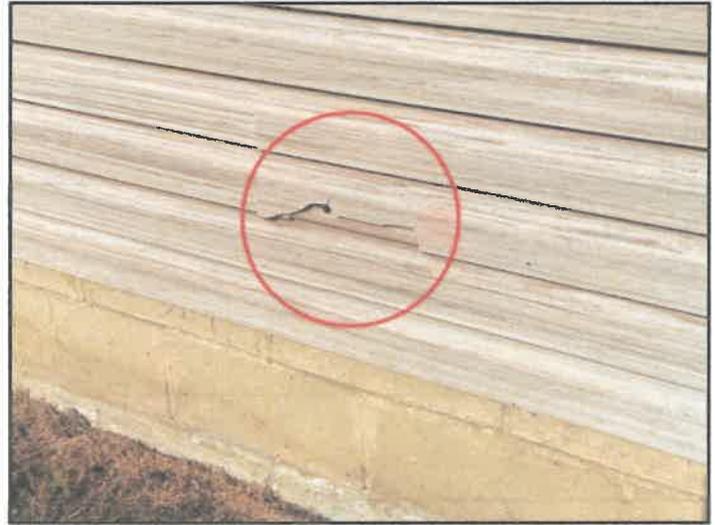
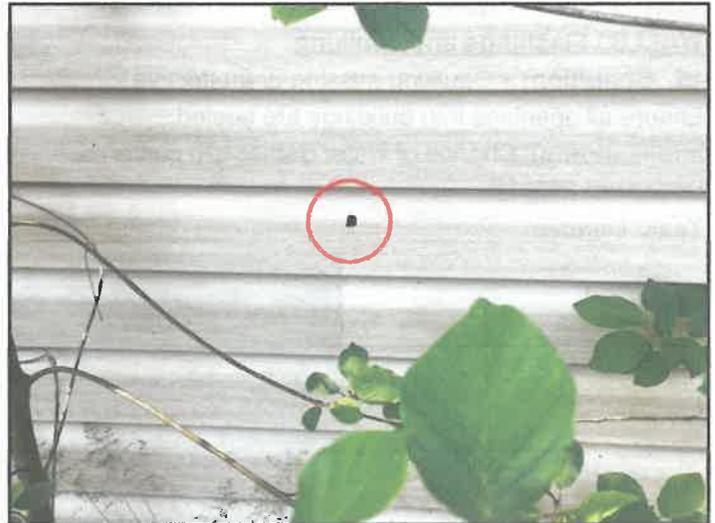
**16. Condition:** • Mechanical damage

**Implication(s):** Chance of water damage to contents, finishes and/or structure

**Task:** Repair or replace

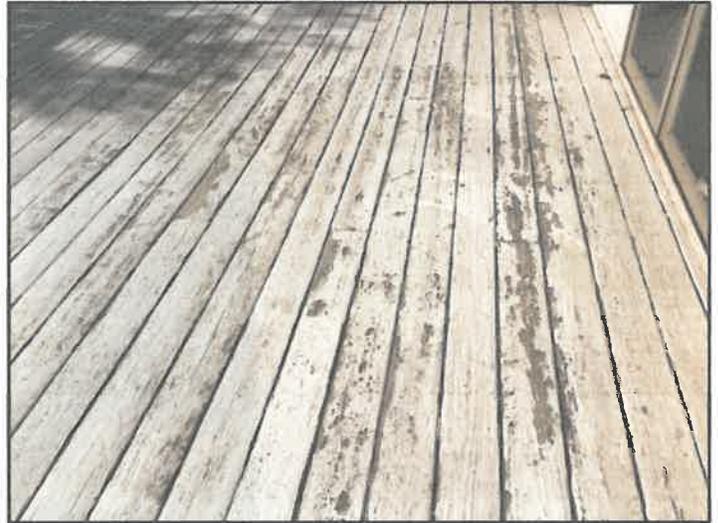
67. Seal or stain decking

**23. Condition:** • Seal or stain decking

**Implication(s):** Accelerated material deterioration

Recommend power washing and sealing / staining decking.

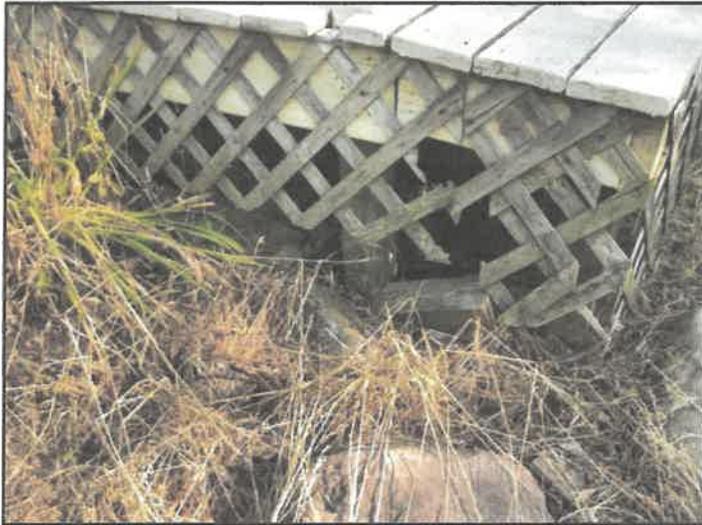
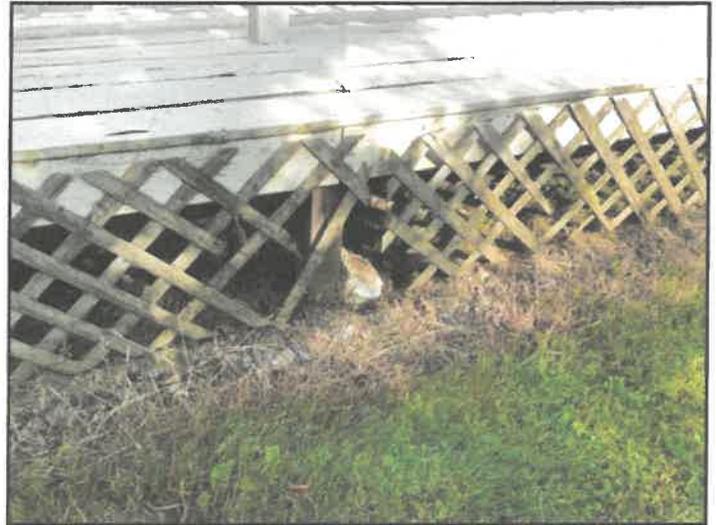
26. Condition: • **Damage**

Task: Repair or replace

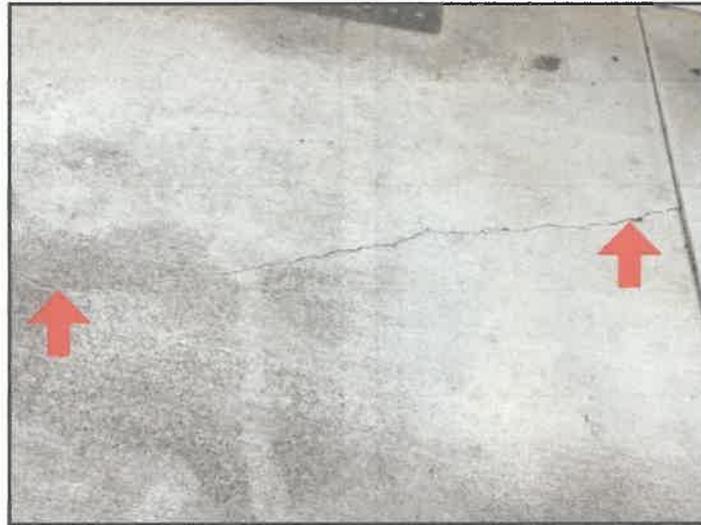
75. Cracked or damaged surfaces

**28. Condition:** • Cracked or damaged surfaces

Porch floor has settled and cracked.

**Implication(s):** Trip / Fall hazard

**Task:** Repair or replace

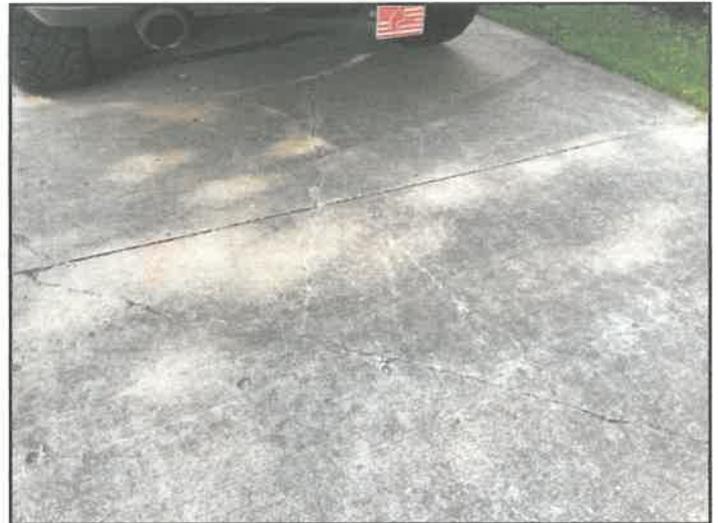
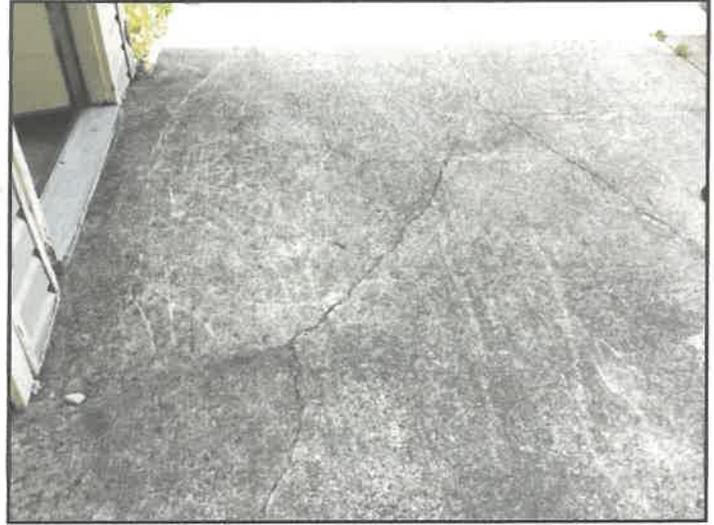
**29. Condition:** • Cracked or damaged surfaces

**Implication(s):** Accelerated Material Deterioration

**Task:** Repair or replace

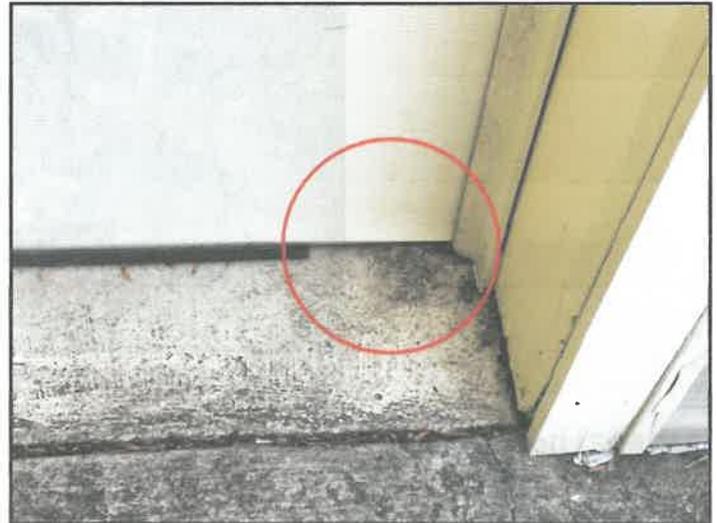
83. Missing / Damaged Weatherstripping

**32. Condition:** • Missing / Damaged Weatherstripping

**Task:** Repair or replace

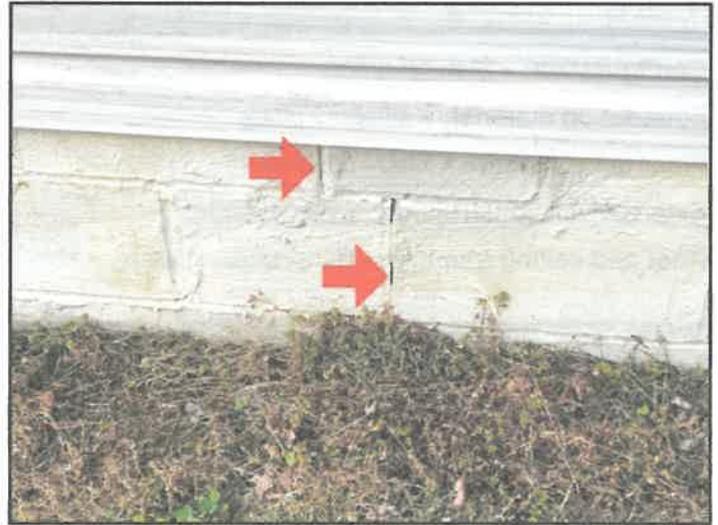
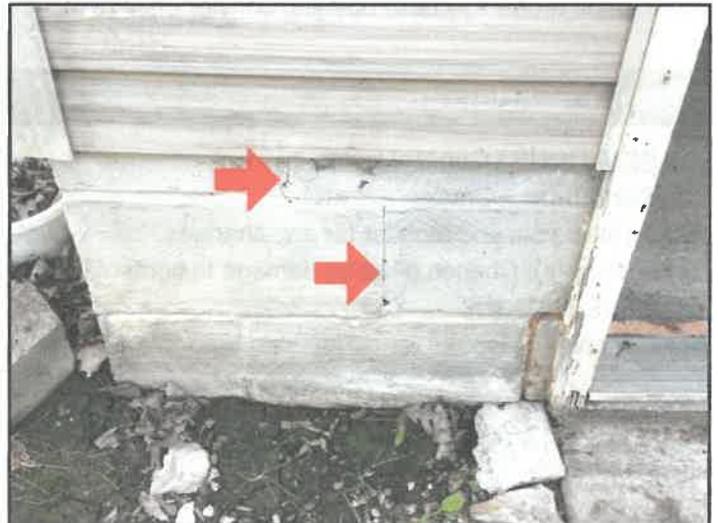
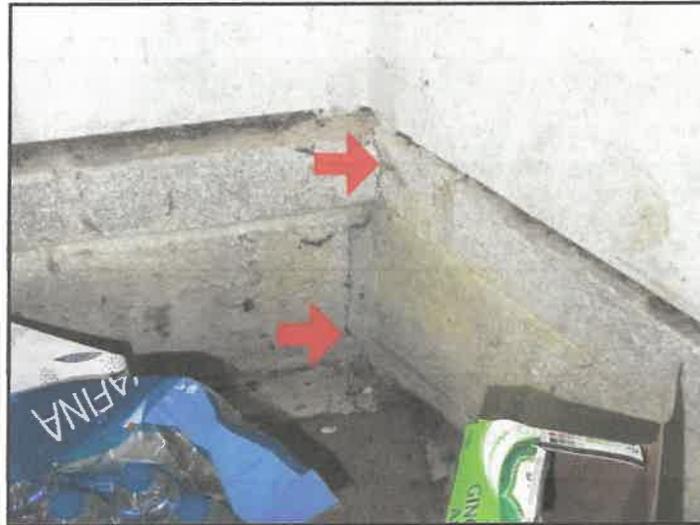
**33. Condition:** • Cracks

**Implication(s):** Chance of water damage to contents, finishes and/or structure | Weakened structure

Repair all cracks and monitor for any changes.

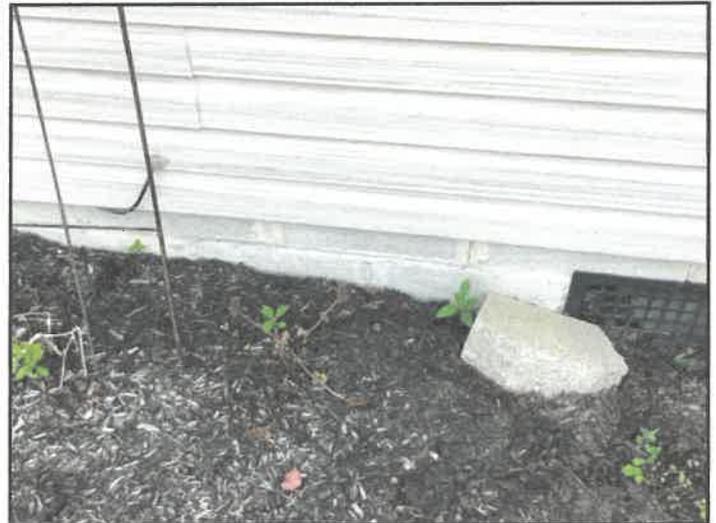
90. Prior repairs

**34. Condition:** • Prior repairs

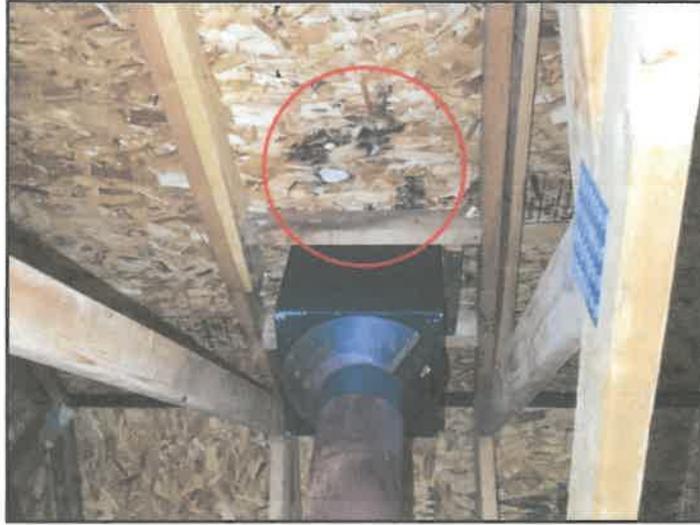
**91.** *Water stains*

**35. Condition:** • Water stains

Water stains noted to roof structure in the garage. Area appeared dry at the time of inspection.

**Implication(s):** Material deterioration / Active roof leak

**Task:** Monitor / Repair

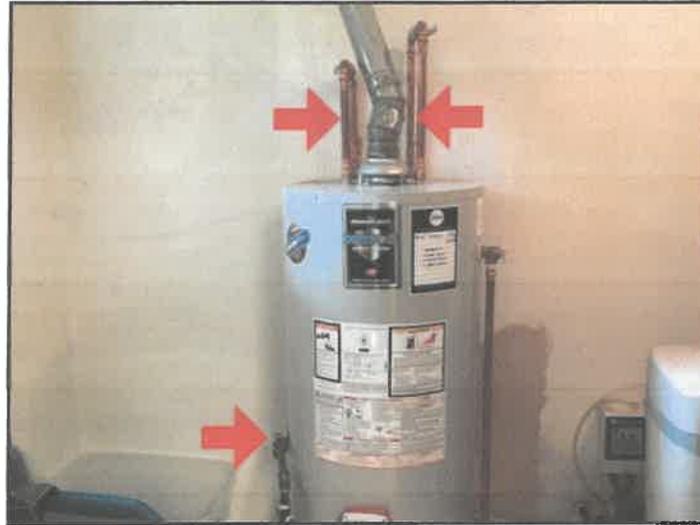
99. Missing bonding wire

#### **36. Condition:** • Missing bonding wire

**Implication(s):** Fire hazard

It is recommended to bond gas / water lines. If the gas lines accidentally carry electricity or even a static charge, proper bonding will allow the electricity to be carried back to its source in a safe manner.

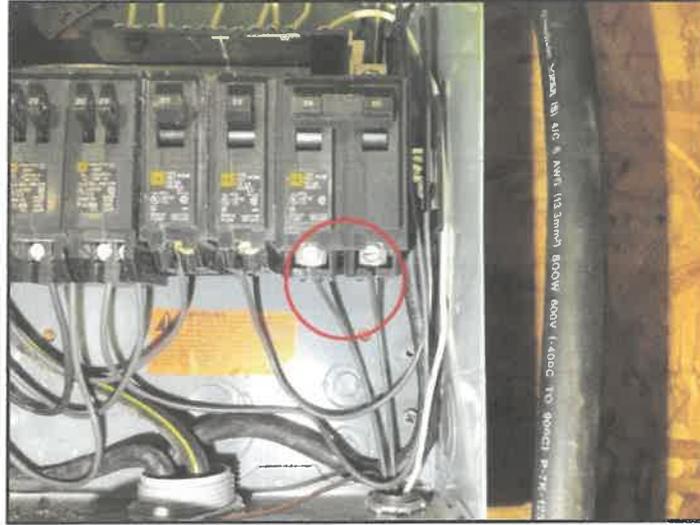
101. Breakers / fuses too big

**38. Condition:** • Breakers / fuses too big

Appears the wires powering the 50-amp breaker are undersized. Recommend having a licensed electrician evaluate and make any needed repairs.

**Implication(s):** Equipment overheating | Fire hazard

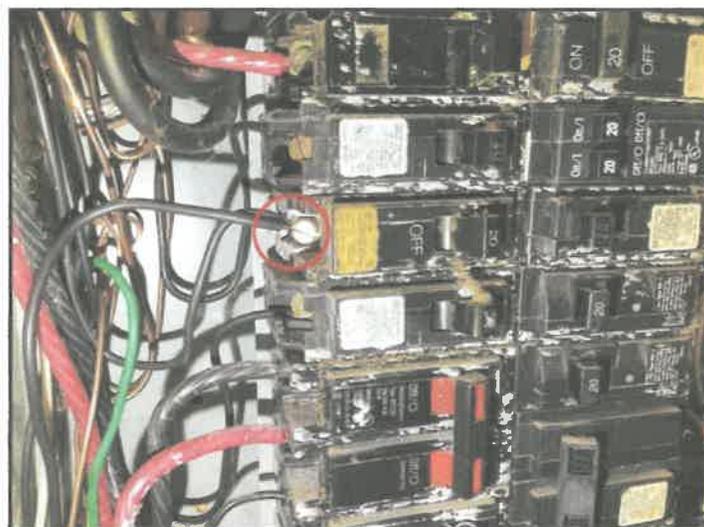
**103. Double taps**

**40. Condition:** • Double taps

**Implication(s):** Fire hazard

Recommend having a licensed electrician correct double taps in panel.

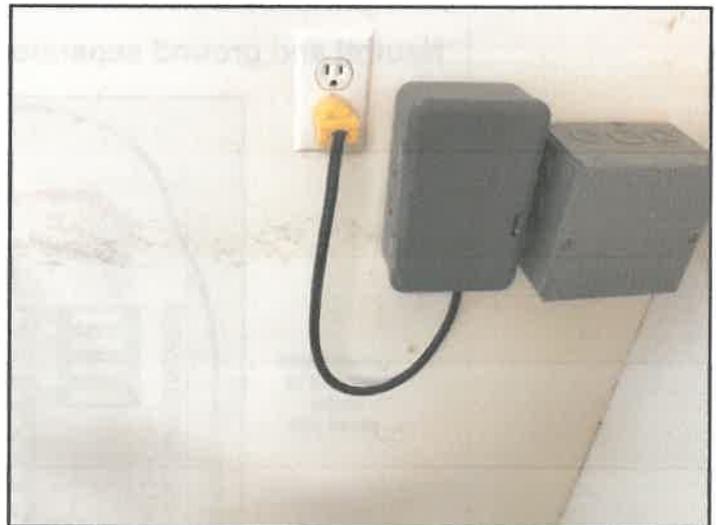
106. Extension cord used as permanent wiring

**42. Condition:** • Extension cord used as permanent wiring

**Implication(s):** Electric shock | Fire hazard

Recommend removing extension cord and properly installing outlet / light fixture box.

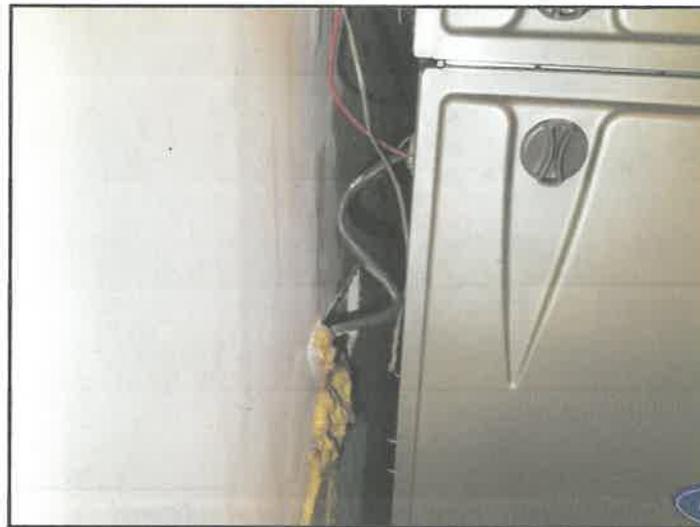
107. Exposed on walls or ceilings

**43. Condition:** • Exposed on walls or ceilings

**Task: Correct**

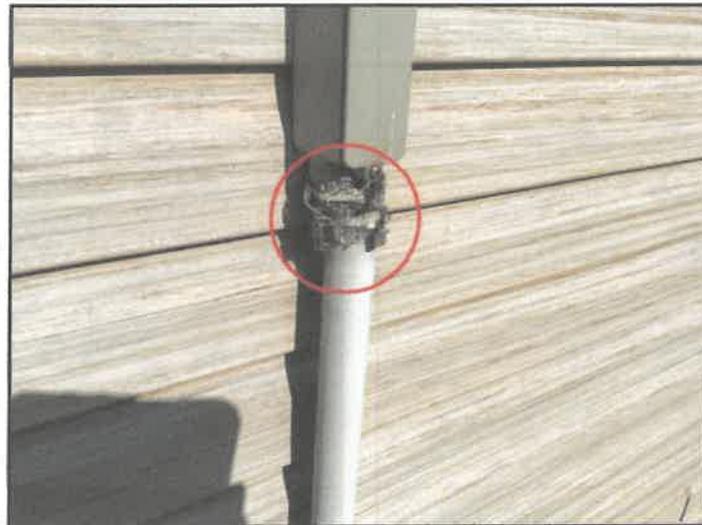
108. Exposed

**44. Condition:** • Exposed

**Task: Repair**

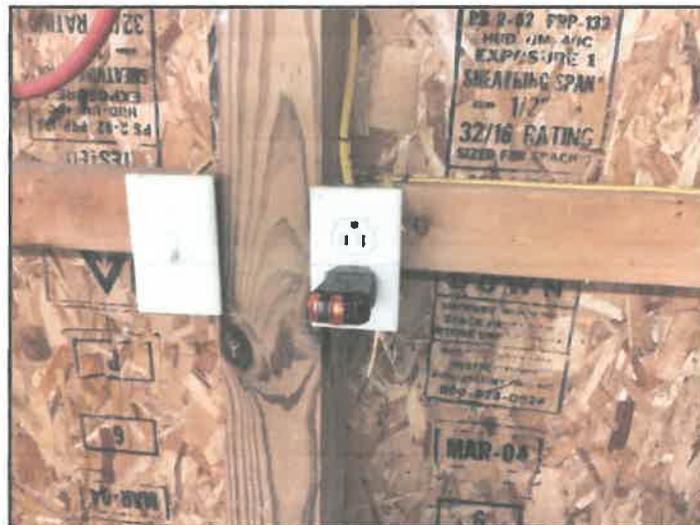
111. GFCI needed

45. Condition: • GFCI needed

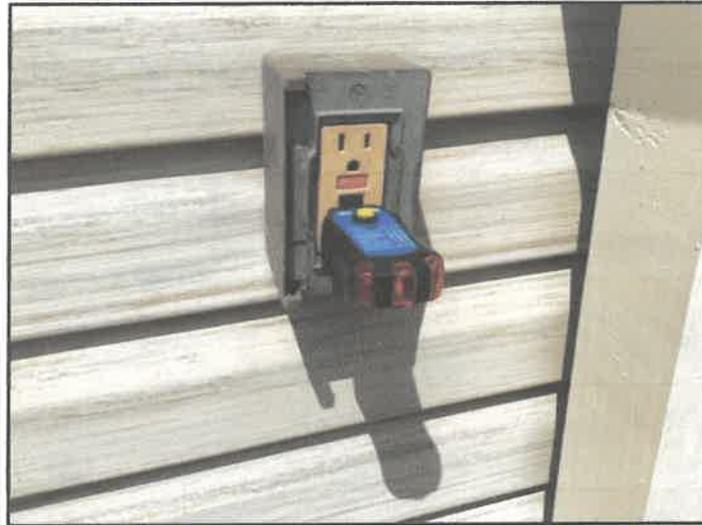
112. Test faulty on GFCI

**46. Condition:** • Test faulty on GFCI

GFCI outlet failed to trip and or reset.

**Task:** Replace

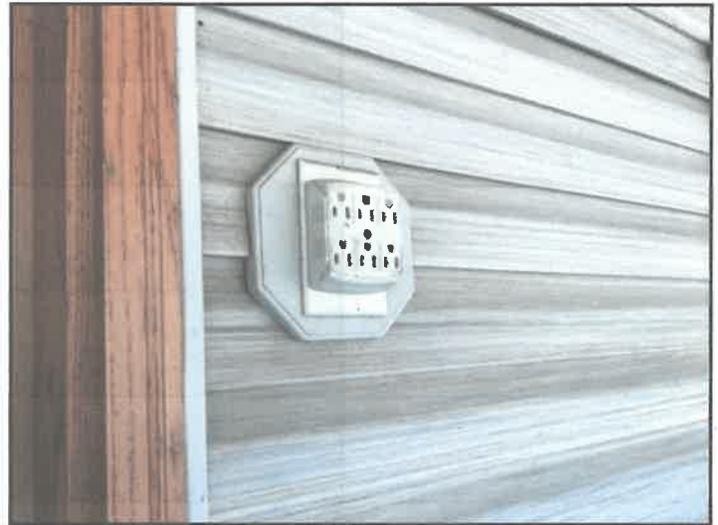
118. Missing

**51. Condition:** • Missing  
**Implication(s):** Electric shock  
**Task:** Replace

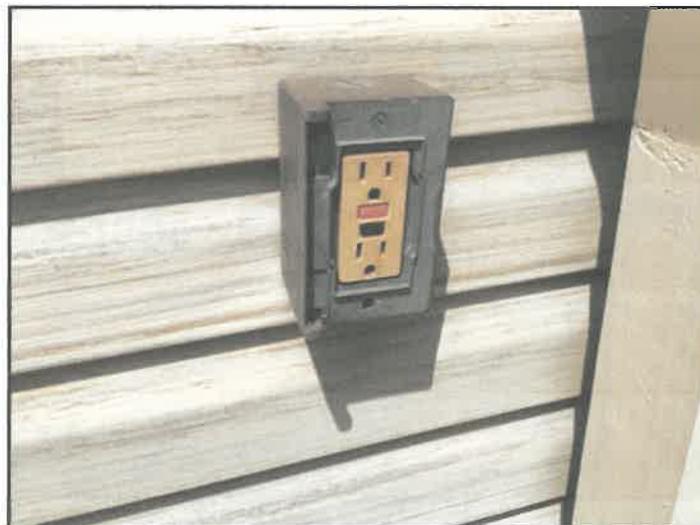
119. Damaged

**52. Condition:** • Damaged

**Task:** Replace

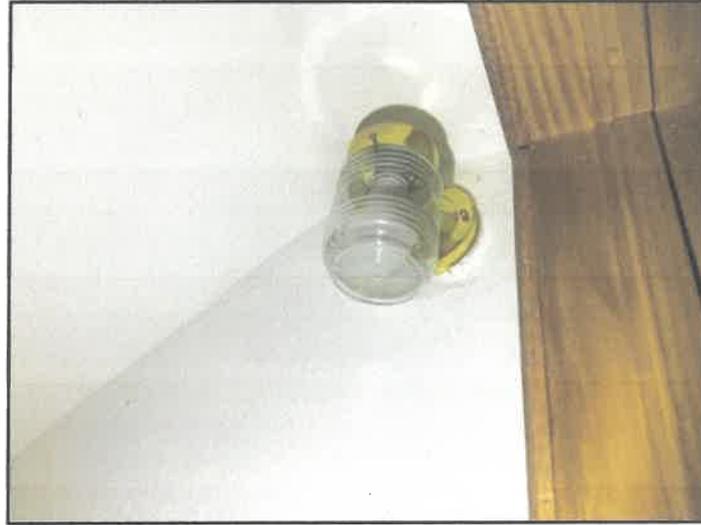
120. Inoperative

**53. Condition:** • Inoperative

**Implication(s):** Inadequate lighting / Nuisance

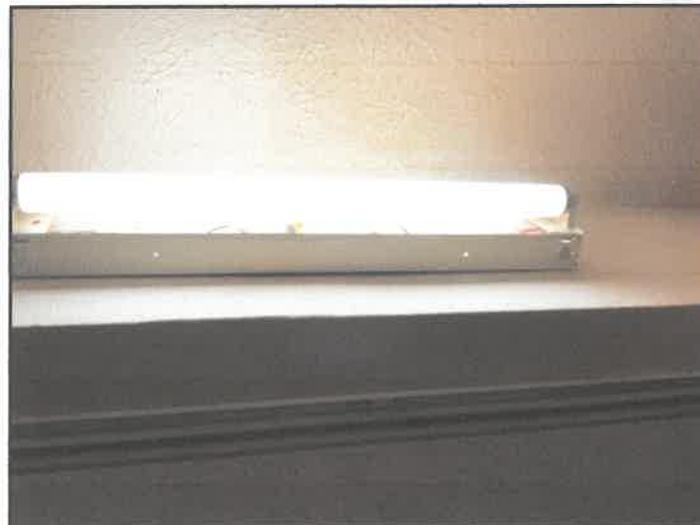
121. Missing light cover

**54. Condition:** • Missing light cover

**Implication(s):** Electrical Hazard

**Task:** Replace
