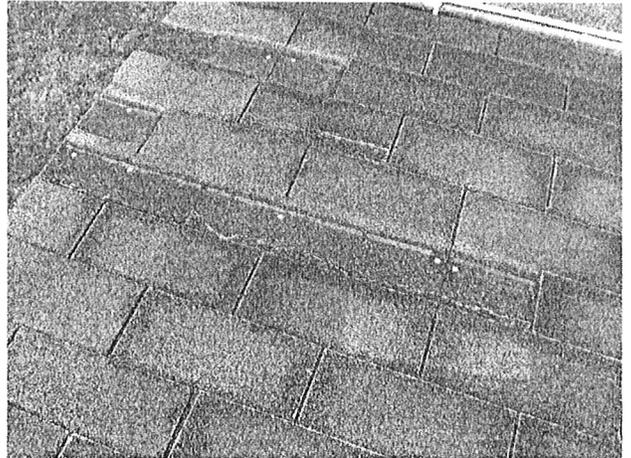
#R4

Missing shingles with expose roofing nails

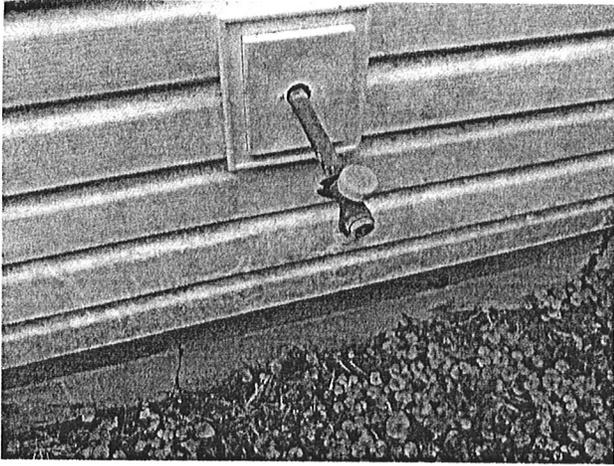
#EX1

Exterior faucet loose from house

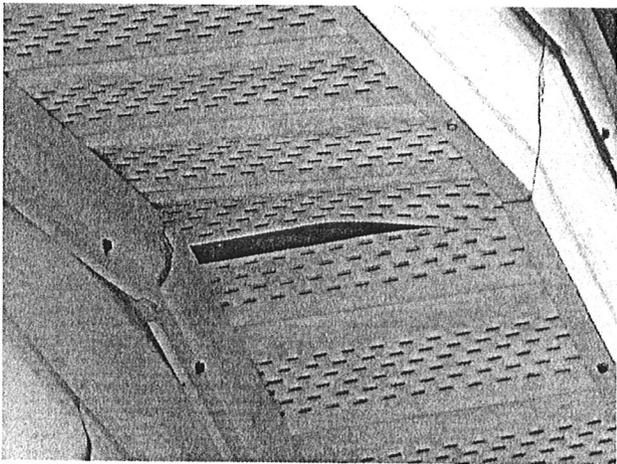
#EX3

Gap in soffit

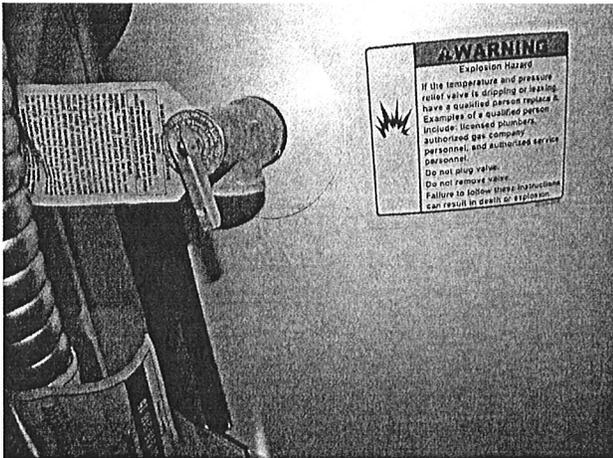
#P3

No extension off hot water tank TPR valve

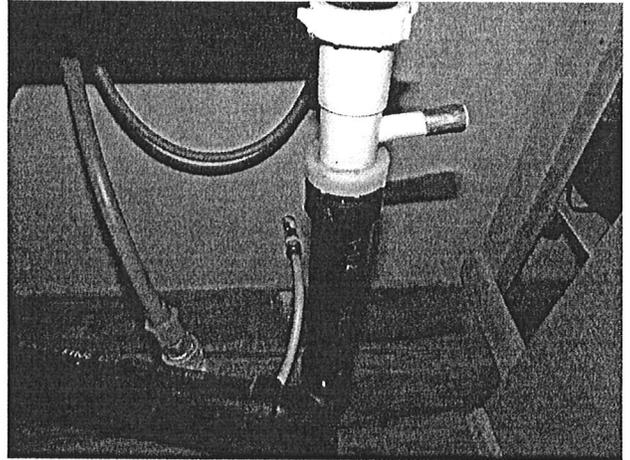
#K2

Kitchen sink plumbing leaks

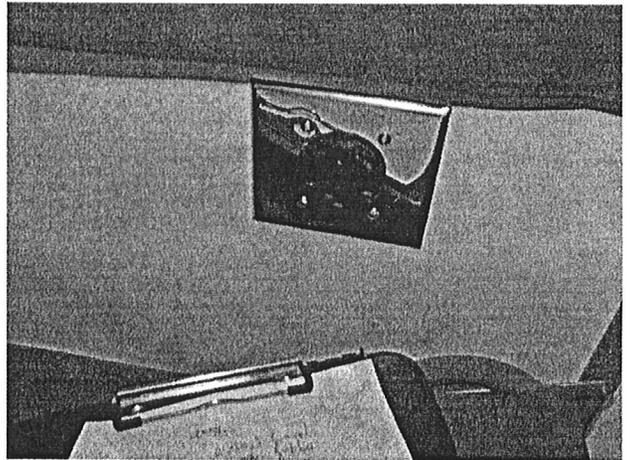
#K4

No power dryer plug

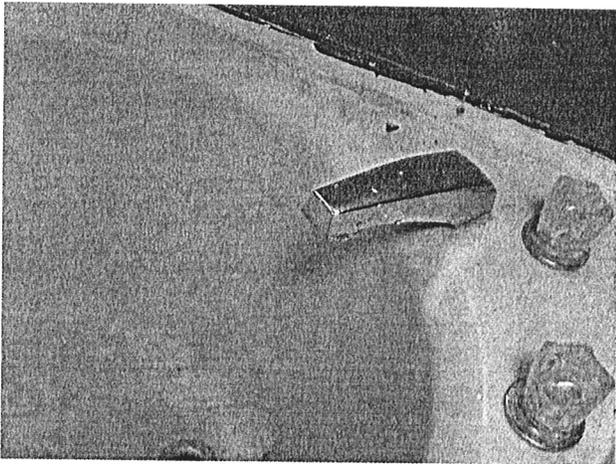
**Bathroom #B3**

**Garden tub faucet drips**
