### Complaint Against the Valuation of Real Property

Customer: Chris Brummitt  
Contact: DariusWilliams, Berkshire  
Phone: 440-381-3599  
Location: 1212 US 6  
Rome, OH 44085

#### 1 - Roof

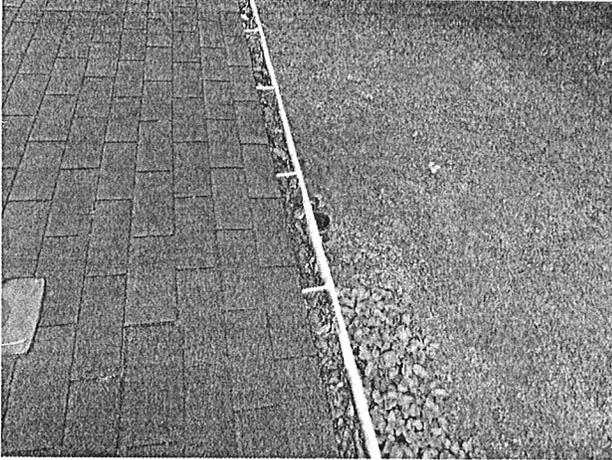
#R1

1. Maintenance Item. Debris in gutters. This will cause excessive water against foundation when gutters clog and possibly enter crawlspace(see photo 1).

Debris in gutters

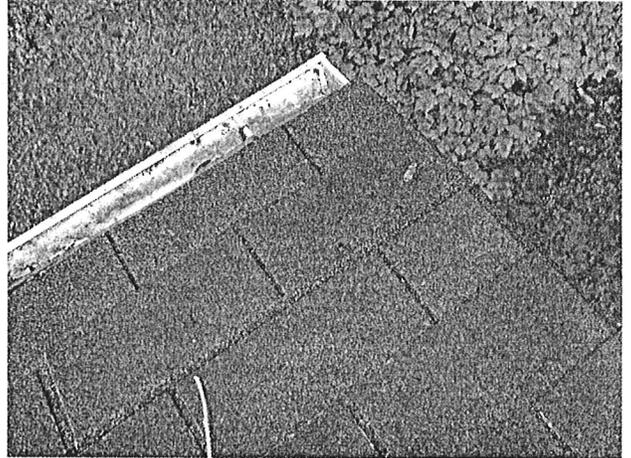
#R2

2. Major Concern. Missing shingles with expose roofing nails. Three holes in shingles that has caused water intrusion and rotted out sheathing. Sewer boot rubber has deteriorated. Roof shingles are 27+ years old. These shingles have a life span of 20 years. Shingles are at the end of their useful life span(see photo 2,3&4).

Holes in shingles has rotted out sheathing

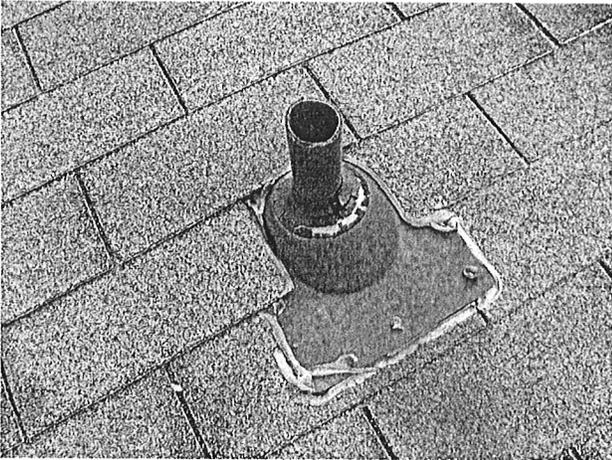
#R3

Sewer boot rubber is deteriorated

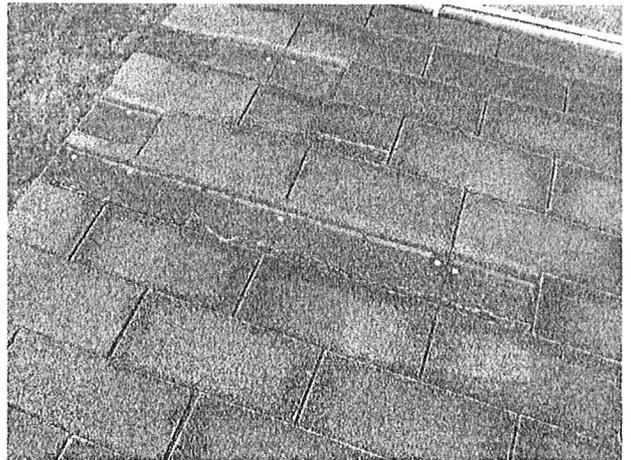
#R4

Missing shingles with expose roofing nails

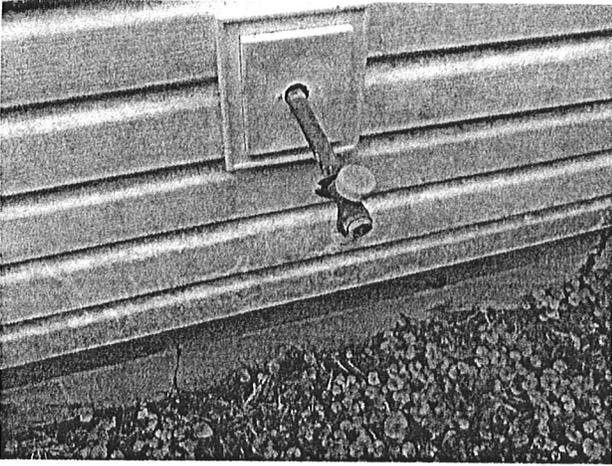
#EX1

Exterior faucet loose from house

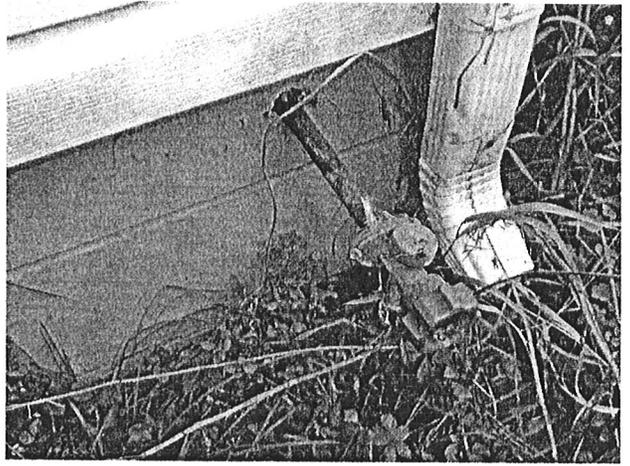
#EX2

Exterior faucet not hooked up to water lines

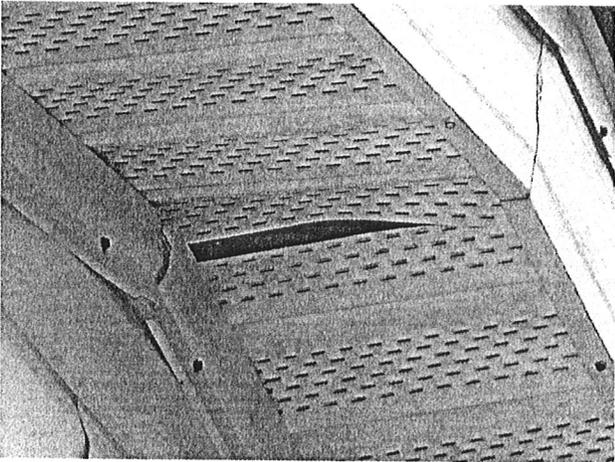
#EX3

Gap in soffit

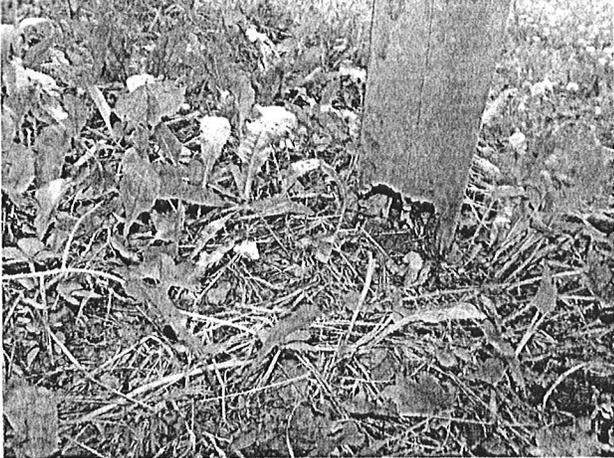
#GD1

- 17  
1. Safety Hazard. Back deck support poles are rotting out at ground level. Recommend a qualified general contractor(see photo 1).

Back deck poles a rotting at the ground

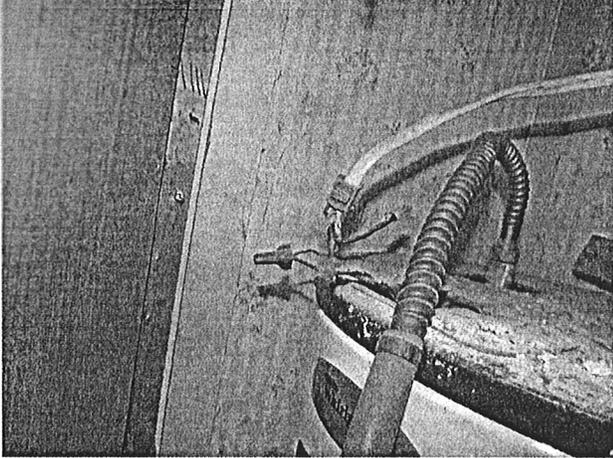
#P1

Expose wire connections to hot water tank

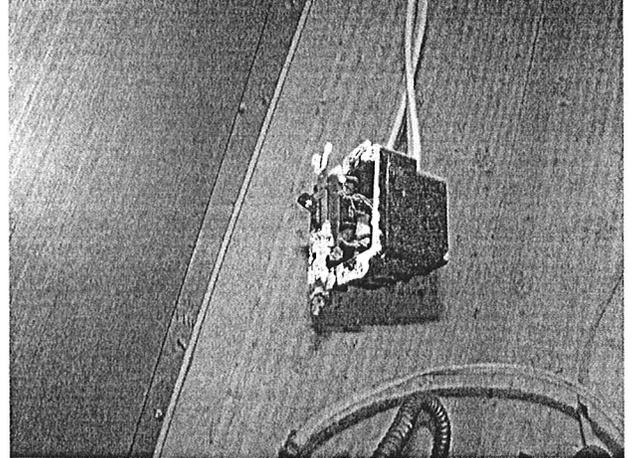
#P2

Hanging switch box

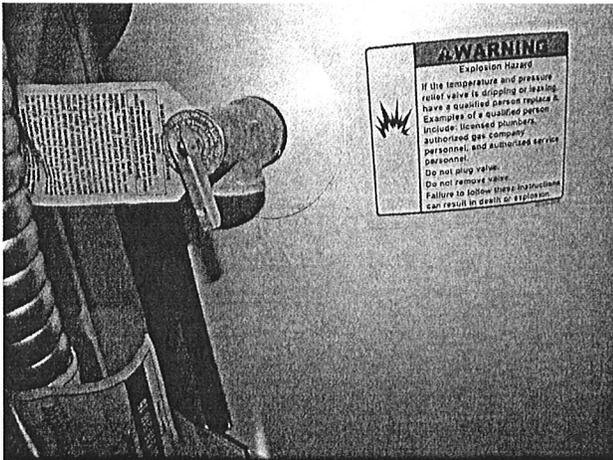
#P3

No extension off hot water tank TPR valve

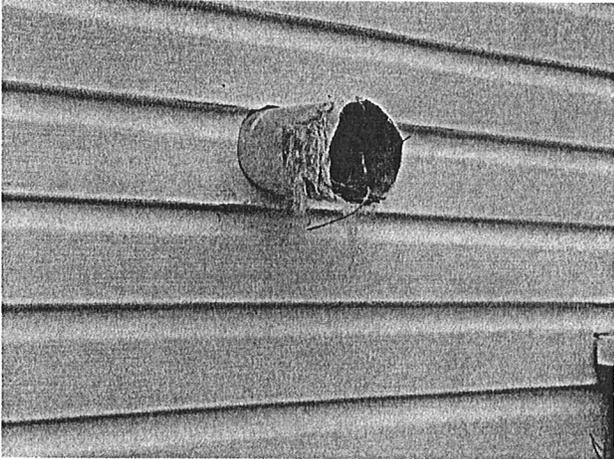
Kitchen & Laundry #K1

No cap on dryer vent

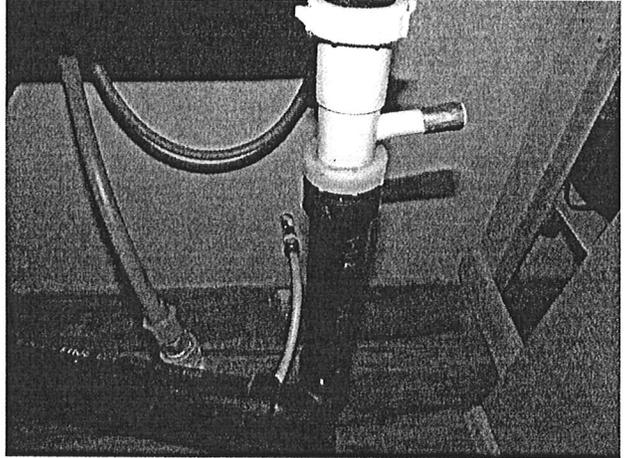
Kitchen & Laundry #K2

Kitchen sink plumbing leaks

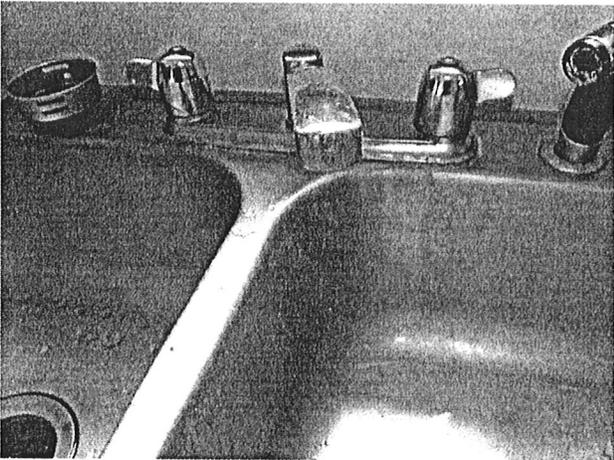
Kitchen & Laundry #K3

Kitchen sink faucet drips

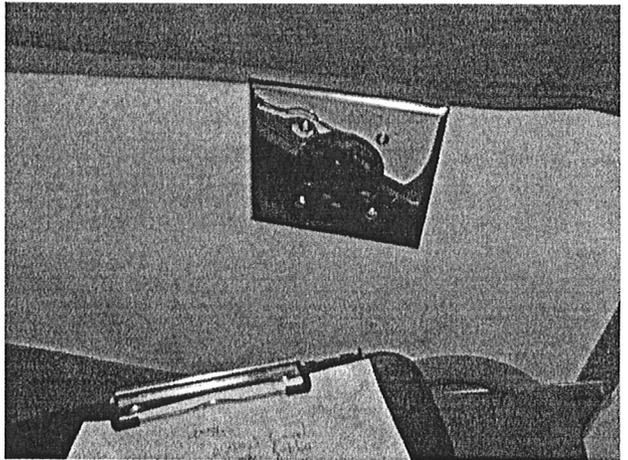
Kitchen & Laundry #K4

No power dryer plug

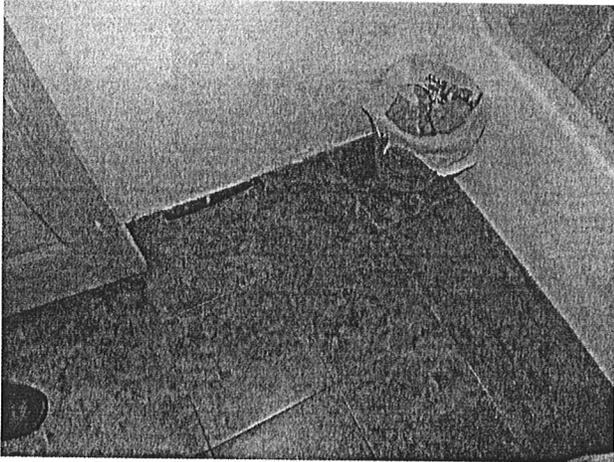
**Bathroom #B1**

**Bathroom floor is soft**

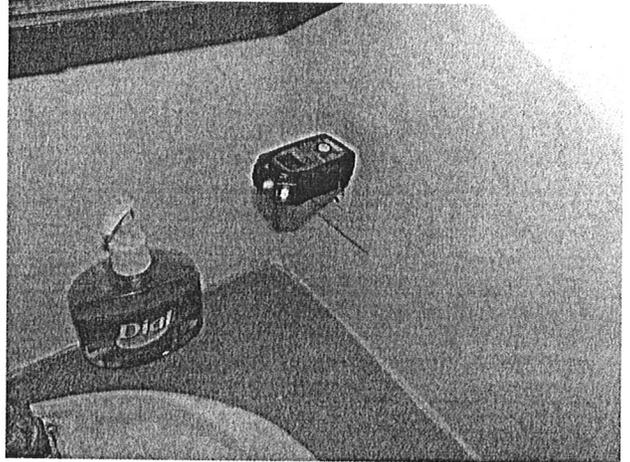
**Bathroom #B2**

**Bathroom GFCI will not trip when tested**

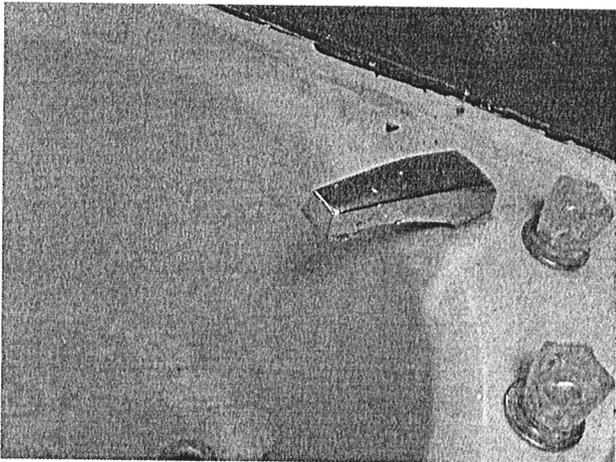
**Bathroom #B3**

**Garden tub faucet drips**

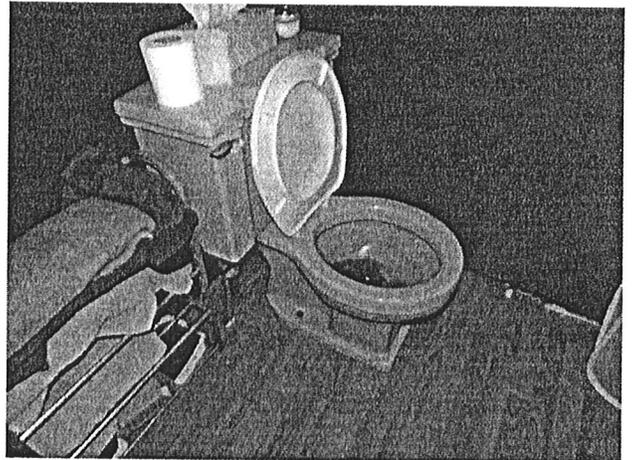
**Bathroom #B4**

**Toilet loose from floor**

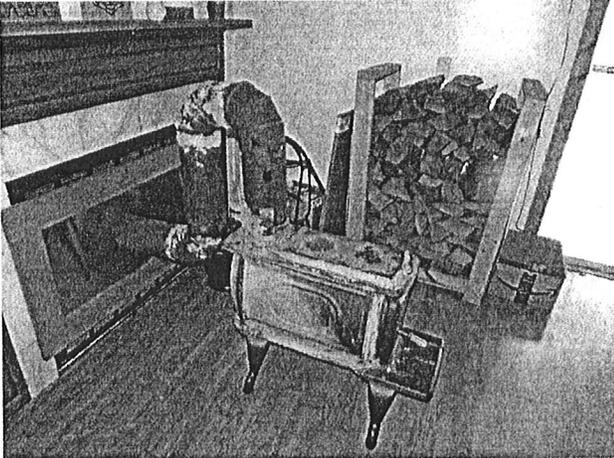
**Interior Rooms #IR1**

**Woodstove is not installed properly (fire Hazard)**

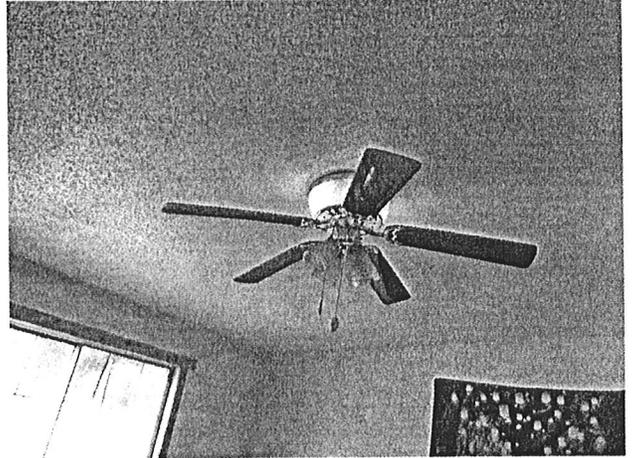
**Interior Rooms #IR2**

**Ceiling fan does not work**

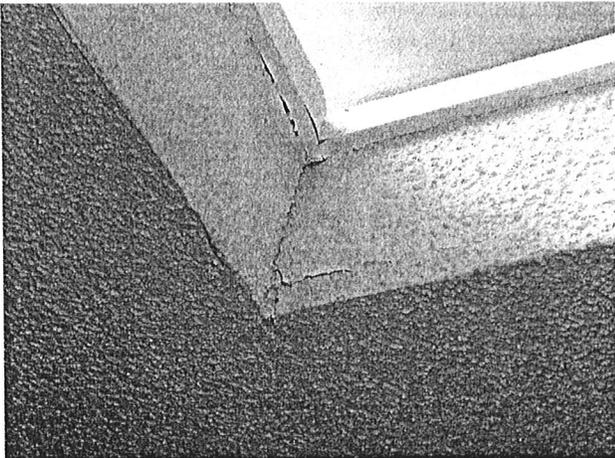
**Interior Rooms #IR3**

**Water stains on trim around skylight**

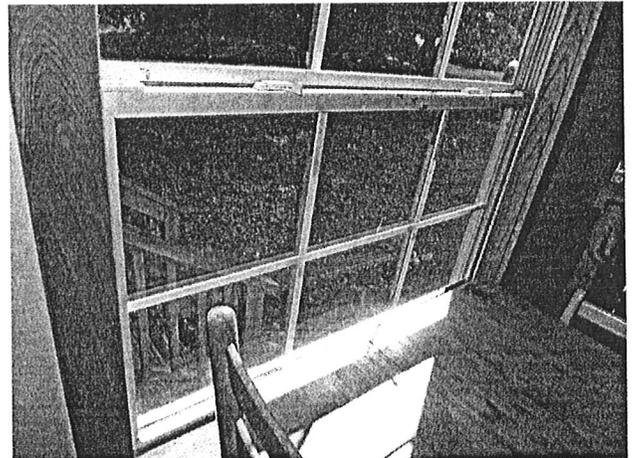
**Interior Rooms #IR4**

**Two windows will not stay open**

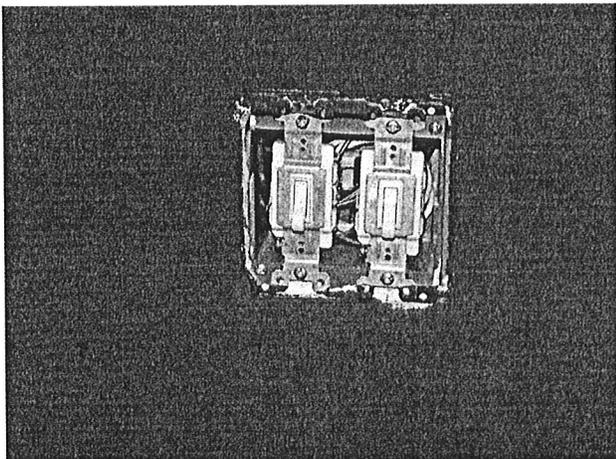
**Interior Rooms #IR5**

**Missing light switch & outlet covers**

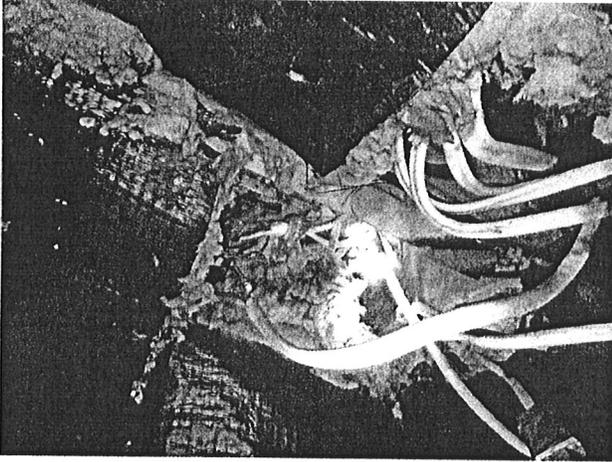
#F1

1. **Safety Hazard.** Open junction box. Per code all junction boxes must have covers. Recommend adding covers(see photo 1).

Open junction box in crawlspace

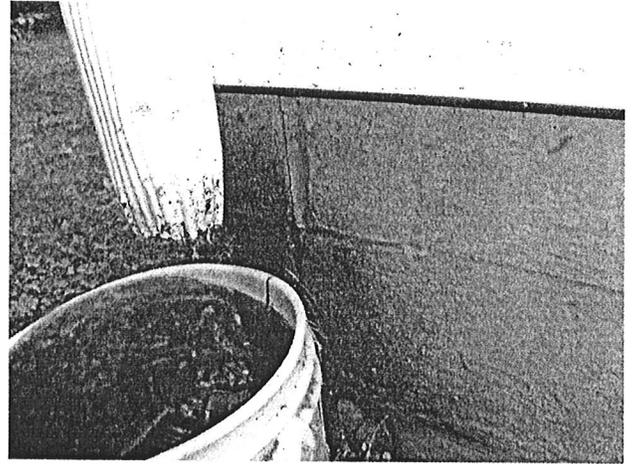
#F2

FYI-Cracks on two foundation corners. This is caused by excessive water against foundation from no downspout extensions(see photo 2).

Crack in foundation
