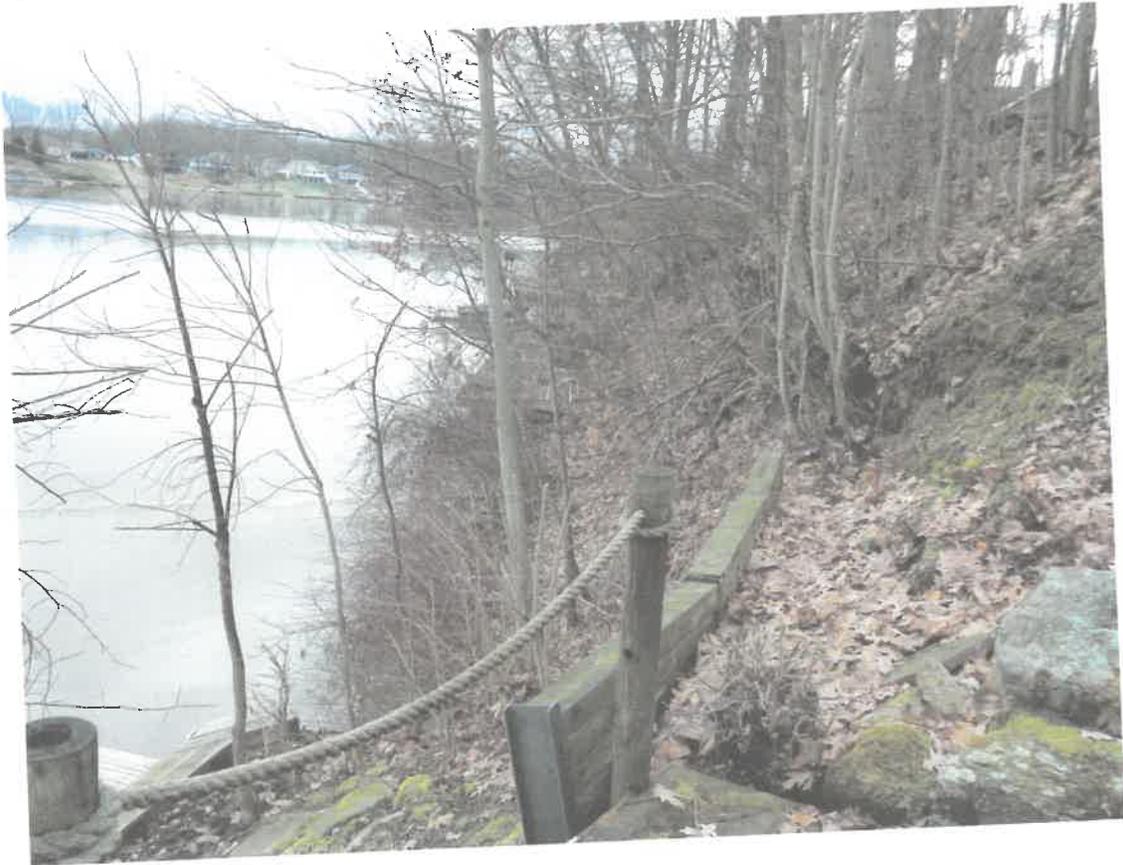
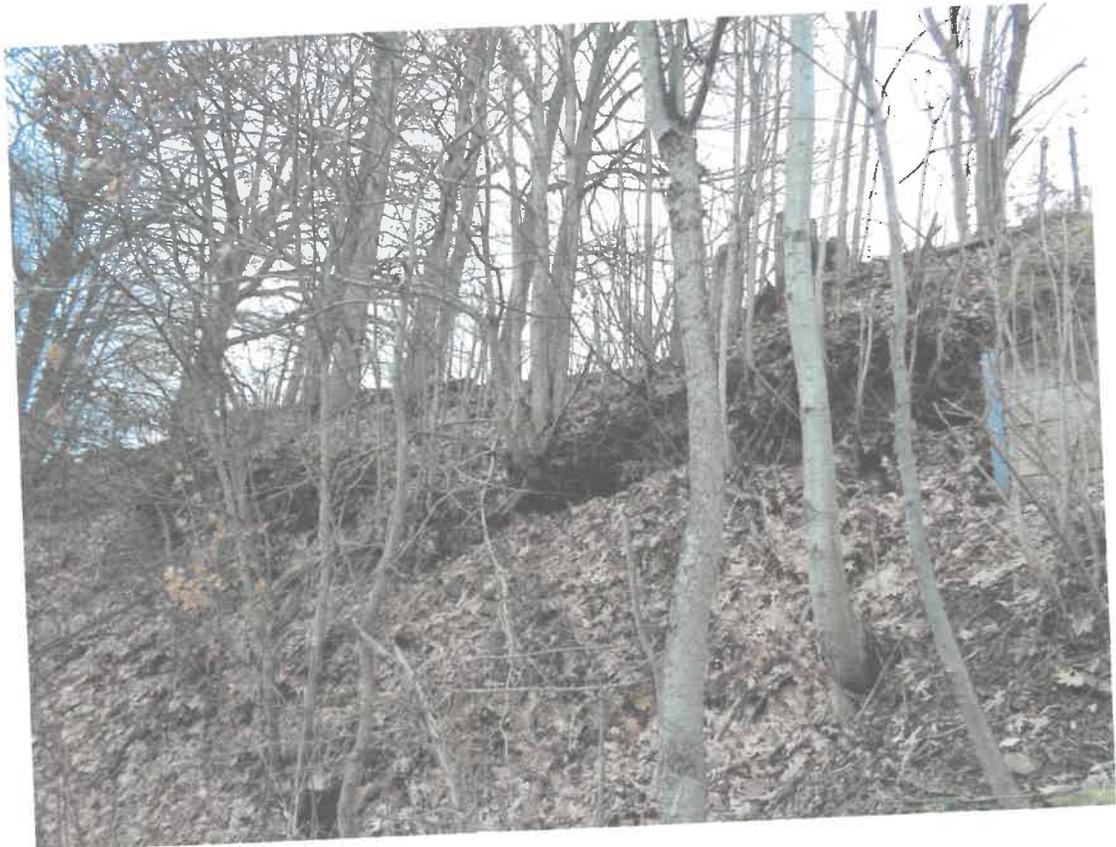
This stand-alone waterfront property will require extensive work in order to build due to the unstable waterfront and subsurface. See attached photos of the bluff-face where, years ago, a portion of the property fell into the water when erosion undercut the trees. Note the additional undercut trees above. Lack of seawall and dock is due to offshore water depth of 19 feet. Extensive (\$\$) landscaping needed to remove undermined trees and stabilize the property.
