Additional
information/witness
for our "hearing" on
5/1/24.

BOARD OF REVISION HEARING NOTICE TO
ASHTABULA COUNTY PROPERTY OWNER OR HIS/HER
AGENT

B.O.R. CASE NUMBER: 2023-0037

- 1) 07-021-10-009-21 located at 1170 GREENBRIER DR, the market value is \$356,600. The market value sought is \$200,000.

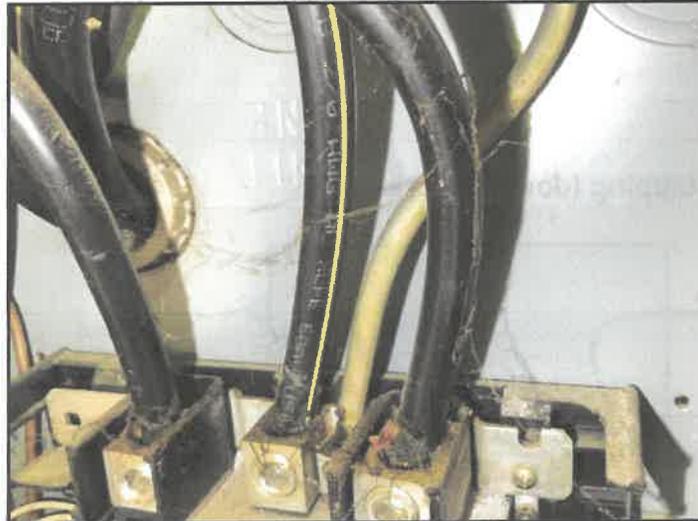
Condition: • Breakers / fuses too big

Appears the wires powering the 200-amp breaker are undersized. Recommend having a licensed electrician evaluate and make any needed repairs.

Implication(s): Equipment overheating | Fire hazard

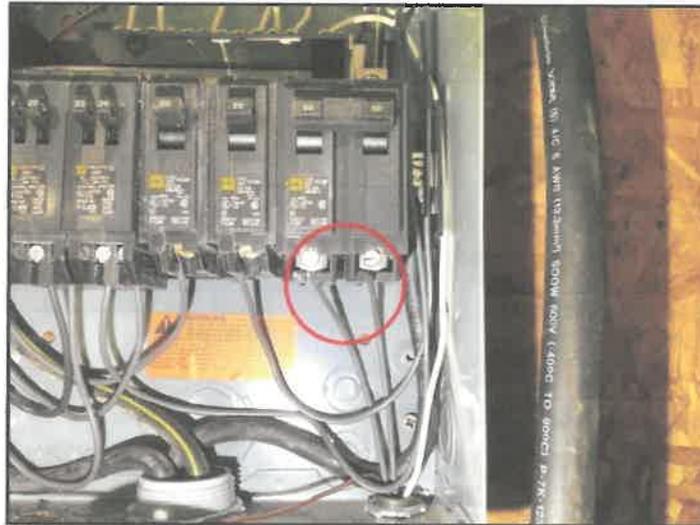
3. Breakers / fuses too big

Condition: • Breakers / fuses too big

Appears the wires powering the 50-amp breaker are undersized. Recommend having a licensed electrician evaluate and make any needed repairs.

Implication(s): Equipment overheating | Fire hazard

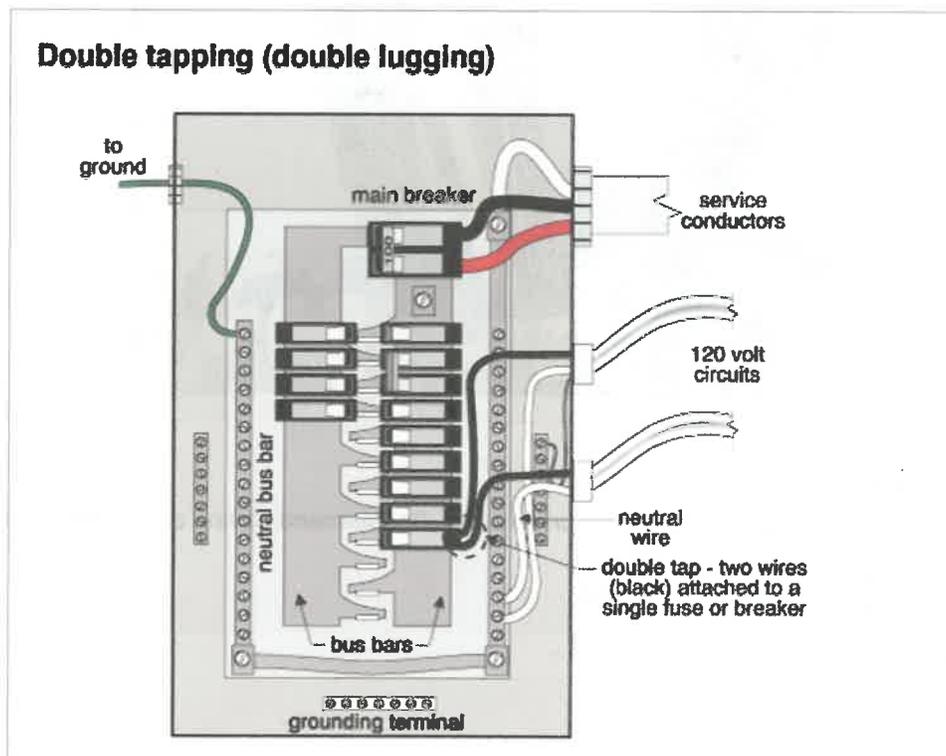
Condition: • Double taps

Recommend having a licensed electrician correct double taps in panel.

Implication(s): Fire hazard

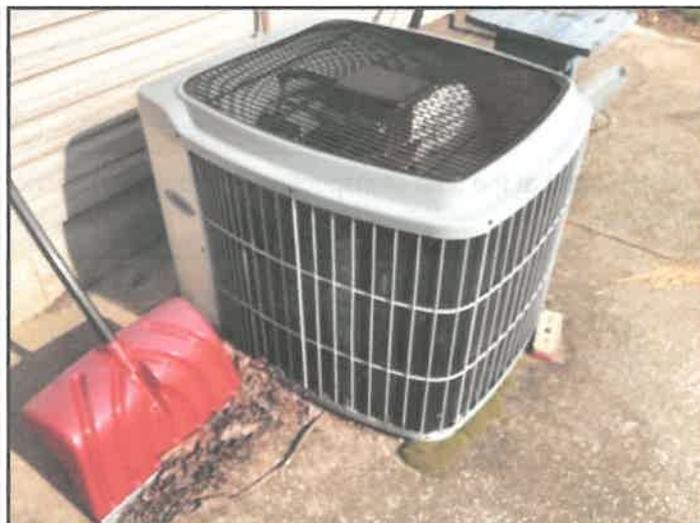
12. Past life expectancy

Condition: • Past life expectancy

27-year old unit appeared to run as expected at the time of inspection. Unit is beyond the typical life span of 15 years. Recommend having the unit serviced by an HVAC tech to help prolong the life span. Unit may need replaced in the near future.

Implication(s): Equipment failure | Reduced comfort

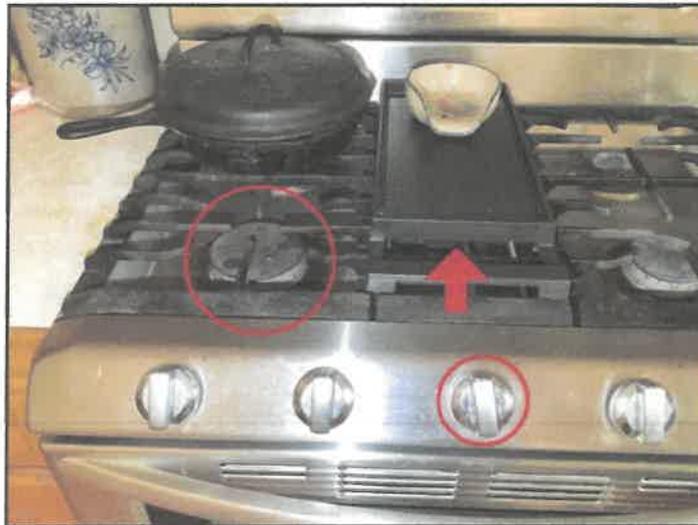
16. Burner inoperative

Condition: • Burner inoperative

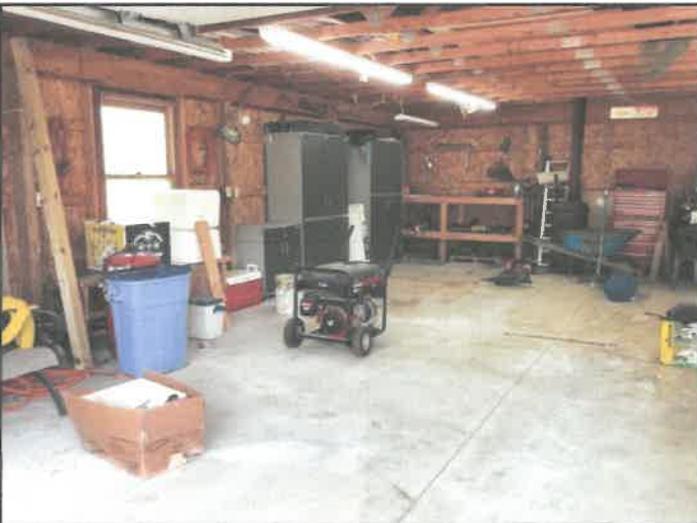
36. Car and or storage in garage

- Vines/shrubs/trees against wall

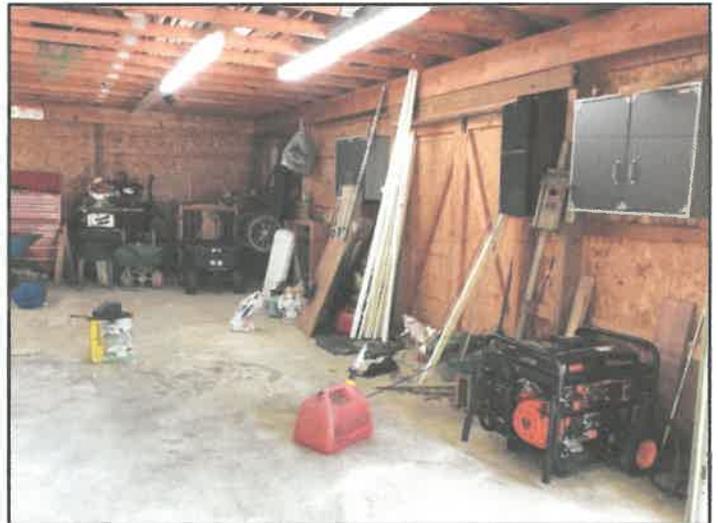
37. Car and or storage in garage

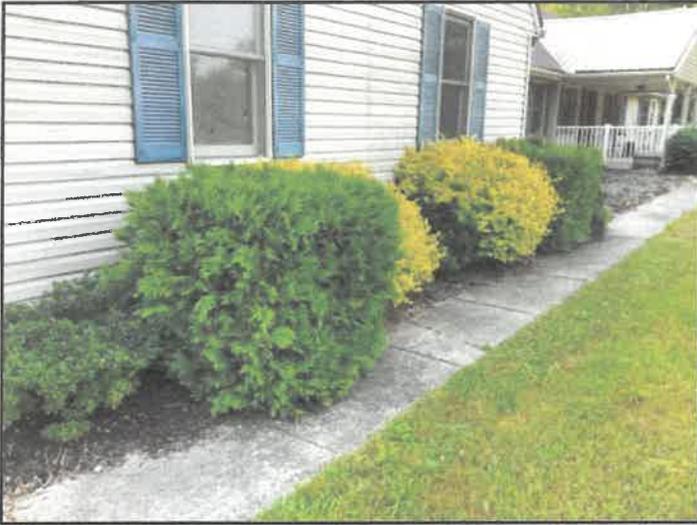
38. Vines/shrubs/trees against wall

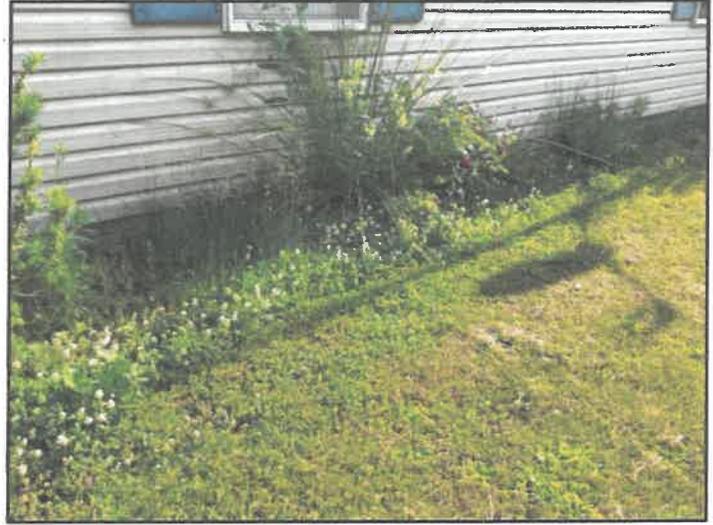
39. Vines/shrubs/trees against wall

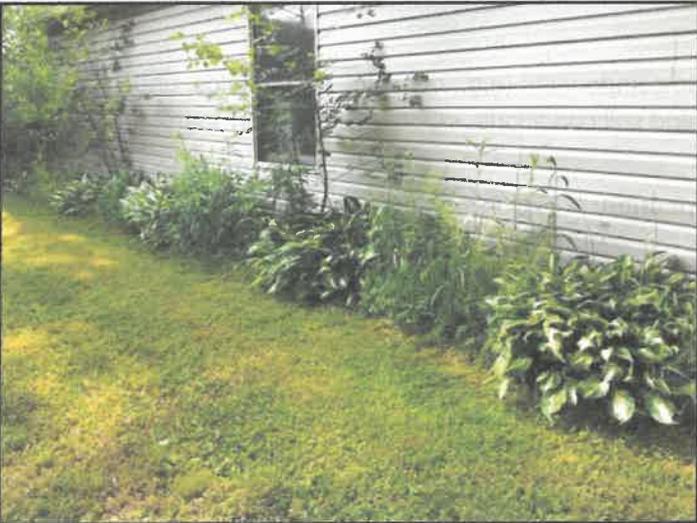
40. Vines/shrubs/trees against wall

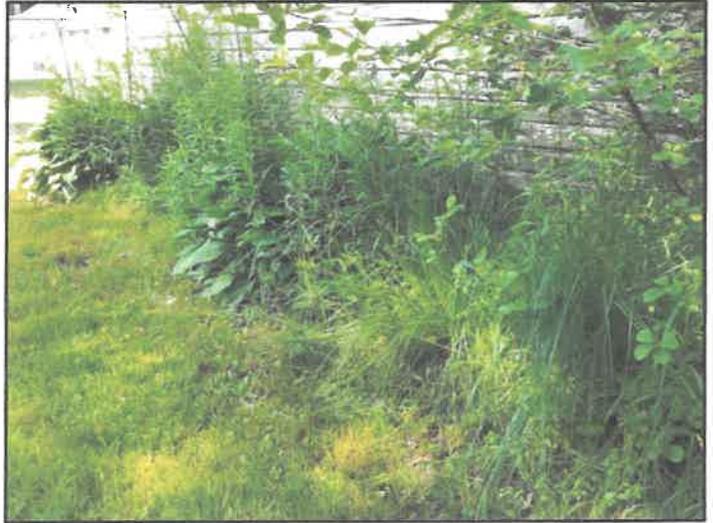
41. Vines/shrubs/trees against wall

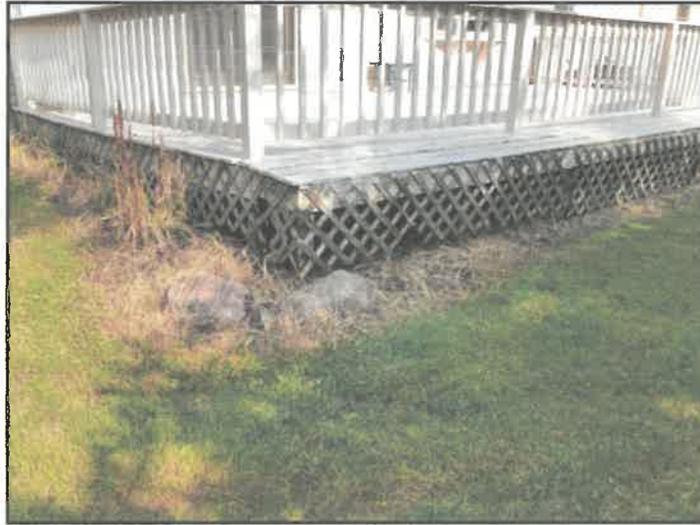
42. Area below steps, deck, porches

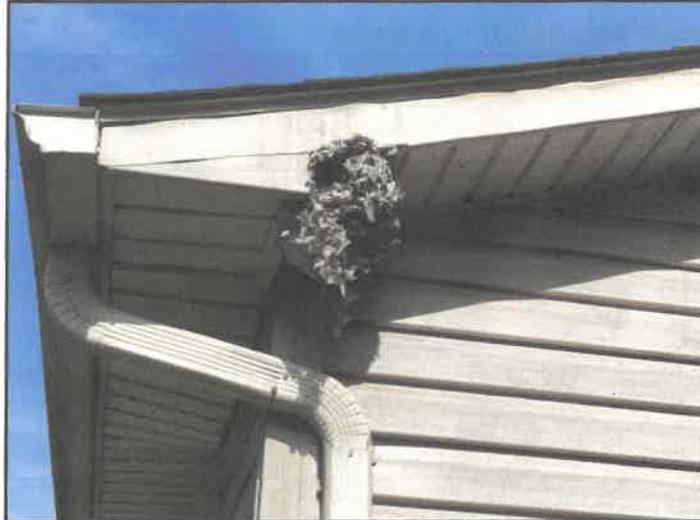
45.

7. Condition: • Remove hornet's net.

Task: Remove

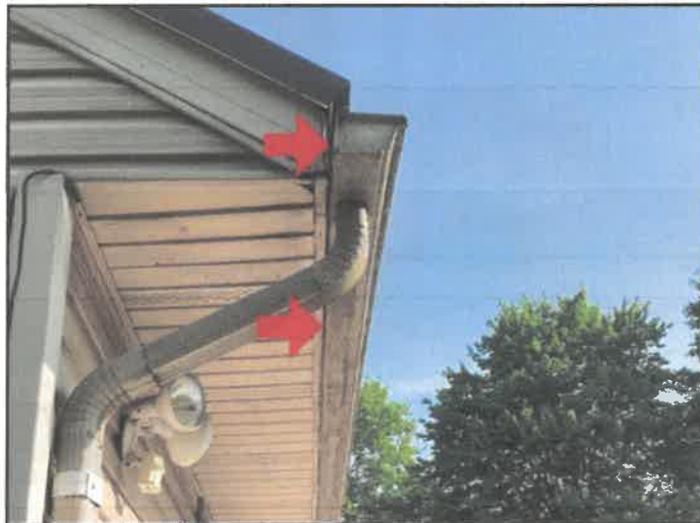
8. Condition: • Loose

Implication(s): Chance of water damage to contents, finishes and/or structure

46. Loose

Secure loose gutter.

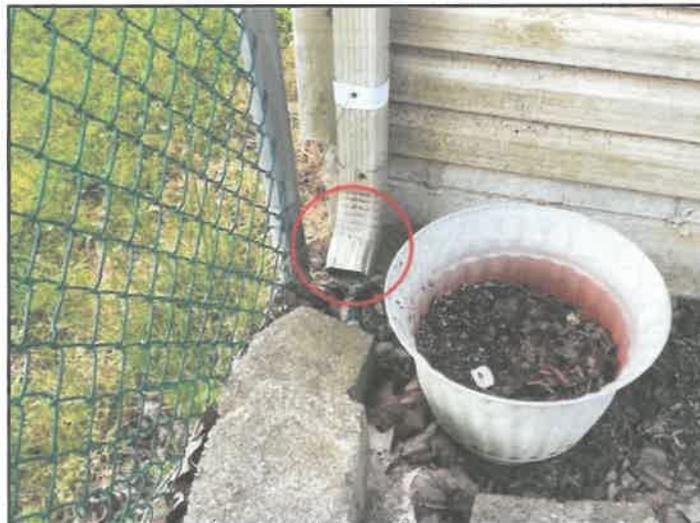
9. Condition: • Discharge too close to building

Implication(s): Chance of water damage to contents, finishes and/or structure

47. Discharge too close to building

Task: improve

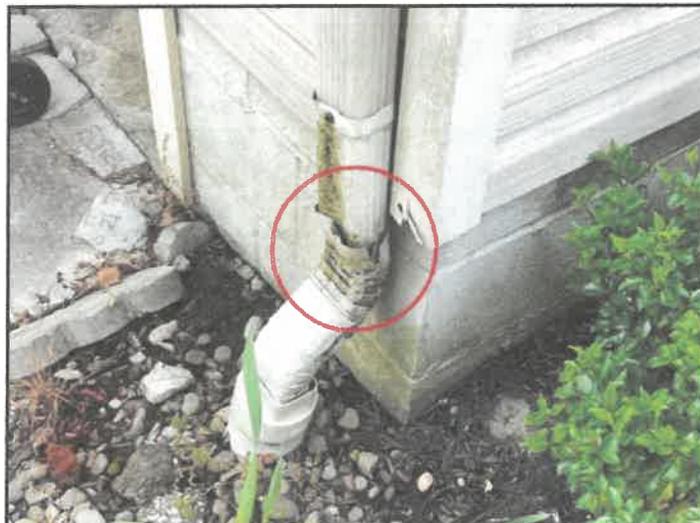
10. Condition: • Damaged / Crushed

Implication(s): Clogging / Leakage

48. Damaged / Crushed

Task: Replace

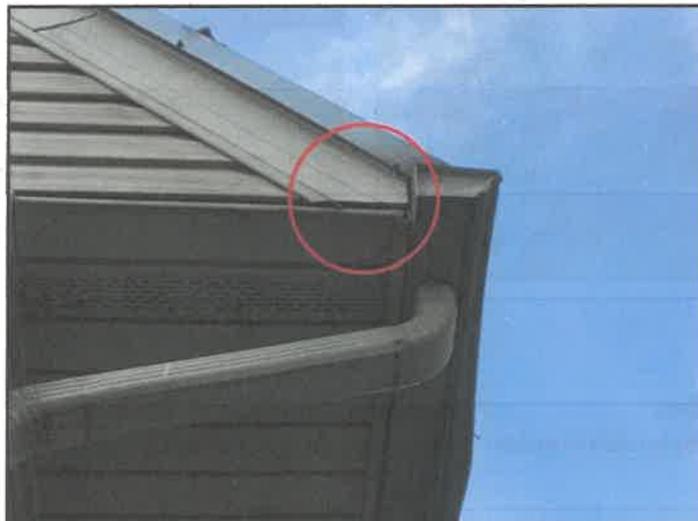
15. Condition: • Caulking missing or ineffective
Ensure all openings into buildings are sealed.

Implication(s): Chance of water damage to contents, finishes and/or structure

54. Caulking missing or ineffective

Task: Improve

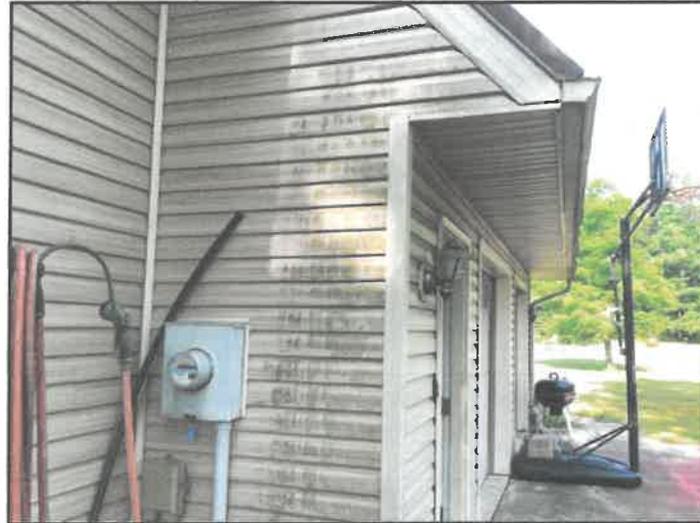
17. **Condition:** • Siding dirty

Implication(s): Accelerated material deterioration

59. Siding dirty

Recommend power washing siding.

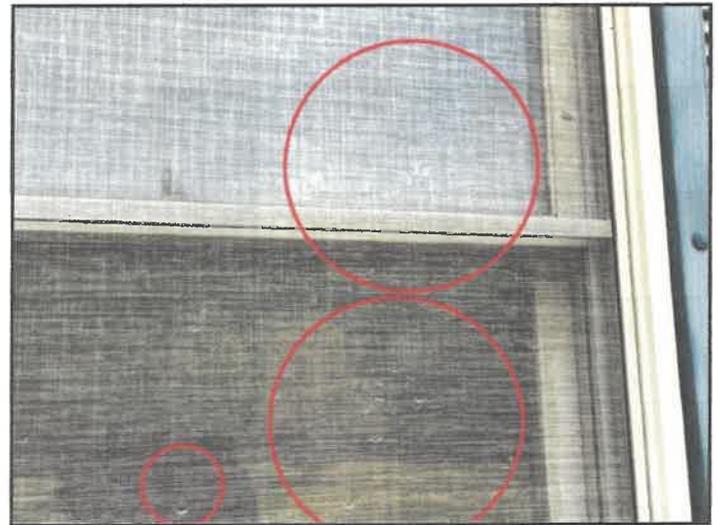
61. Torn or holes

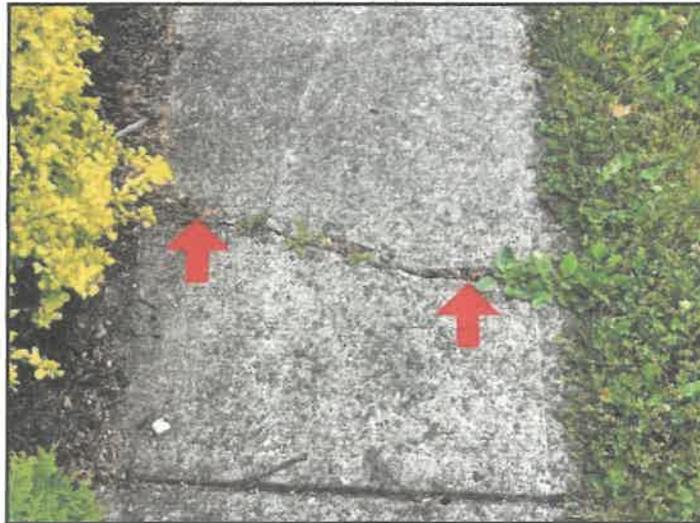
27. **Condition:** • Cracked or damaged surfaces

Implication(s): Trip or fall hazard

74. Cracked or damaged surfaces

Task: Repair or replace

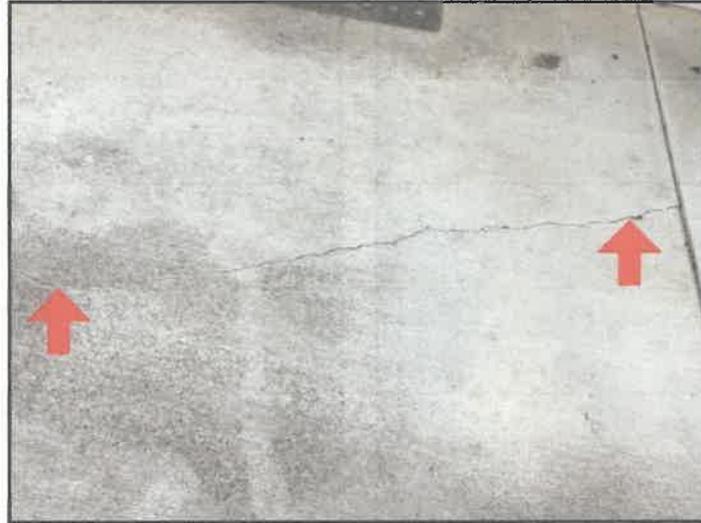
28. **Condition:** • Cracked or damaged surfaces

Porch floor has settled and cracked.

Implication(s): Trip / Fall hazard

75. Cracked or damaged surfaces

Task: Repair or replace

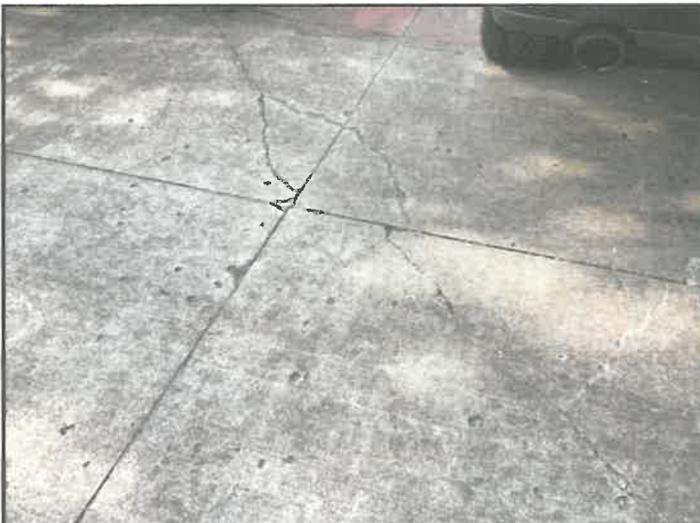
29. Condition: • Cracked or damaged surfaces

Implication(s): Accelerated Material Deterioration

76. Cracked or damaged surfaces

Task: Repair or replace

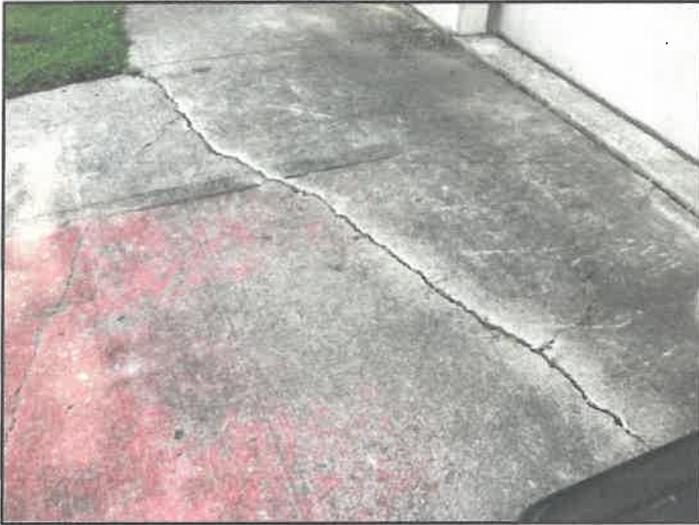
78. Cracked or damaged surfaces

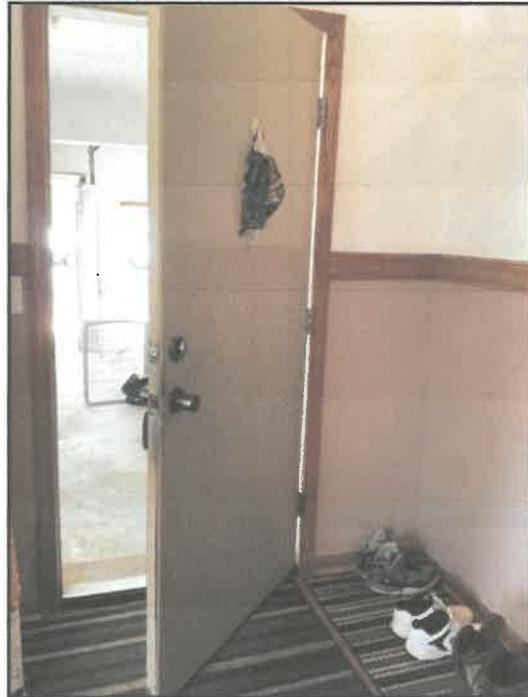
31. Condition: • No self-closer

Implication(s): Hazardous combustion products entering home | Increased fire hazard

81. No self-closer

Task: Replace

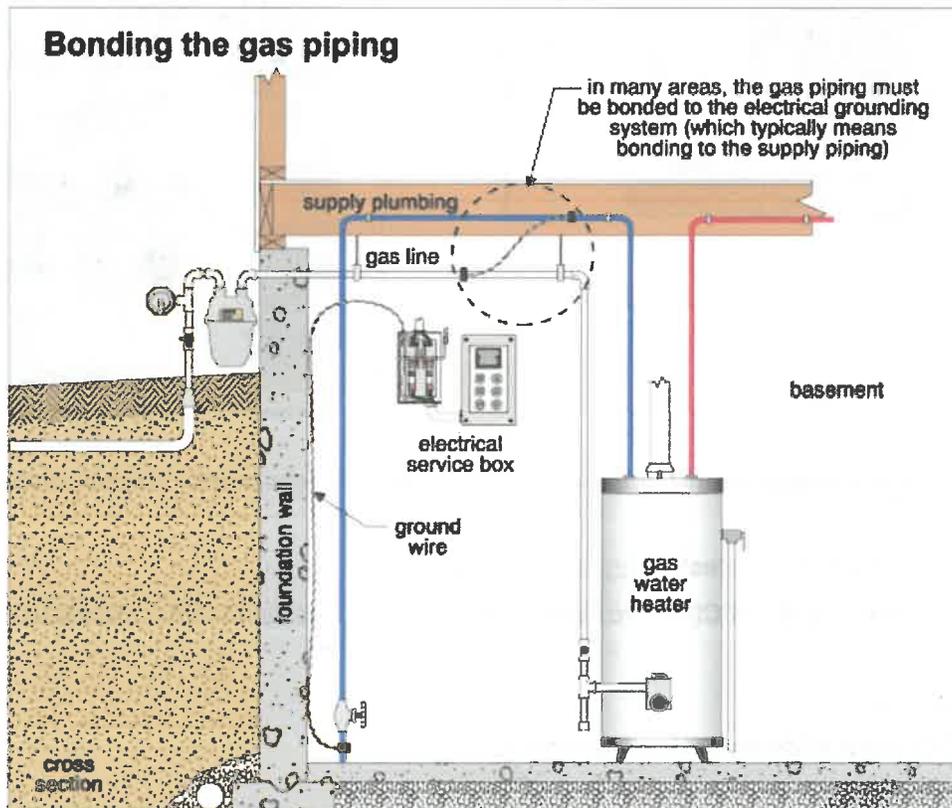
99. Missing bonding wire

36. Condition: • Missing bonding wire

Implication(s): Fire hazard

Location: Basement

It is recommended to bond gas / water lines. If the gas lines accidentally carry electricity or even a static charge, proper bonding will allow the electricity to be carried back to its source in a safe manner.

Task: Correct

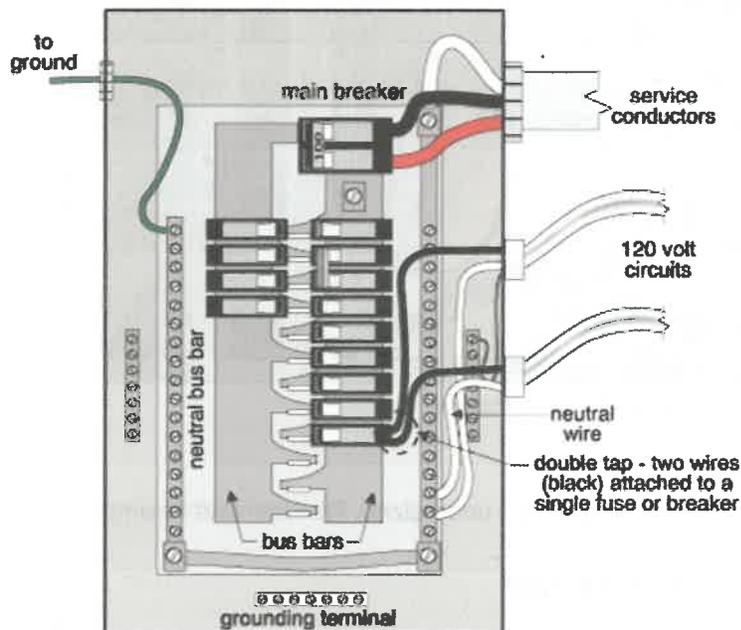
103. Double taps

40. Condition: • Double taps

Implication(s): Fire hazard

Recommend having a licensed electrician correct double taps in panel.

Task: Correct

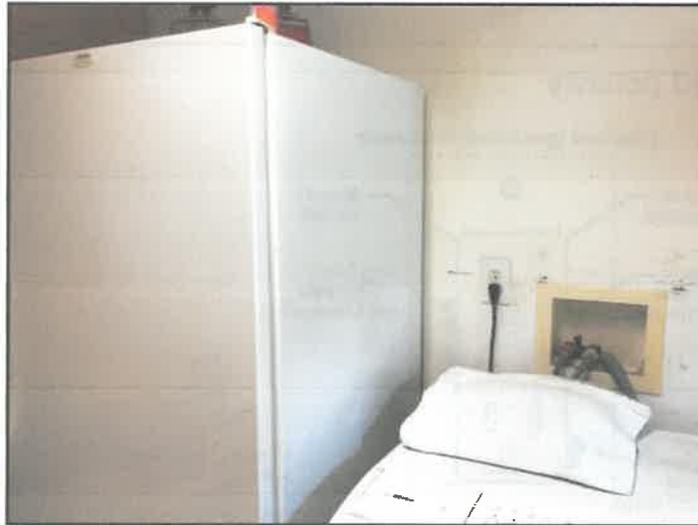
114. *Dedicated circuit needed*

48. Condition: • Dedicated circuit needed
Refrigerator should be on a dedicated circuit.

Location: Laundry room

Task: Correct

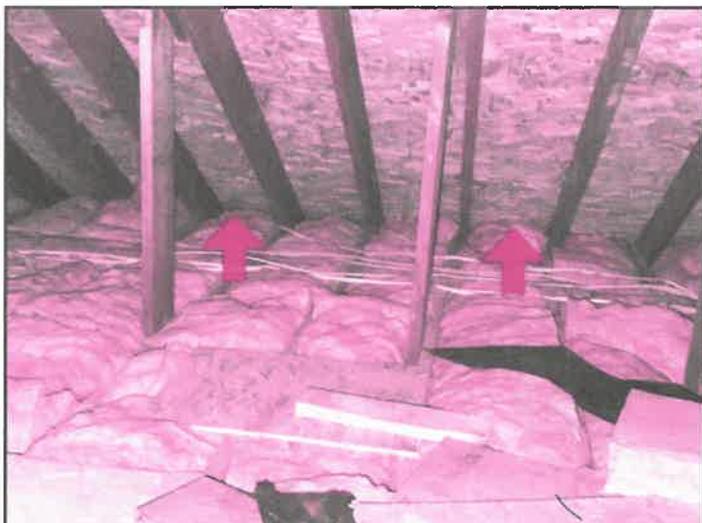
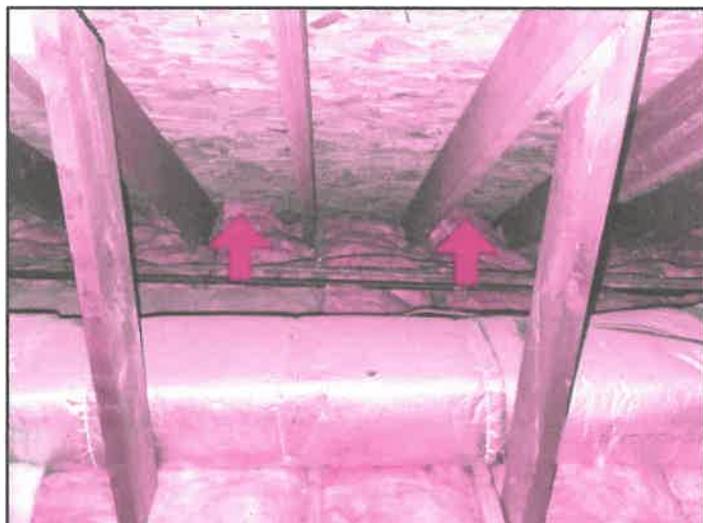
63. Condition: • Soffit vents blocked by insulation

Implication(s): Chance of condensation damage to finishes and/or structure / Mold growth

144. Soffit vents blocked by insulation

145. Soffit vents blocked by insulation

146. *Soffit vents blocked by insulation*

Recommend installing baffles to prevent insulation from blocking soffit vents.

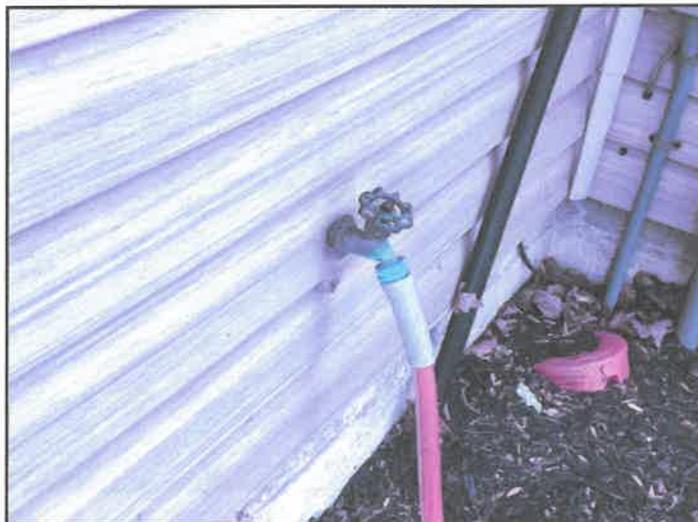
68. Condition: • Not Frost Free

Implication(s): Chance of water damage to contents, finishes and/or structure

156. Not Frost Free

Recommend replacing older style spigots with newer frost free styles when feasible.

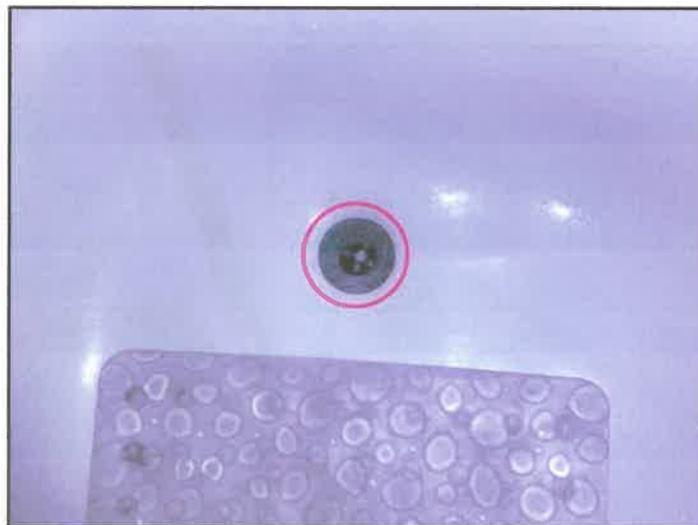
70. Condition: • Drain stop missing

158. Drain stop missing

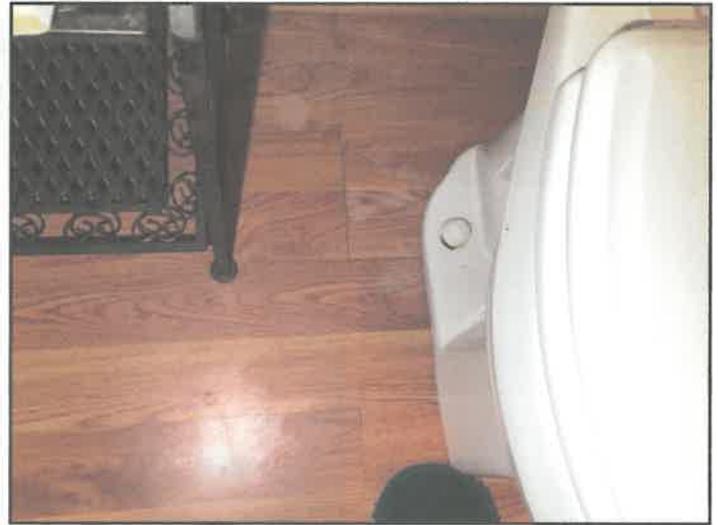
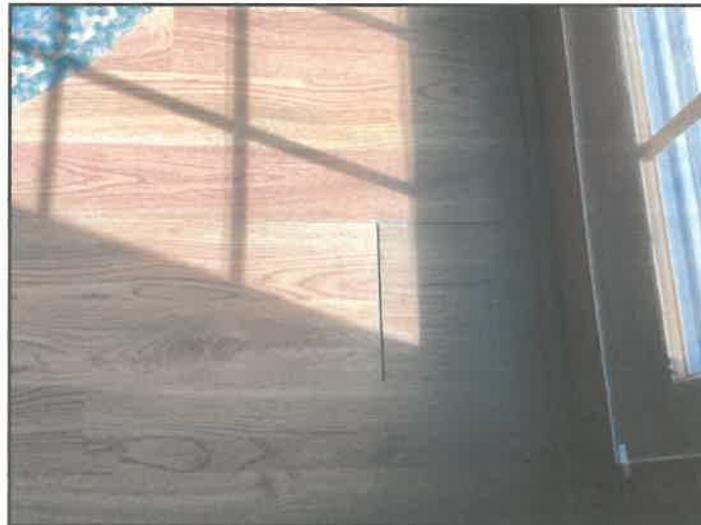
77. Condition: • Exposed tongues

179. Exposed tongues

180. Exposed tongues

181. Exposed tongues

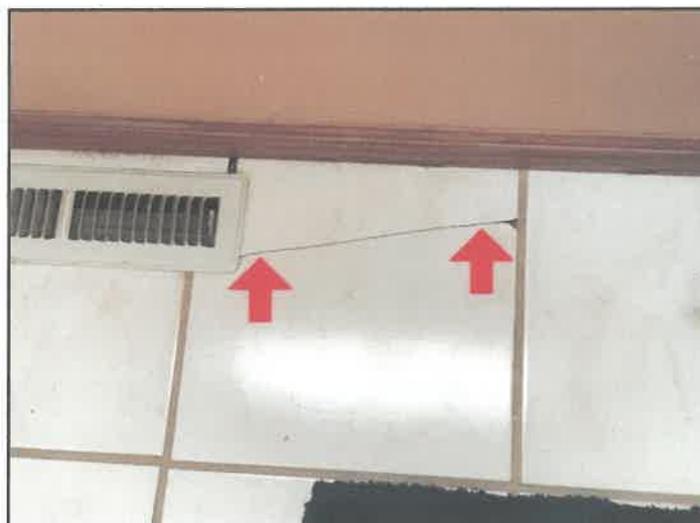
78. Condition: • Tiles cracked or broken

Implication(s): Further material deterioration / Physical injury

182. Tiles cracked or broken

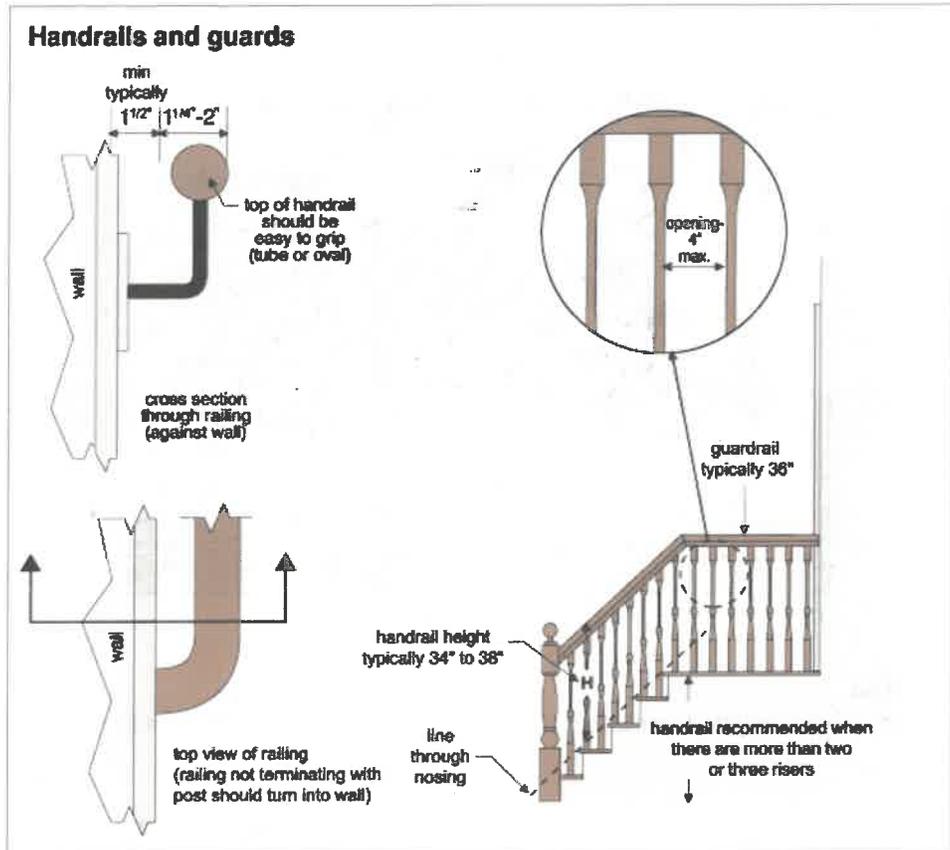
185. Missing

80. Condition: • Missing

Implication(s): Fall hazard

Location: Staircase

Task: Replace / Install
