### Complaint Against the Valuation of Real Property

6. Parcel numbers from tax bill	Address of property
<u>07-021-10-009-21</u>	<u>1170 Greenbriar DR. Rock Creek, Ohio 44084 (Austinburg TWP)</u>

1170 Greenbriar Dr, Rock Creek, OH June 19, 2023

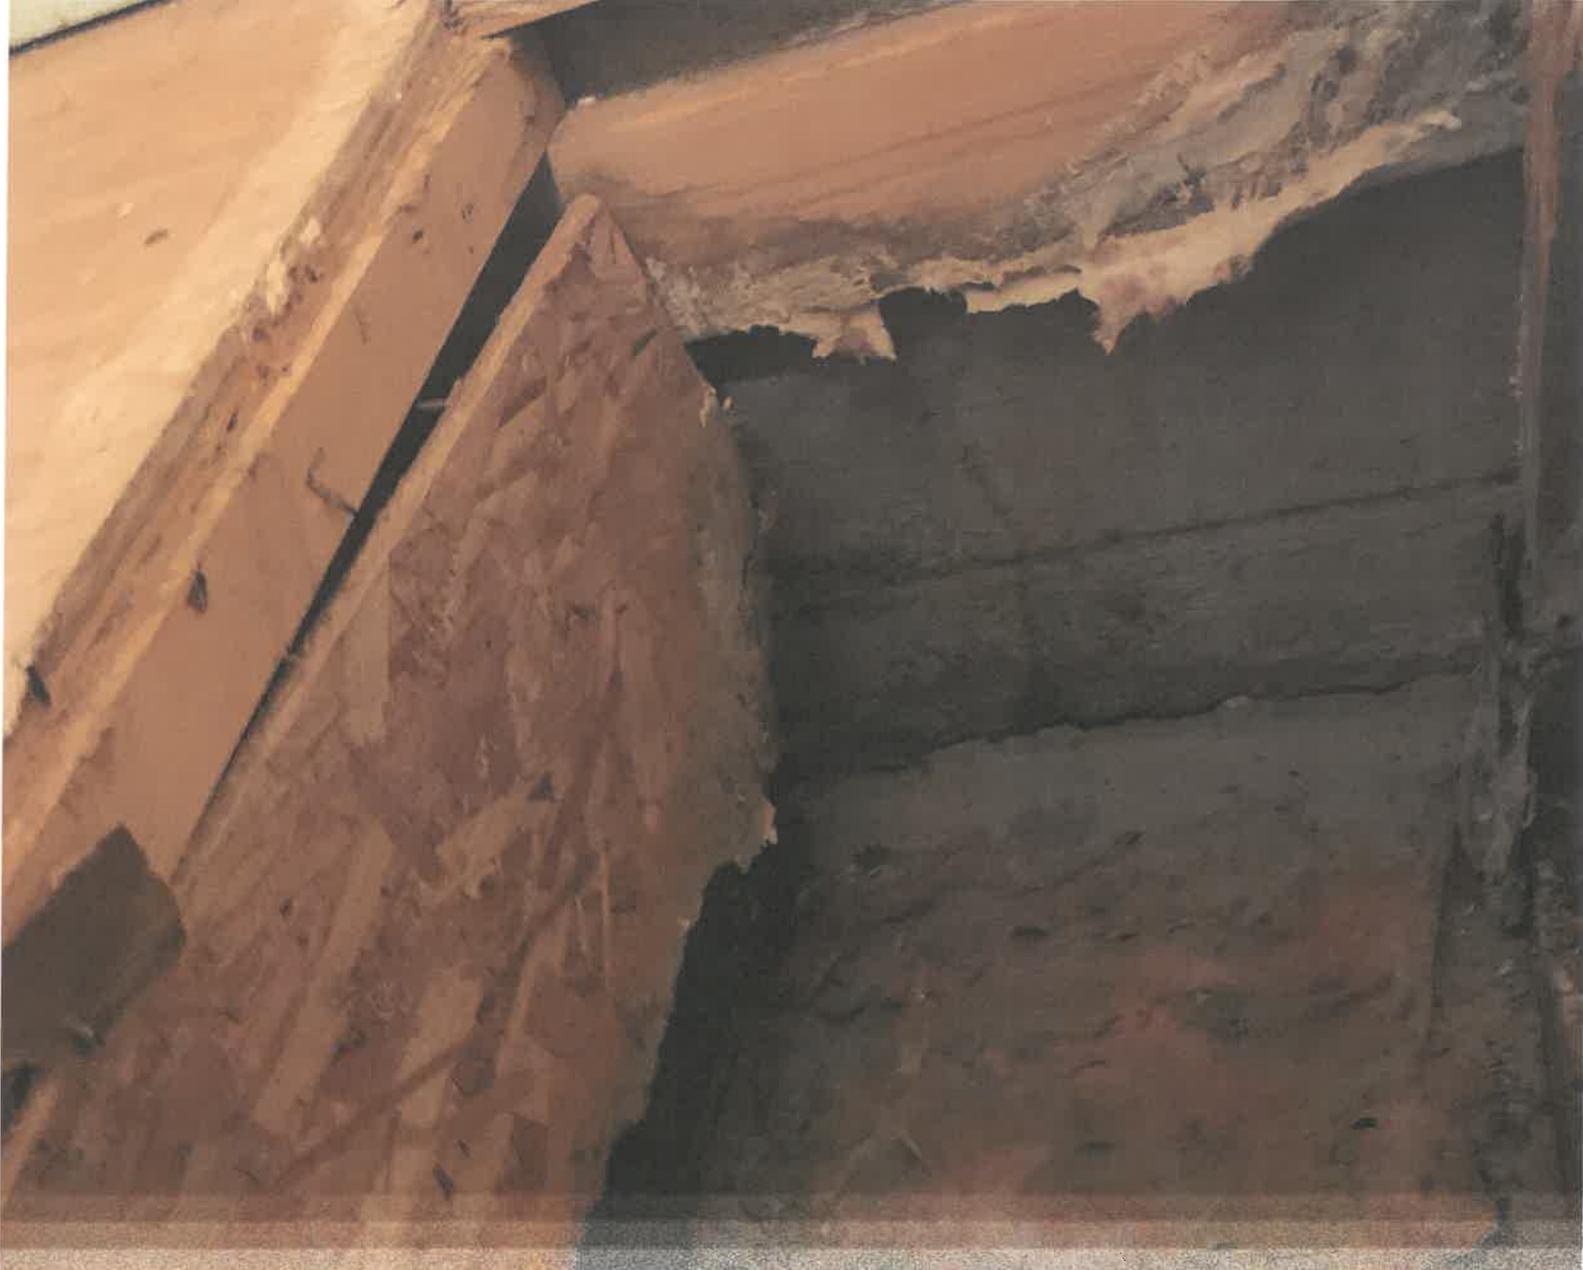
Rotted floor joists in  
Bedroom. floor falling in

\* Was hidden  
Same in Kitchen, living room,  
dining room, foyer, hallway  
bathroom, Bedrooms.

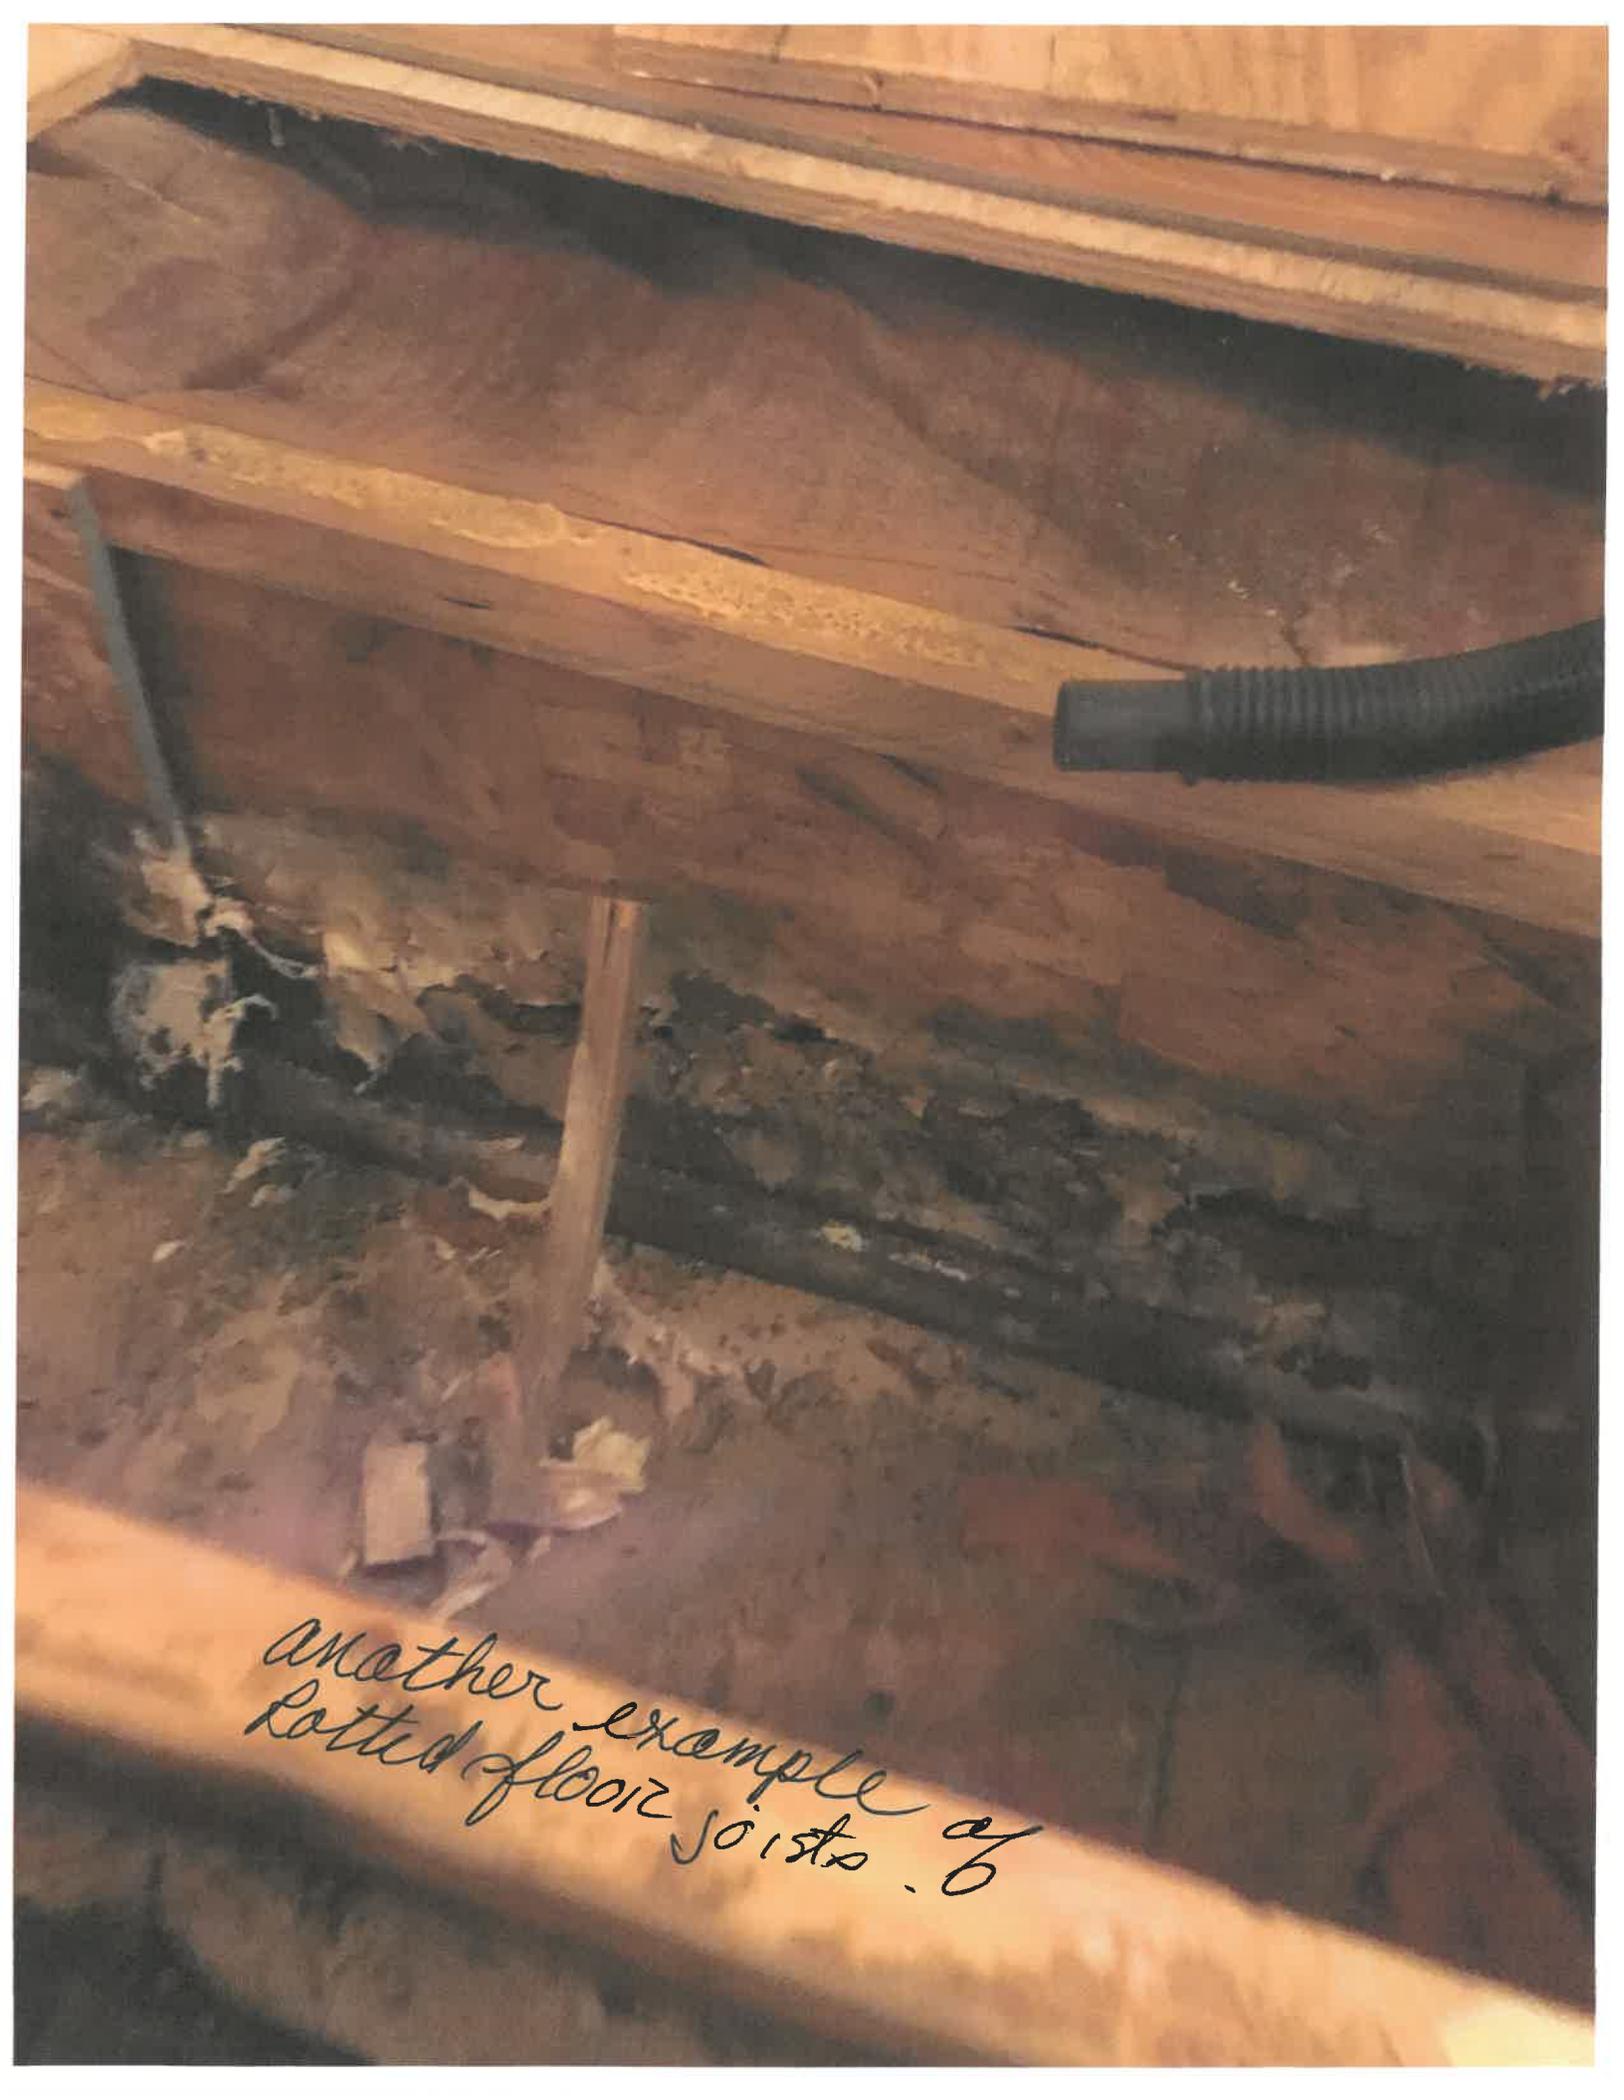
Another example of  
Rotted floor joists . 6

\*Was hidden  
Regarding  
falling in

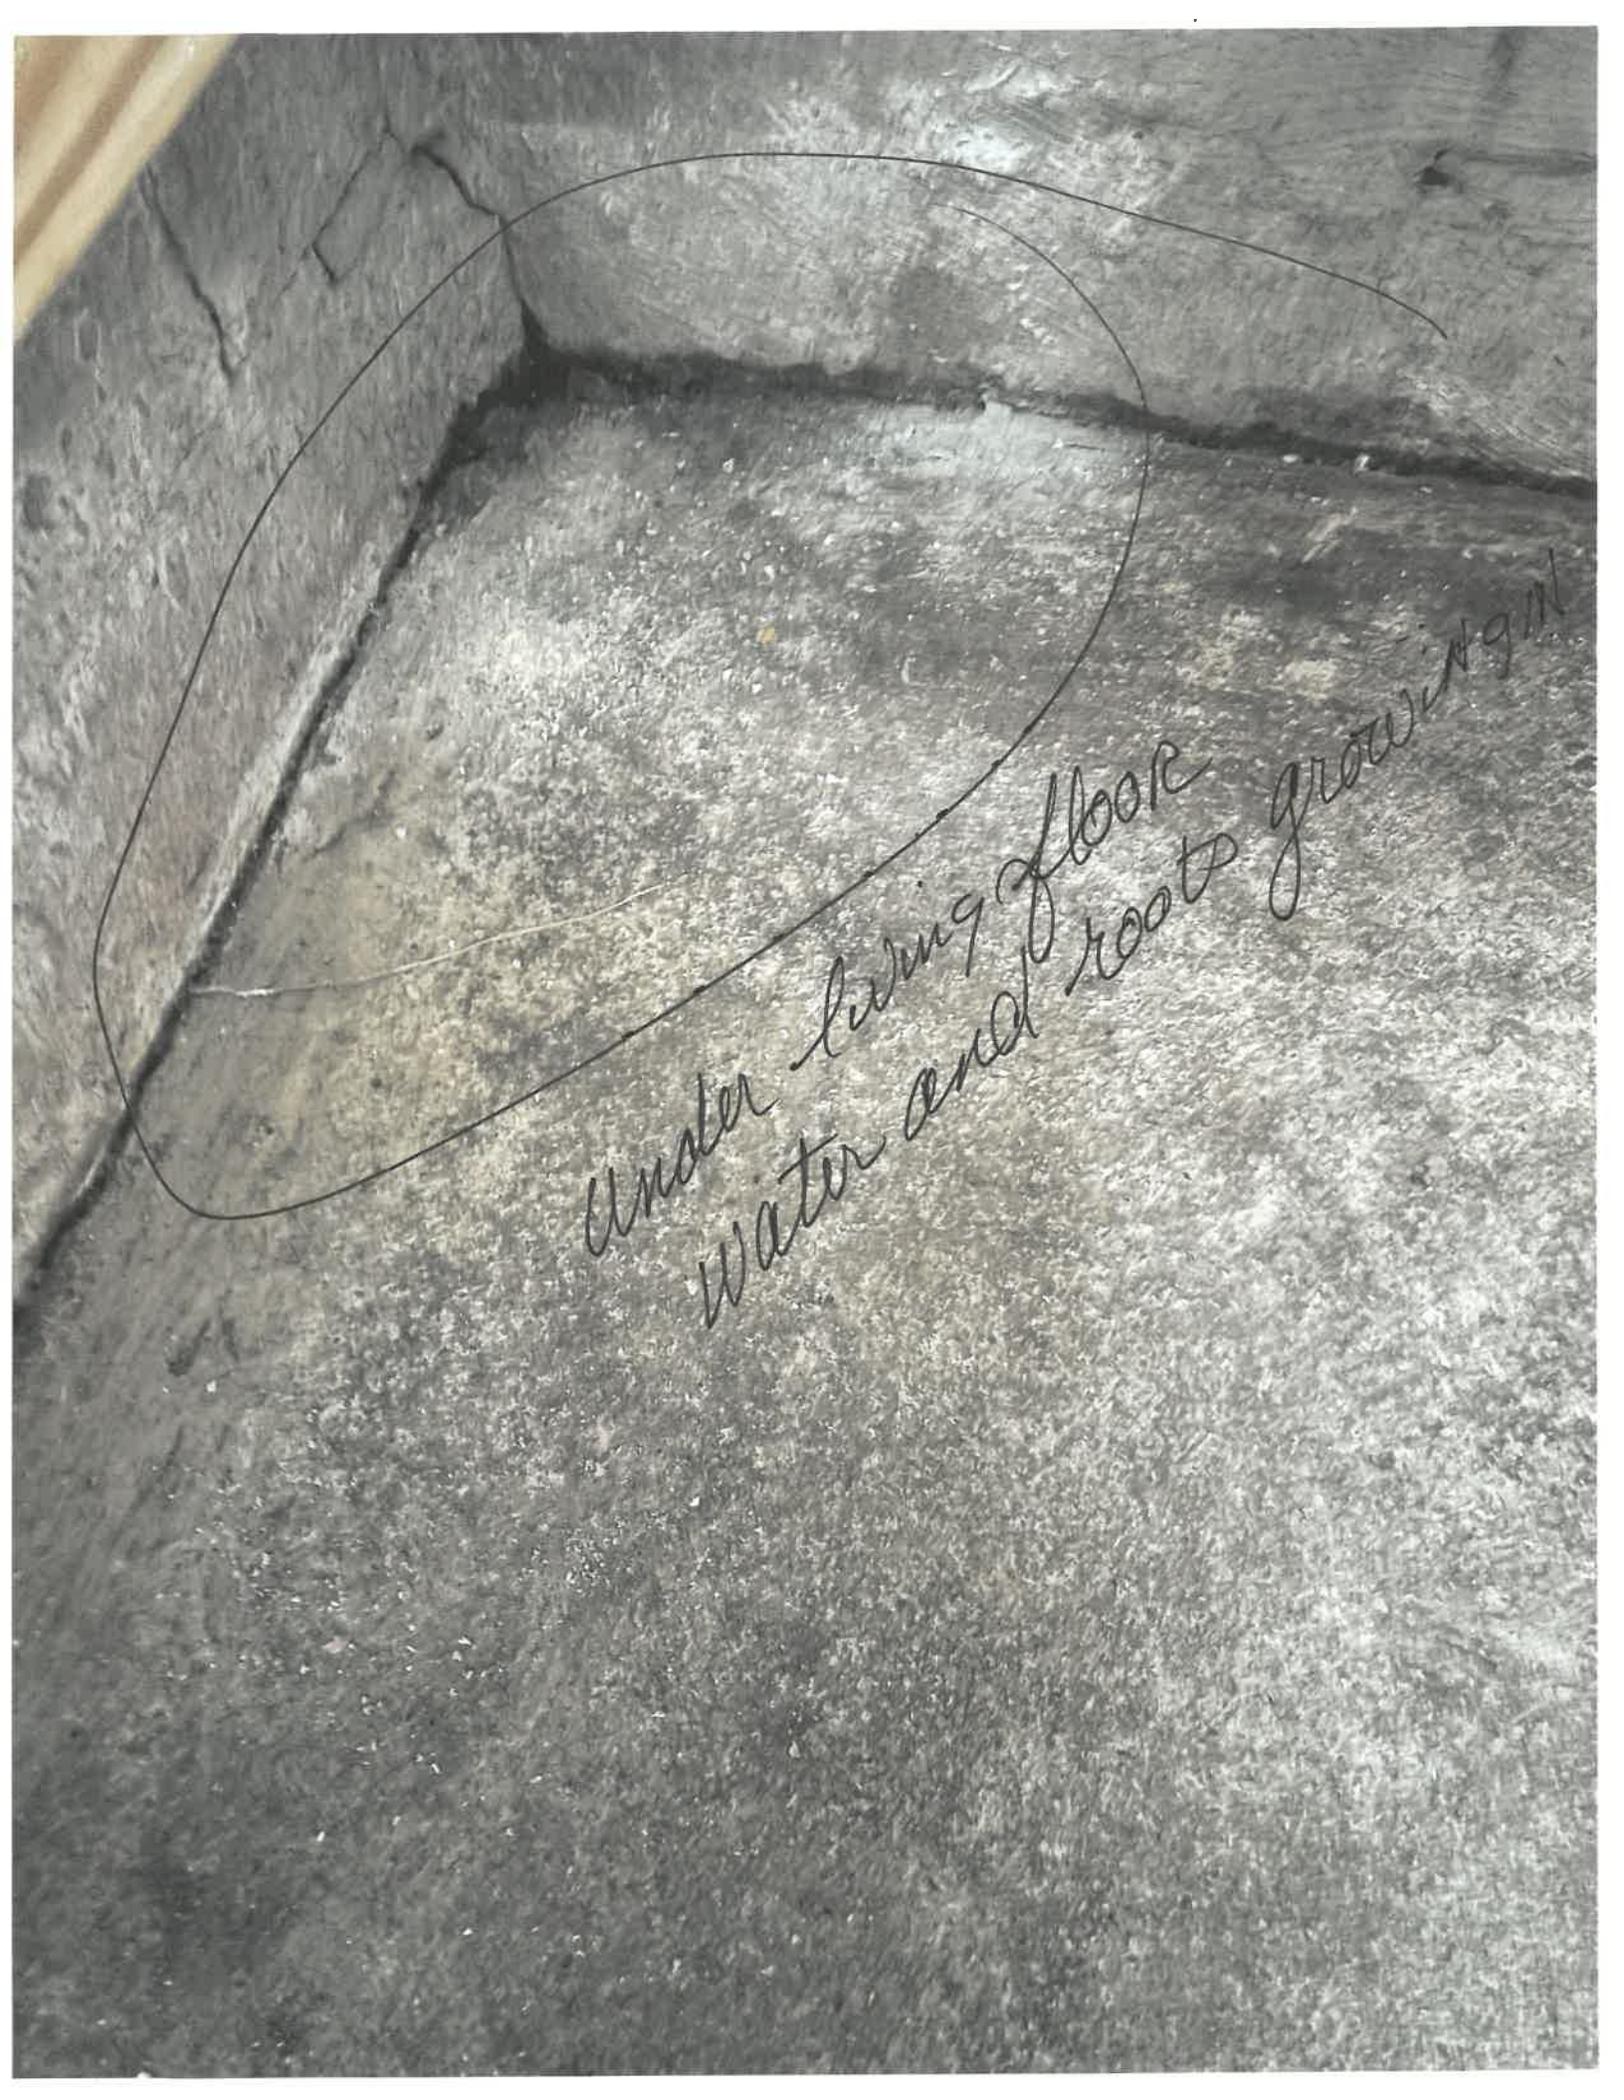
Under living floor  
water and roots growing

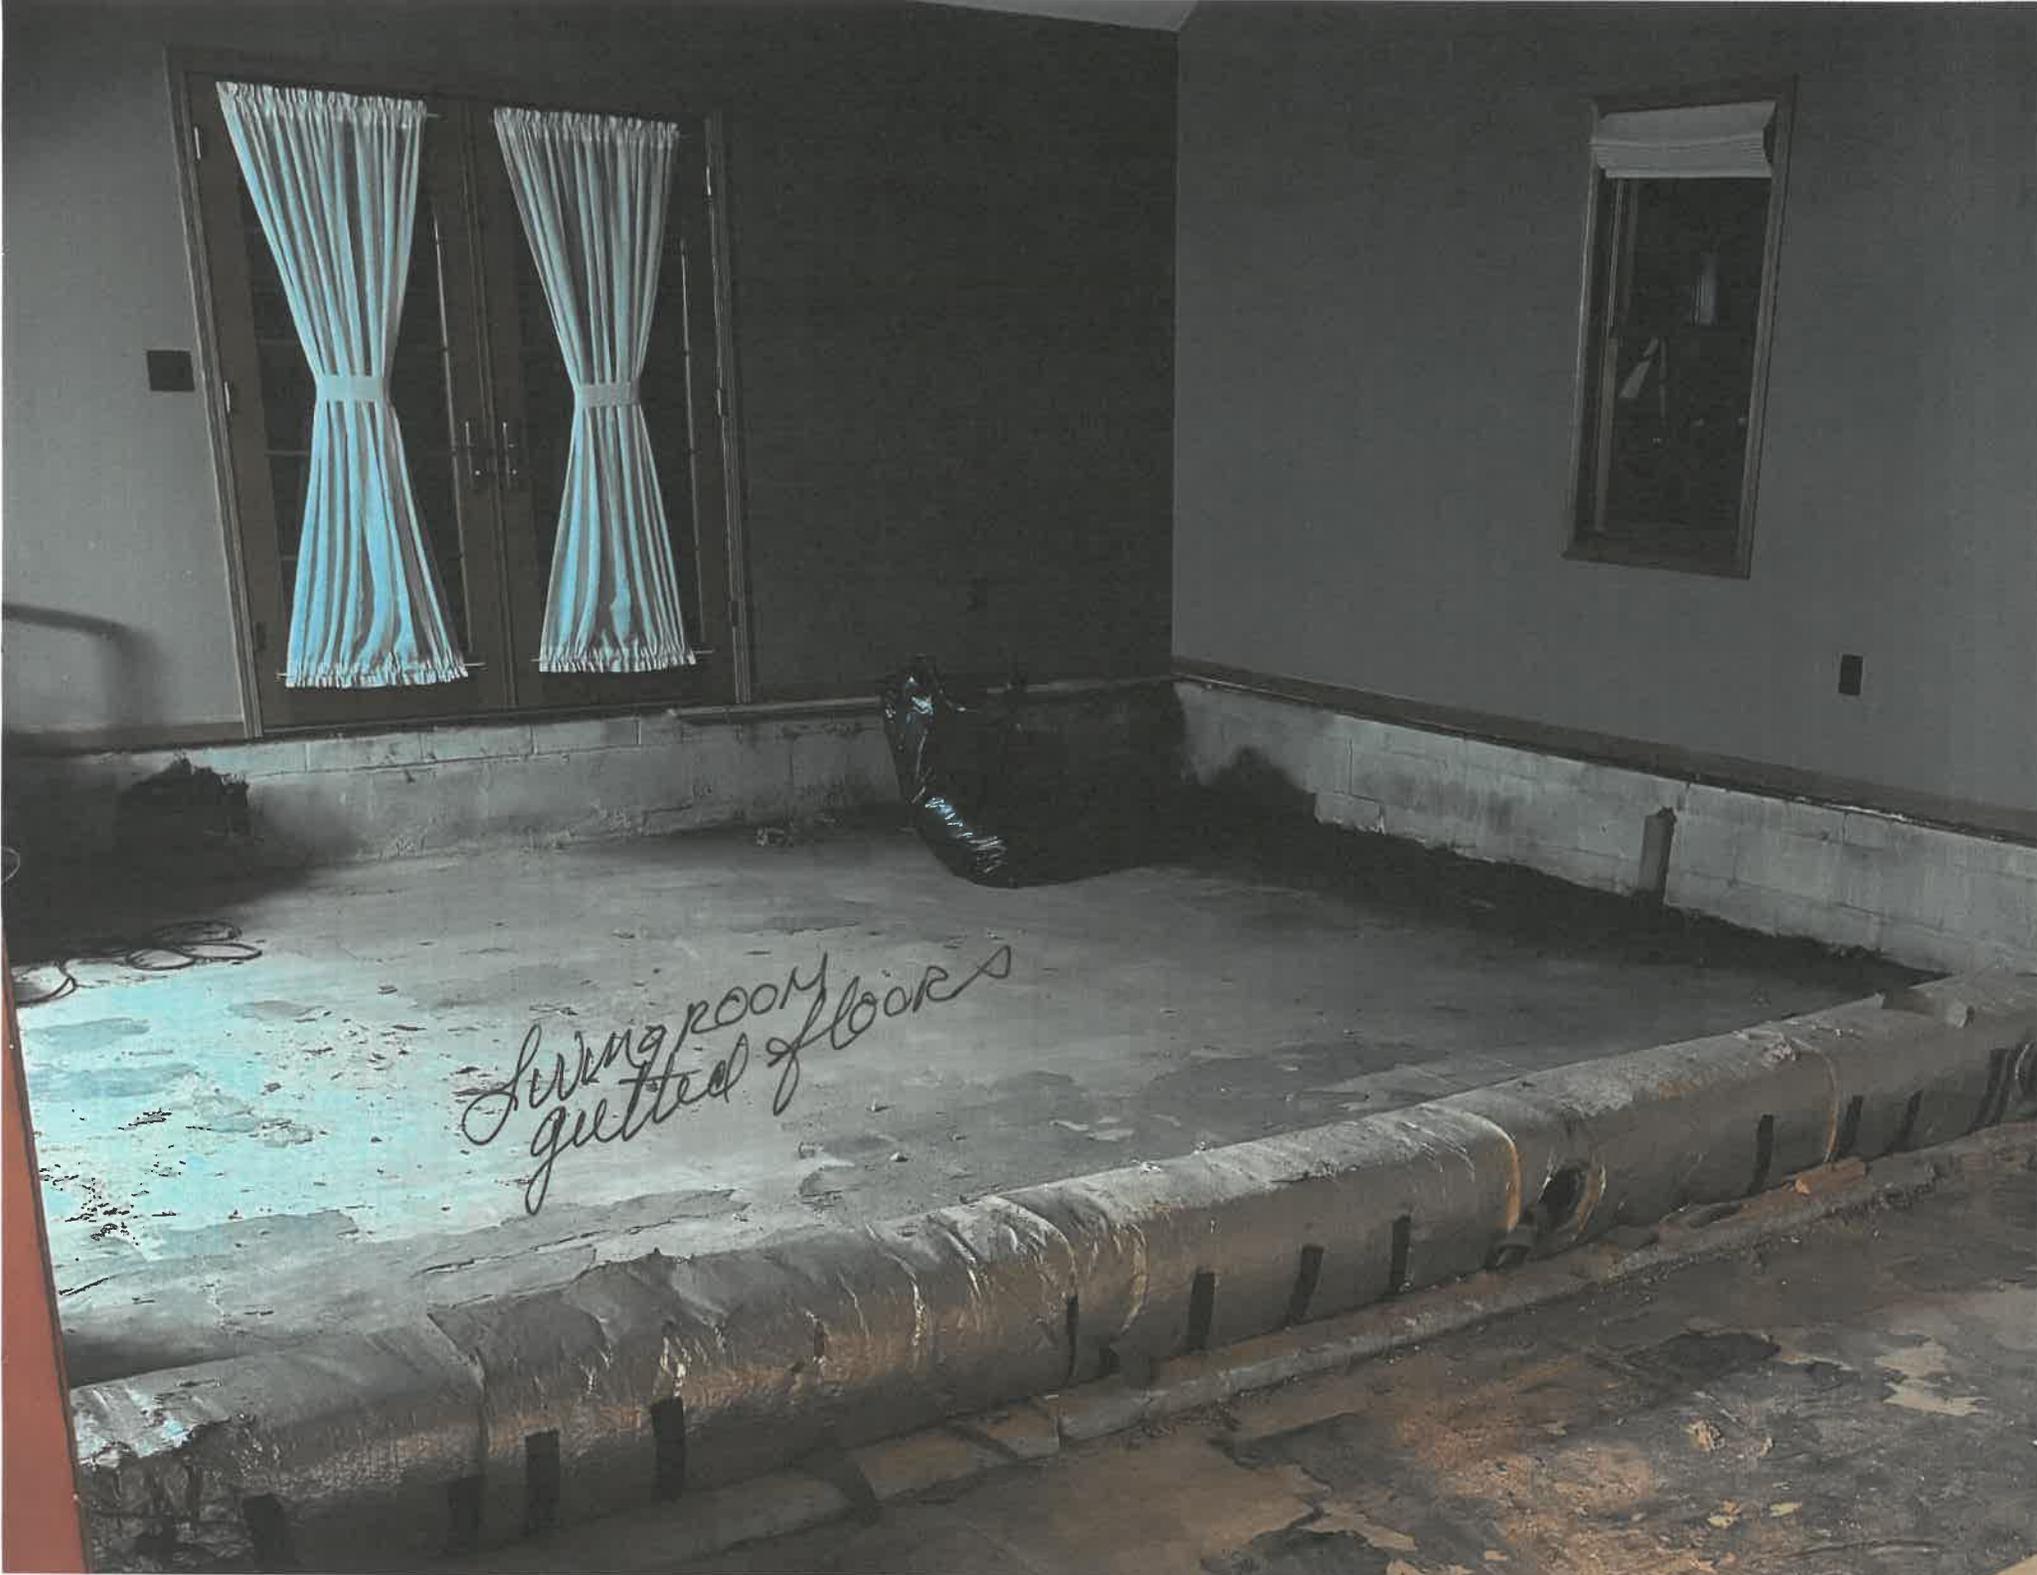
*Living room gutted floors*

example of  
current living ROOM  
floor

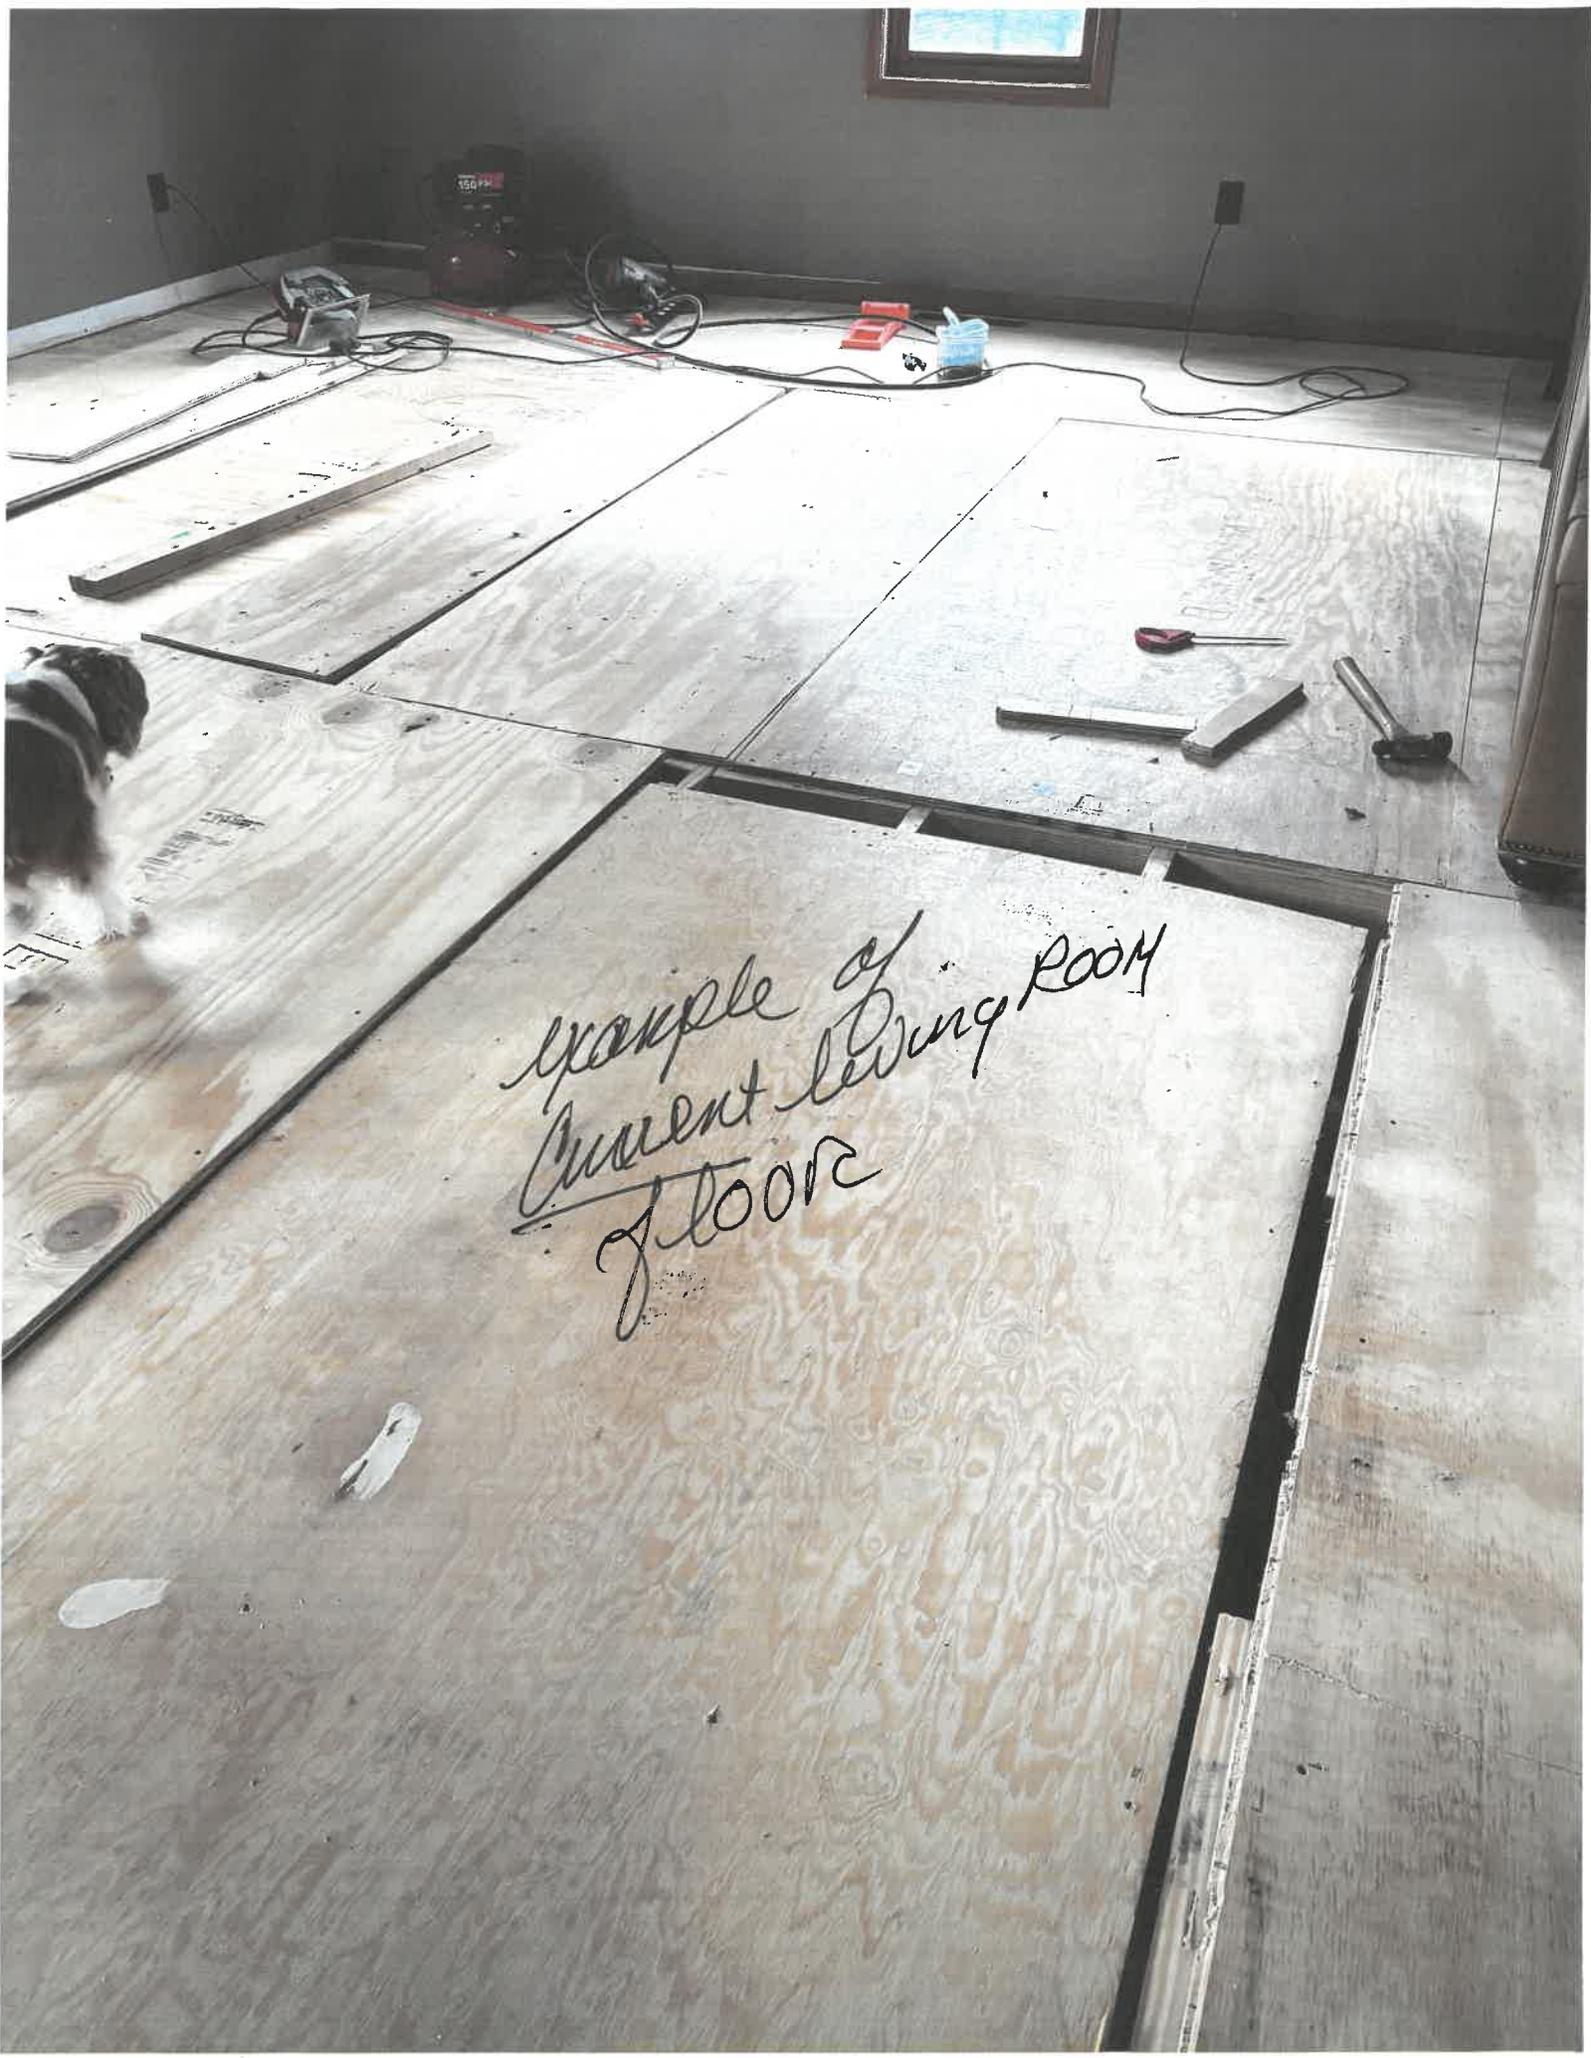
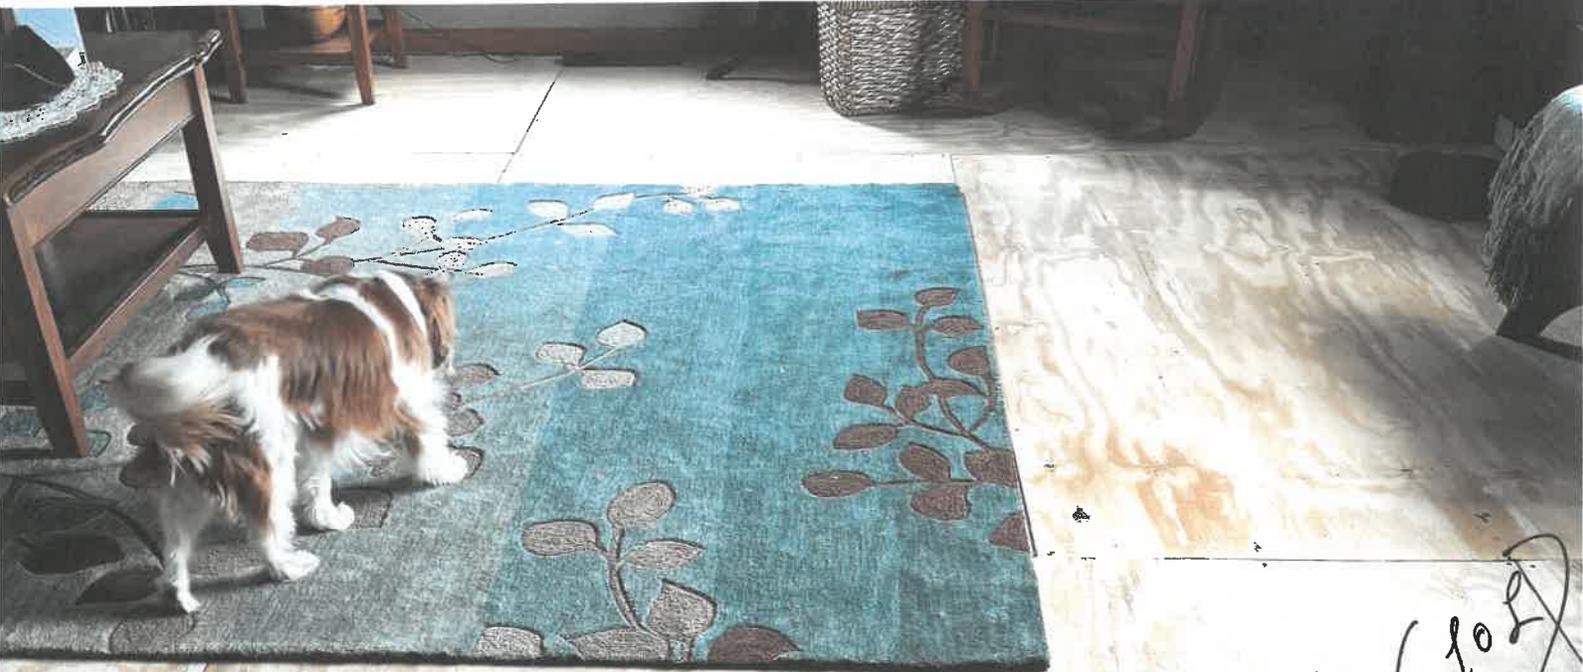
This is our  
current "New"  
plywood living floor (2017)  
- still working on  
living room floors

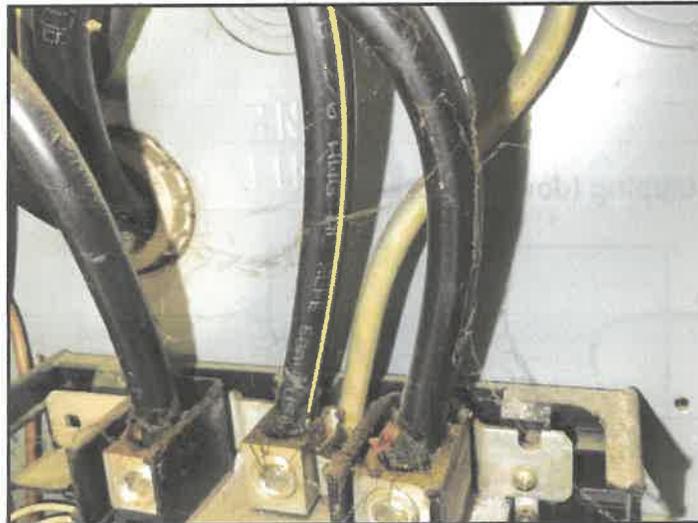
2. Not determined

**Condition:** • Breakers / fuses too big

Appears the wires powering the 50-amp breaker are undersized. Recommend having a licensed electrician evaluate and make any needed repairs.

**Implication(s):** Equipment overheating | Fire hazard

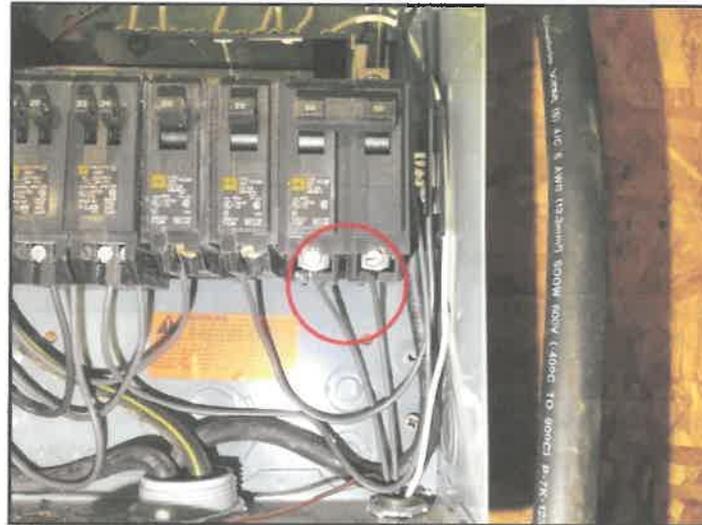
3. Breakers / fuses too big

**Condition:** • Breakers / fuses too big

Appears the wires powering the 200-amp breaker are undersized. Recommend having a licensed electrician evaluate and make any needed repairs.

**Implication(s):** Equipment overheating | Fire hazard

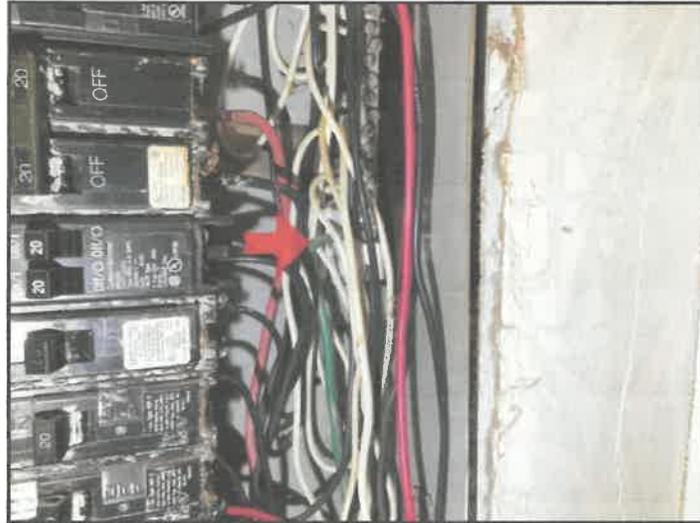
5. Neutral and ground wires bonded at subpanel

**Condition:** • Neutral and ground wires bonded at subpanel

Recommend having a licensed electrician separate neutrals and grounds in the sub-panel and ensure panel is properly bonded.

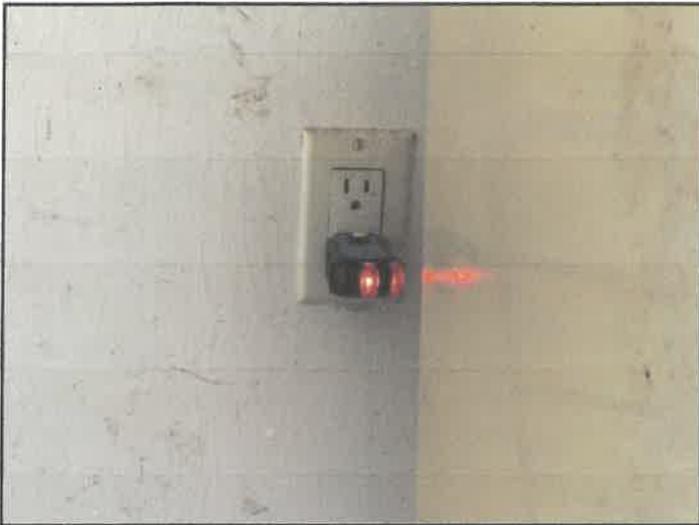
6. GFCI needed

**Condition:** • GFCI needed

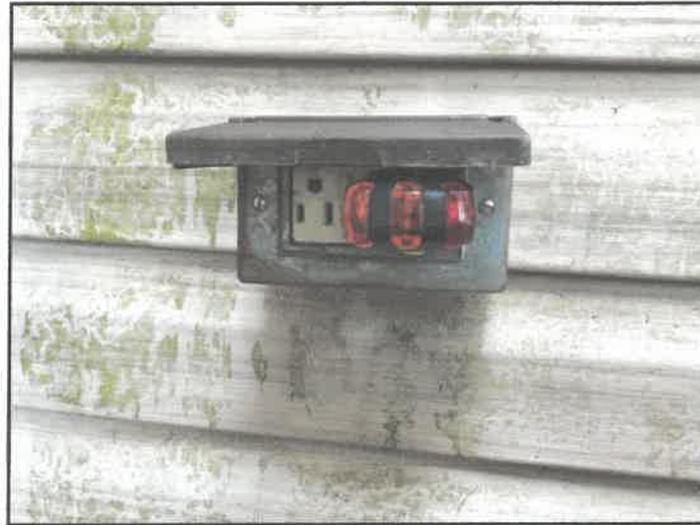
10. Reversed polarity

**Condition:** • Reversed polarity

GFCI outlet showed reversed polarity. Recommend having a qualified electrician evaluate and correct.

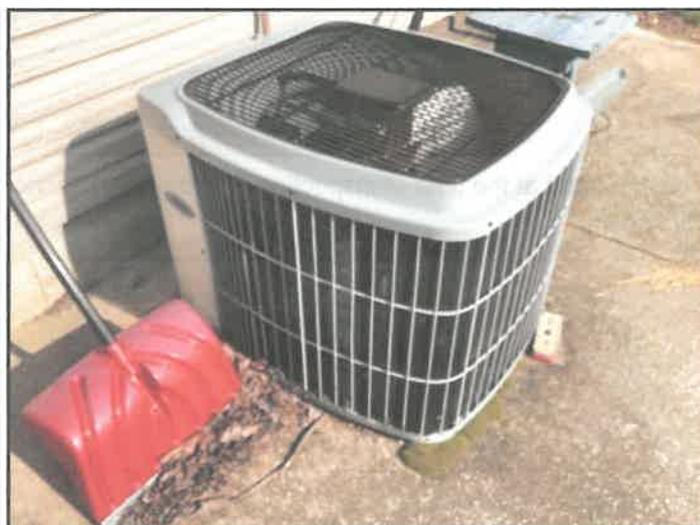
12. Past life expectancy

**Condition:** • Past life expectancy

27-year old unit appeared to run as expected at the time of inspection. Unit is beyond the typical life span of 15 years. Recommend having the unit serviced by an HVAC tech to help prolong the life span. Unit may need replaced in the near future.

**Implication(s):** Equipment failure | Reduced comfort

**Task:** Service

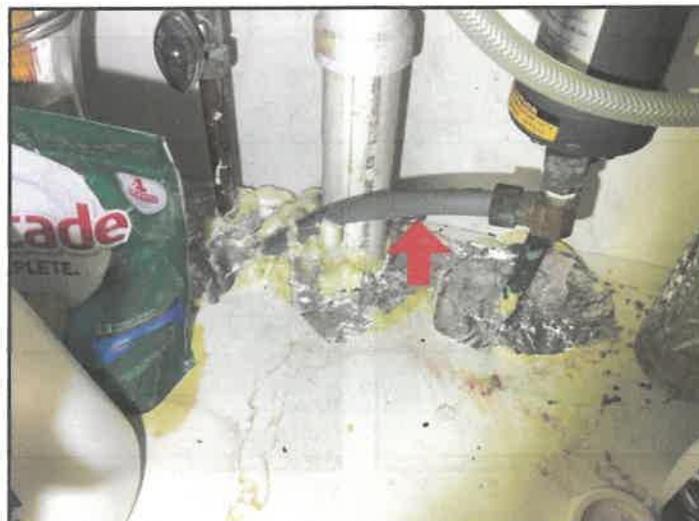
13. Polybutylene

**Condition:** • [Polybutylene](#)

PB supply lines have been the center of class action lawsuits. Pipes are known to leak or fail without warning. It is often recommended to replace entire supply system when found. Recommend having licensed plumber further evaluate and make replacement recommendations.

**Implication(s):** Chance of water damage to contents, finishes and/or structure | Leakage

**Task:** Further evaluation

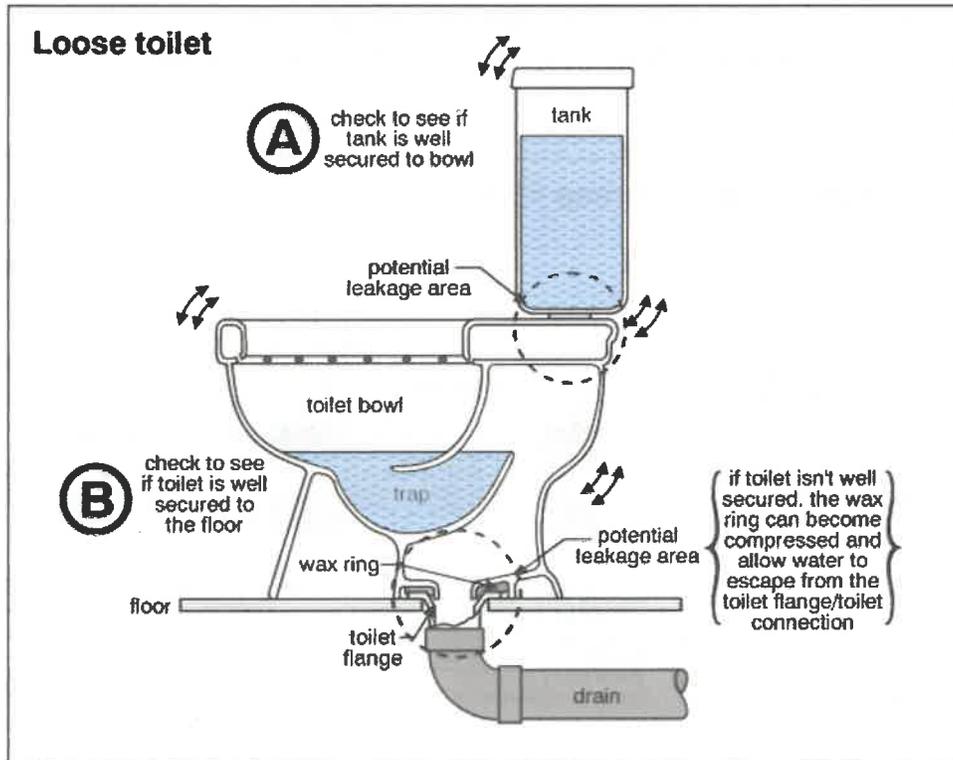
14. Loose

**Condition:** • [Loose](#)

Both toilets were very loose at the base. Recommend properly securing both toilets to prevent the toilets from leaking.

**Implication(s):** Chance of water damage to structure, finishes and contents | Sewage entering the building | Possible hidden damage

**Task:** Correct

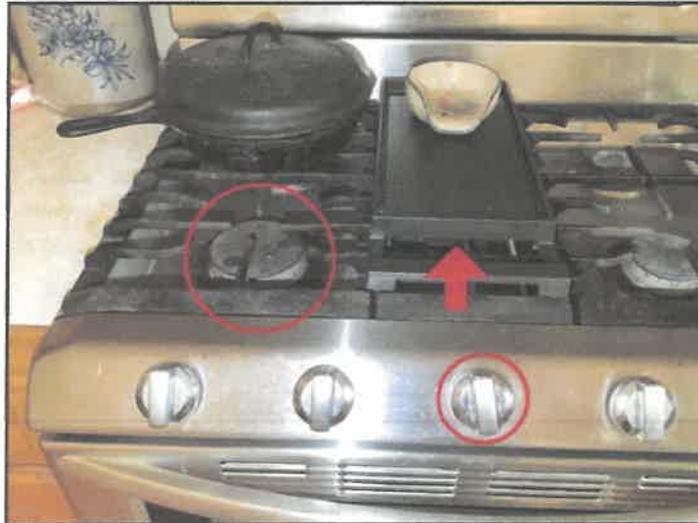
16. Burner inoperative

**Condition:** • Burner inoperative

**Task:** Repair or replace

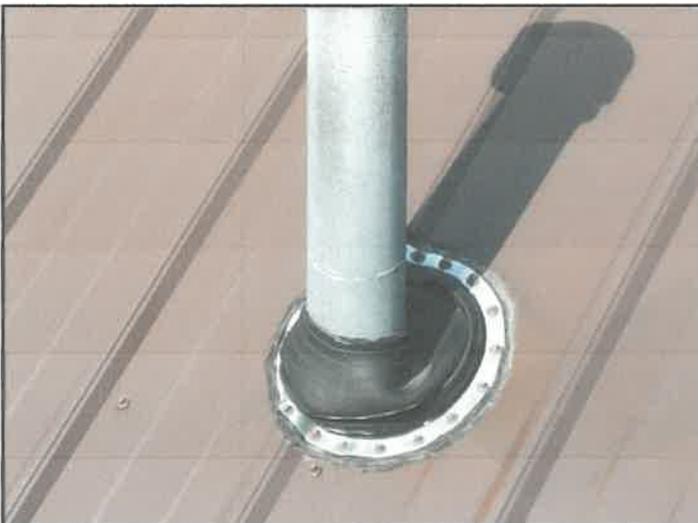
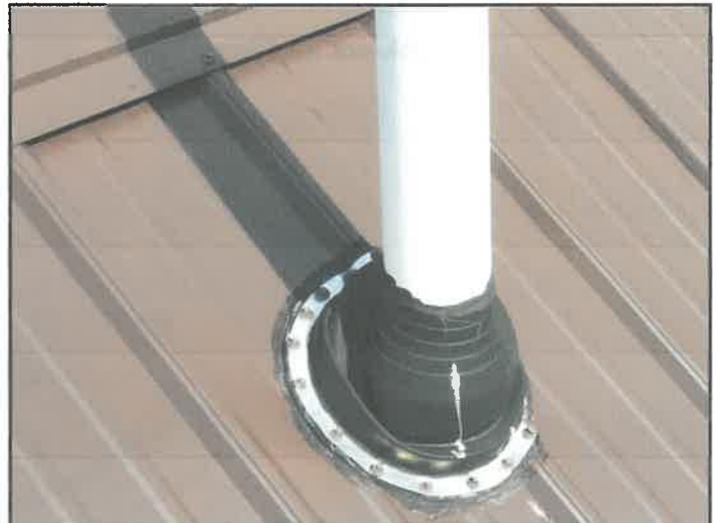
5. Condition: • Inverted boot

Implication(s): Chance of water damage to contents, finishes and/or structure

27. Inverted boot

28. Inverted boot

Task: Correct

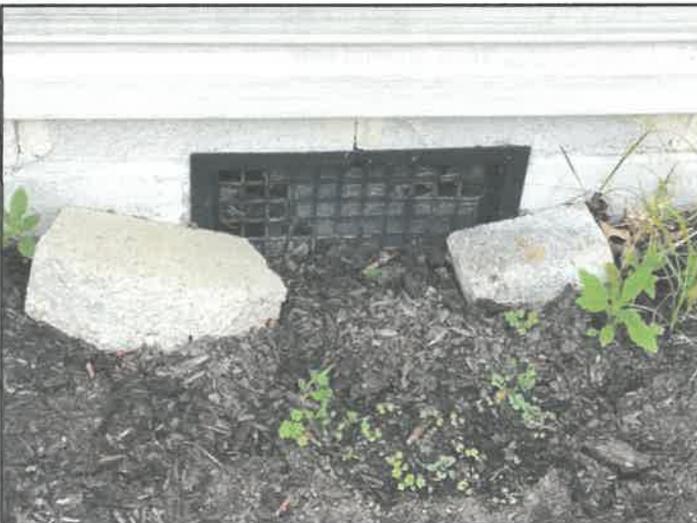
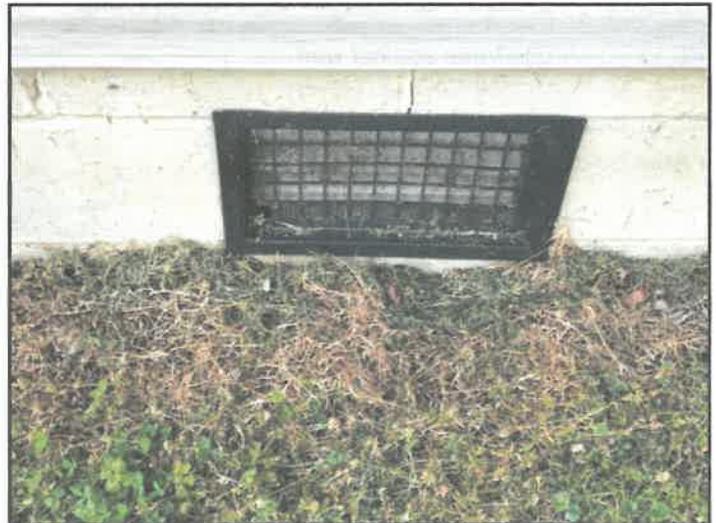
43.

**6. Condition:** • Replace all damaged screens.

**Task:** Replace

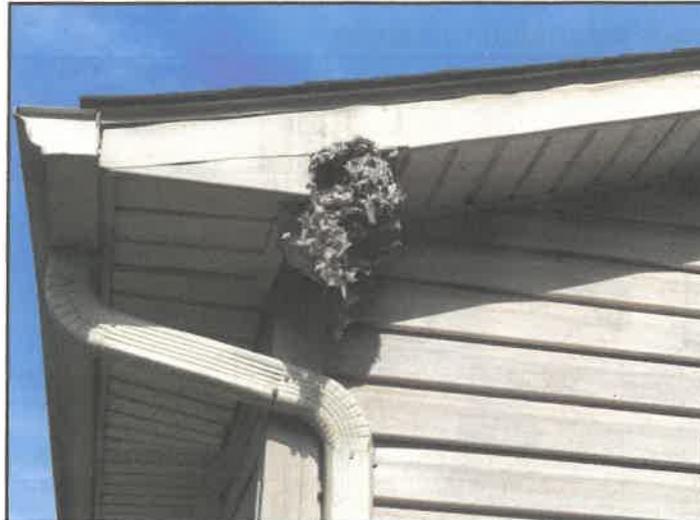
45.

**7. Condition:** • Remove hornet's net.

**Task:** Remove

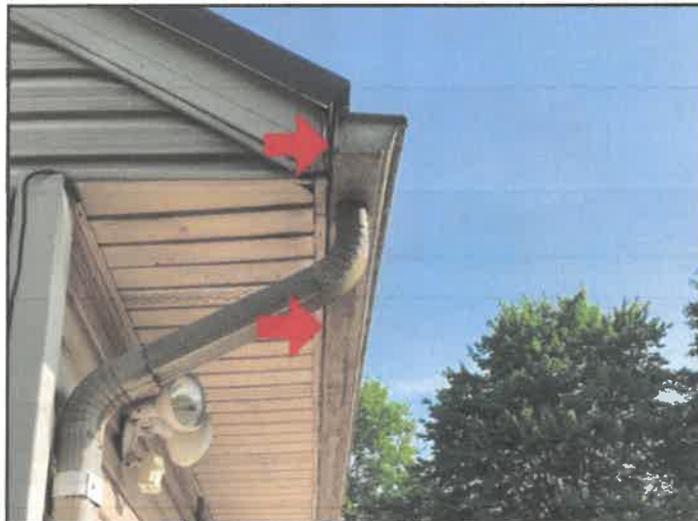
**8. Condition:** • Loose

**Implication(s):** Chance of water damage to contents, finishes and/or structure

46. Loose

Secure loose gutter.
