### Complaint Against the Valuation of Real Property

6. Parcel numbers from tax bill	Address of property
<u>07-021-10-009-21</u>	<u>1170 Greenbriar DR. Rock Creek, Ohio 44084 (Austinburg TWP)</u>

1170 Greenbriar Dr, Rock Creek, OH June 19, 2023

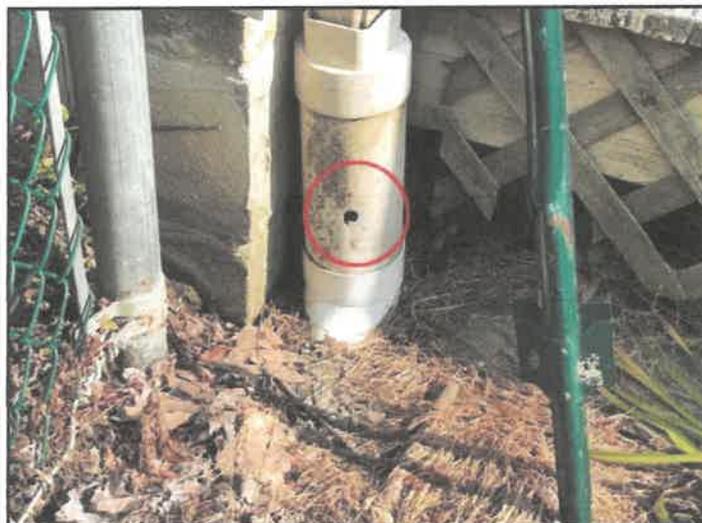
**11. Condition:** • Damaged crock

**49. Damaged crock**

Repair damaged crock:

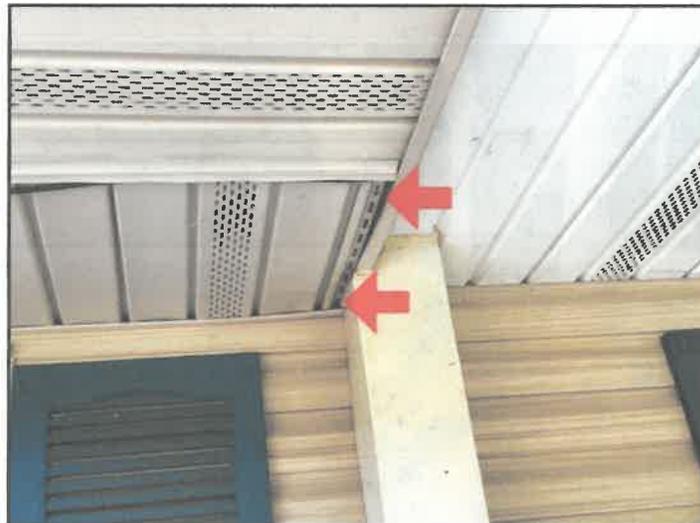
13. Condition: • Loose or missing pieces

51. Loose or missing pieces

Task: Repair

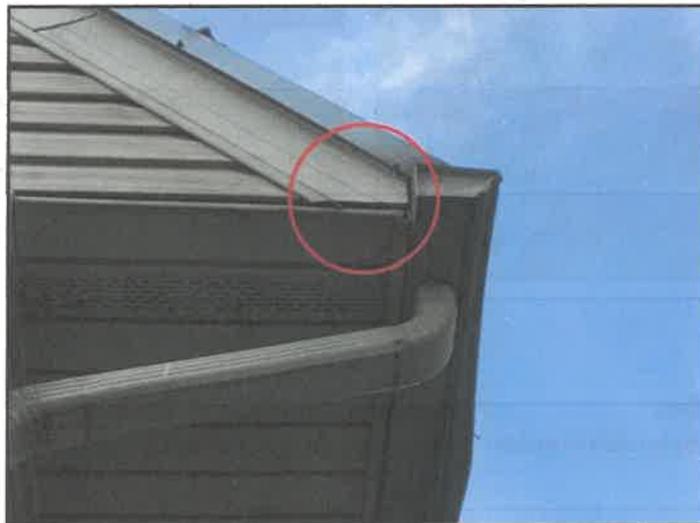
**15. Condition:** • Caulking missing or ineffective  
Ensure all openings into buildings are sealed.

**Implication(s):** Chance of water damage to contents, finishes and/or structure

54. Caulking missing or ineffective

**Task:** Improve

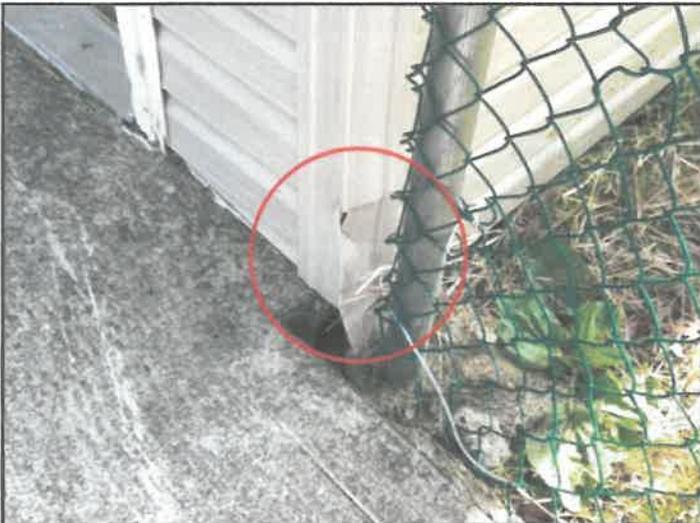
**16. Condition:** • Mechanical damage

**Implication(s):** Chance of water damage to contents, finishes and/or structure

57. Mechanical damage

**Task:** Repair or replace

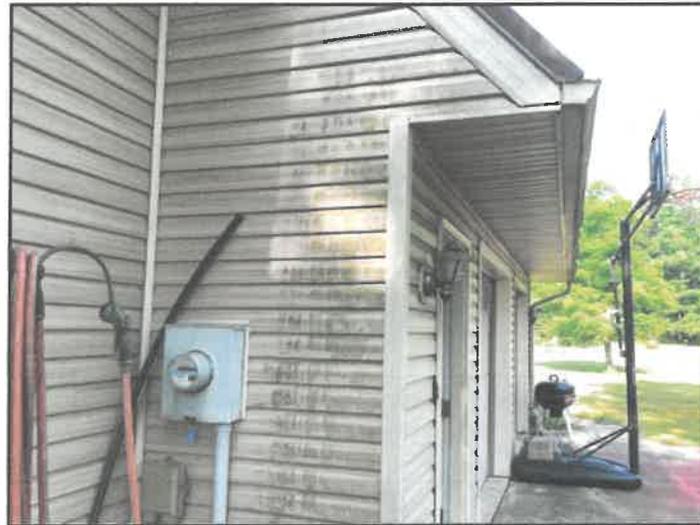
17. **Condition:** • Siding dirty

**Implication(s):** Accelerated material deterioration

59. Siding dirty

Recommend power washing siding.

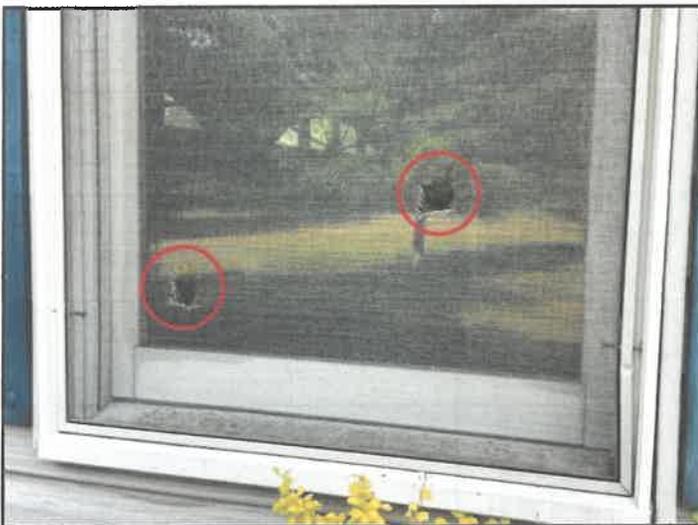
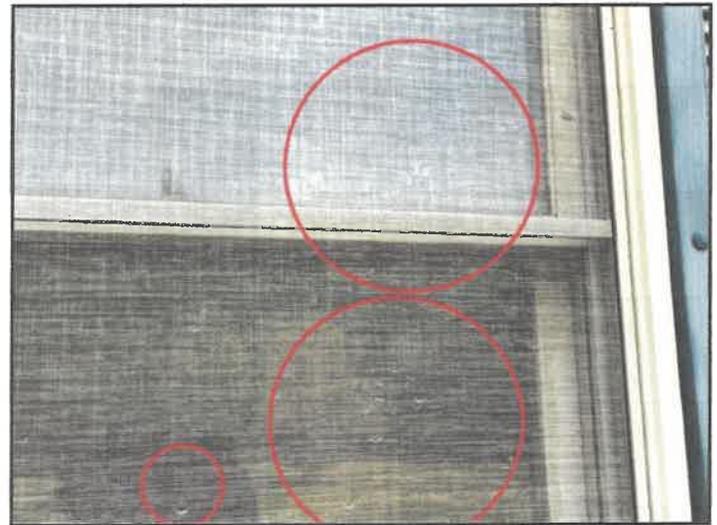
18. Condition: • Torn or holes

60. Torn or holes

61. Torn or holes

Task: Repair or replace

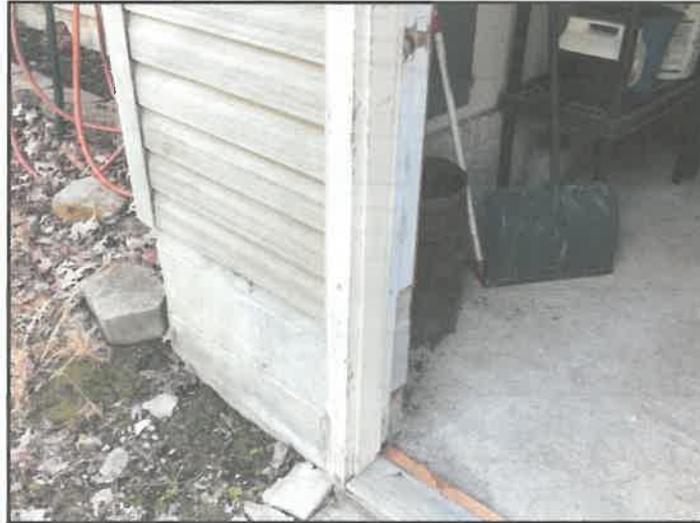
19. Condition: • Paint or stain needed

Implication(s): Accelerated material deterioration

62. *Paint or stain needed*

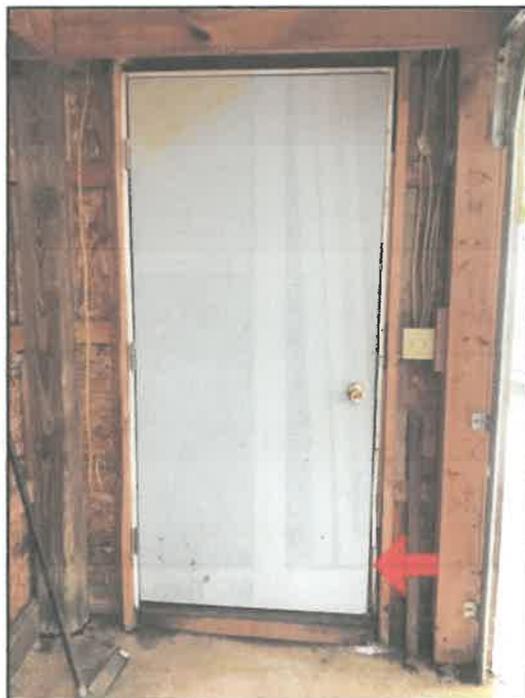
**20. Condition:** • Loose or poor fit

63. *Loose or poor fit*

**Task:** Correct

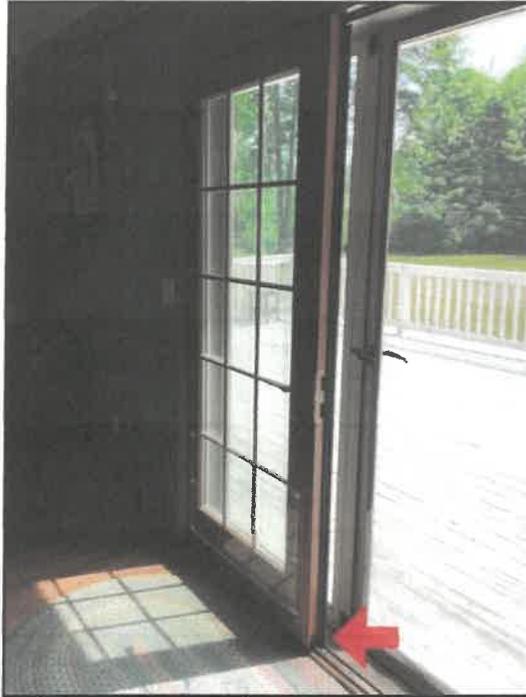
**21. Condition:** • Rubbing

64. Rubbing

**Task:** Repair

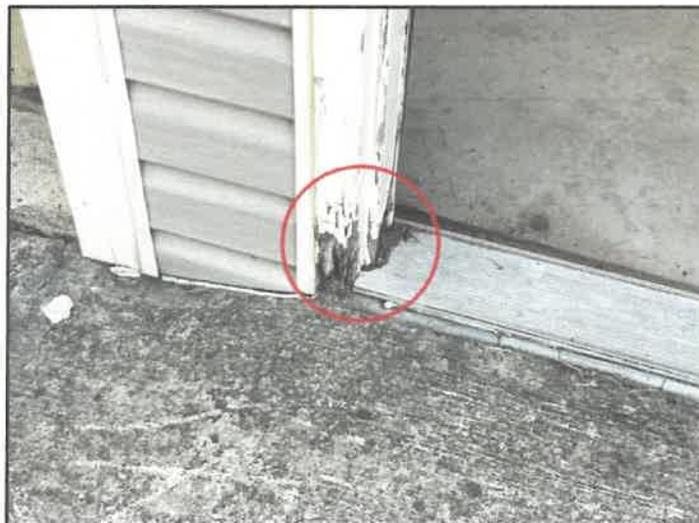
**22. Condition:** • [Rot](#)

**Implication(s):** Chance of damage to finishes and structure

65. Rot

**Task:** Repair or replace

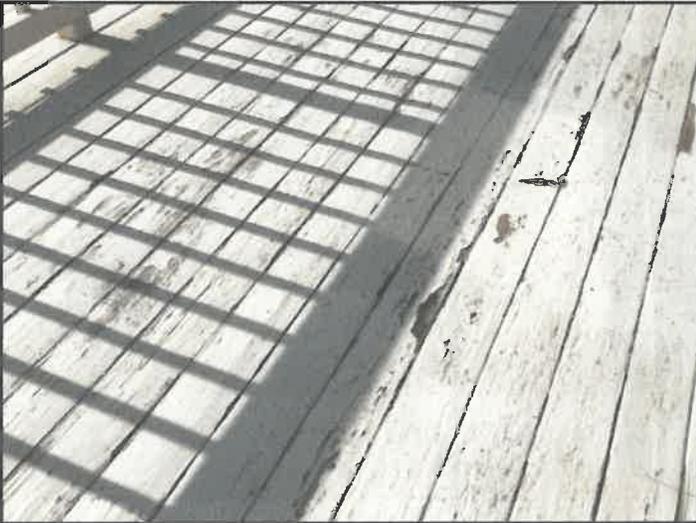
**23. Condition:** • Seal or stain decking

**Implication(s):** Accelerated material deterioration

66. Seal or stain decking

Recommend power washing and sealing / staining decking.

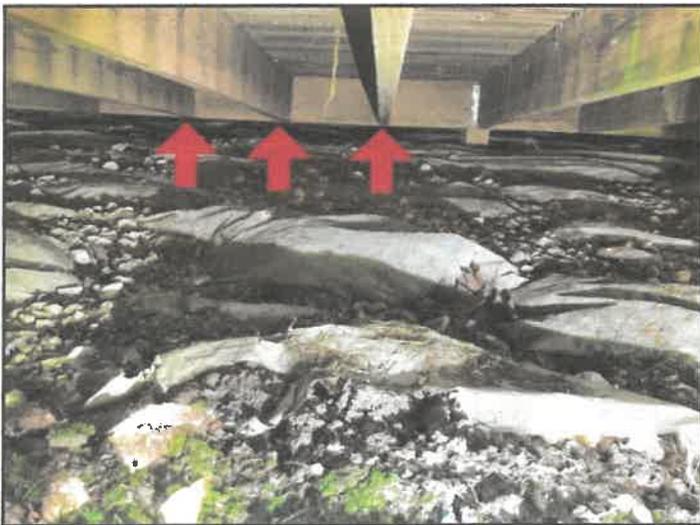
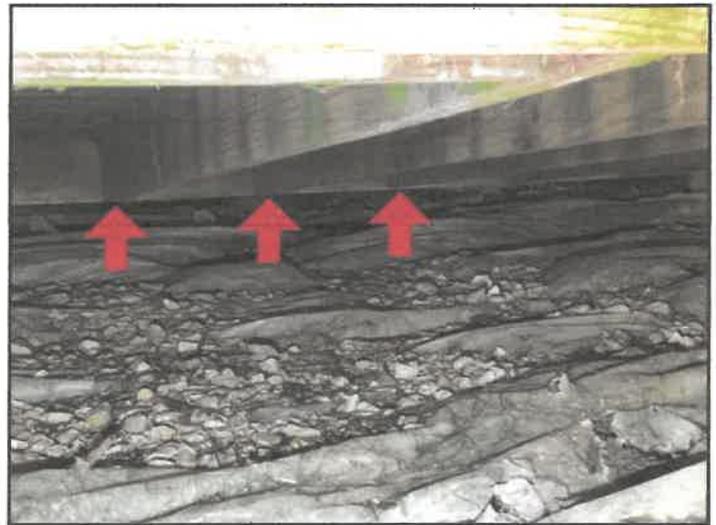
68.

**24. Condition:** • End bearing inadequate

**Task:** Correct

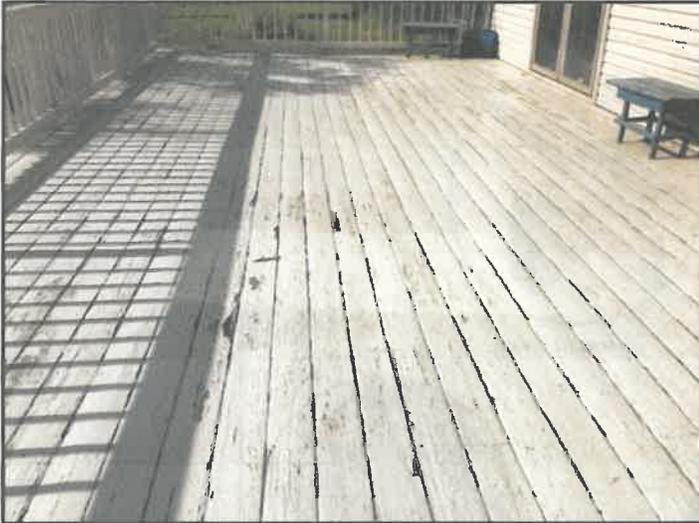
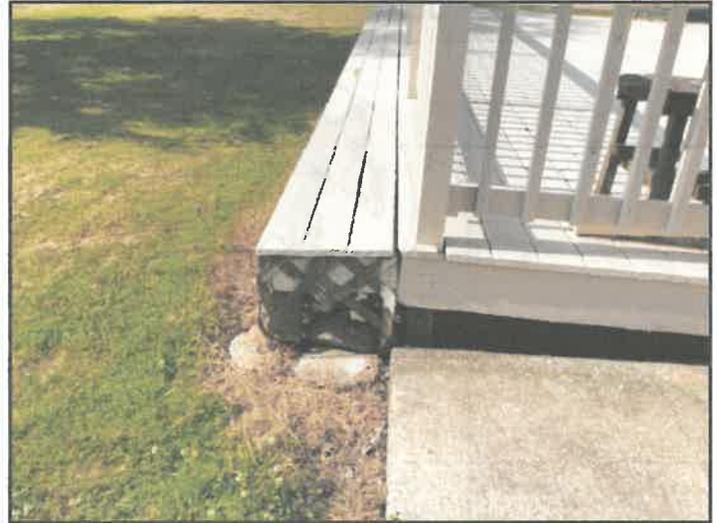
**25. Condition:** • Sloped or Uneven

Appears the deck has settled and is now sloped towards the home. Recommend monitoring and seek further evaluation if worsens or if desired.

70. Sloped or Uneven

71. Sloped or Uneven

## Task: Monitor

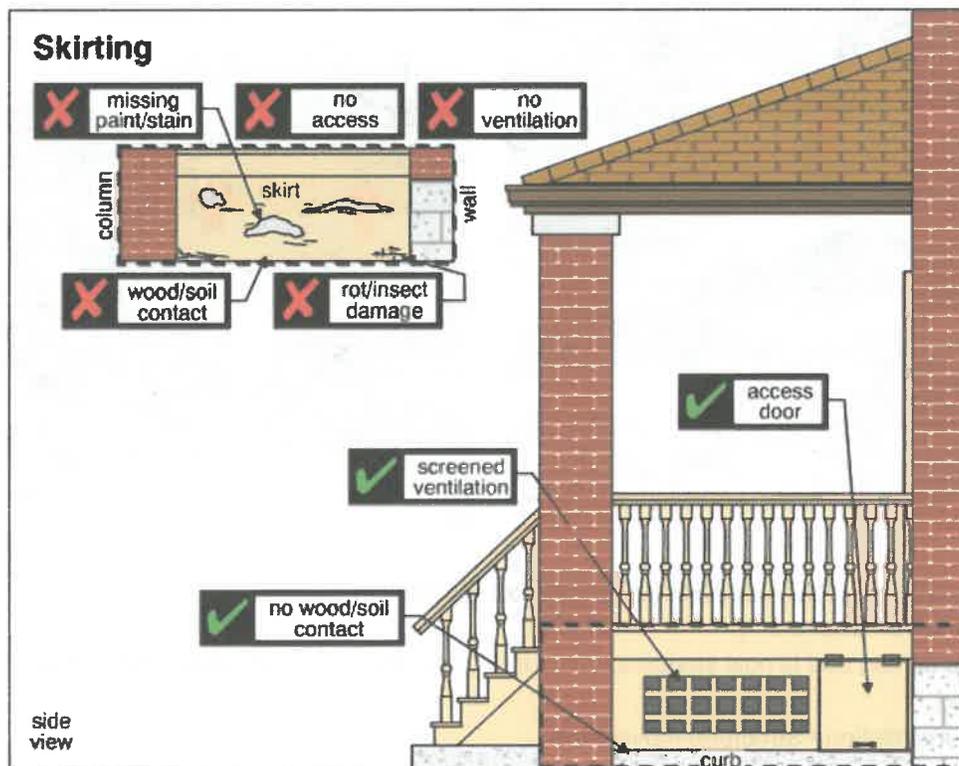
26. Condition: • **Damage**

Task: Repair or replace

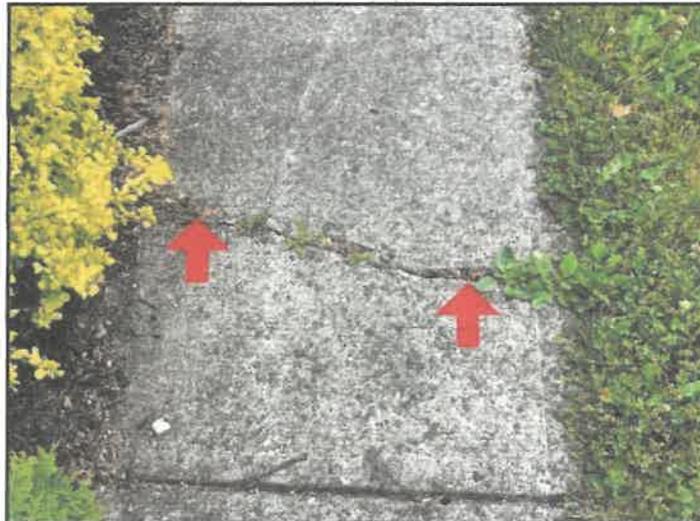
**27. Condition:** • Cracked or damaged surfaces

**Implication(s):** Trip or fall hazard

74. Cracked or damaged surfaces

**Task:** Repair or replace

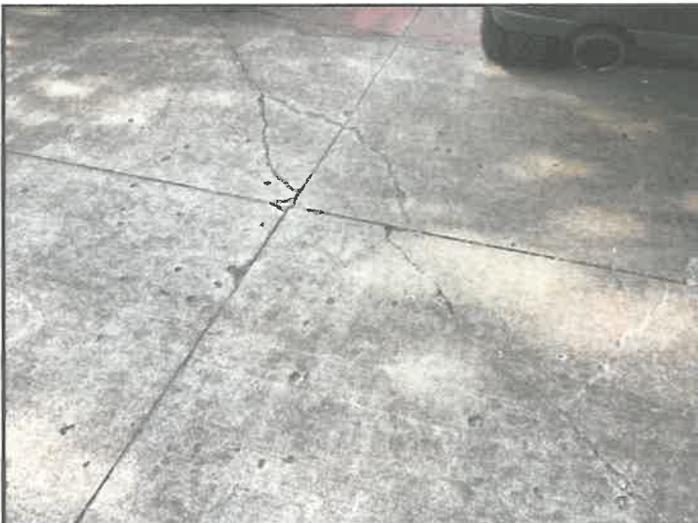
76. Cracked or damaged surfaces

**29. Condition:** • Cracked or damaged surfaces

**Implication(s):** Accelerated Material Deterioration

**Location:** Various driveway

**Task:** Repair or replace

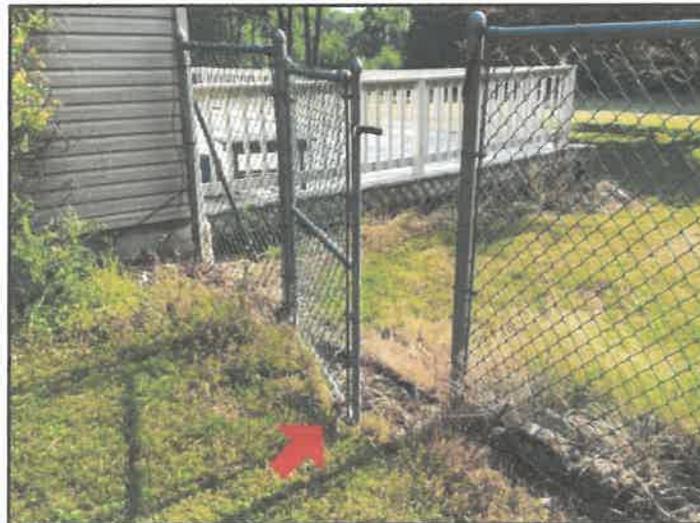
80. Gate - difficult to operate

30. Condition: • Gate - difficult to operate

Location: Exterior

Task: Improve

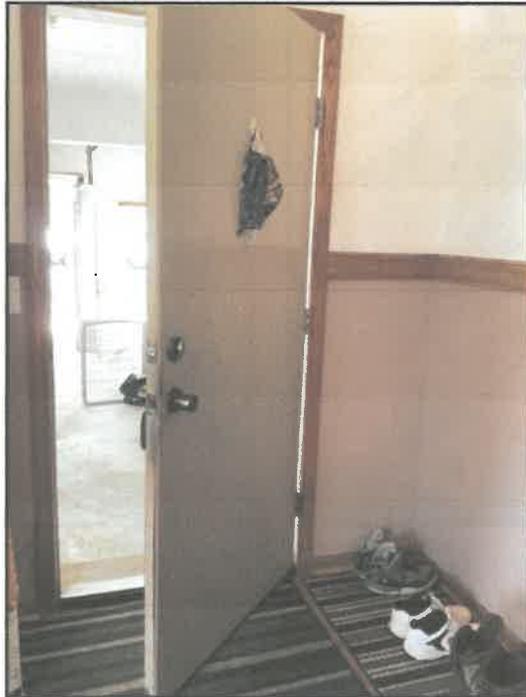
81. No self-closer

31. Condition: • No self-closer

Implication(s): Hazardous combustion products entering home | Increased fire hazard

Task: Replace

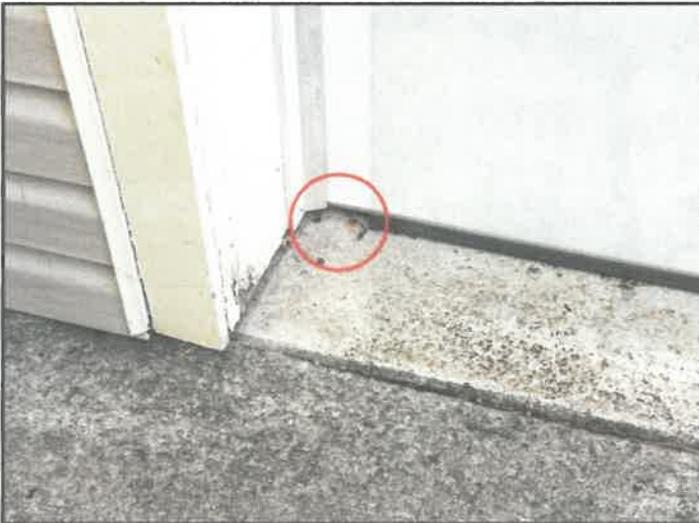
82. Missing / Damaged Weatherstripping

**32. Condition:** • Missing / Damaged Weatherstripping

**Location:** Garage

**Task:** Repair or replace

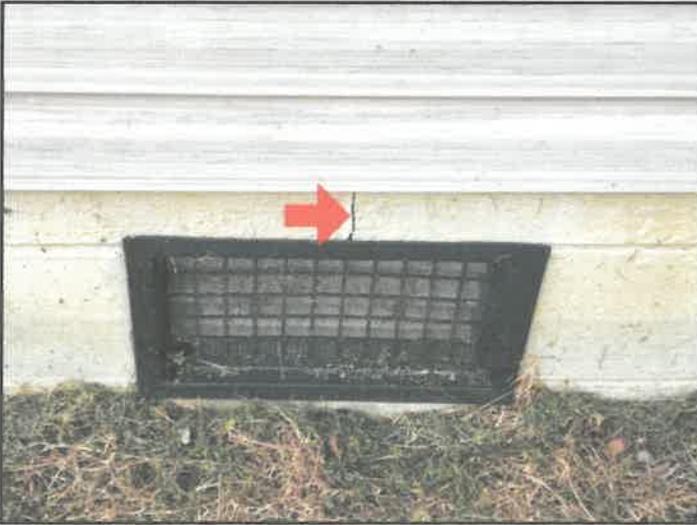
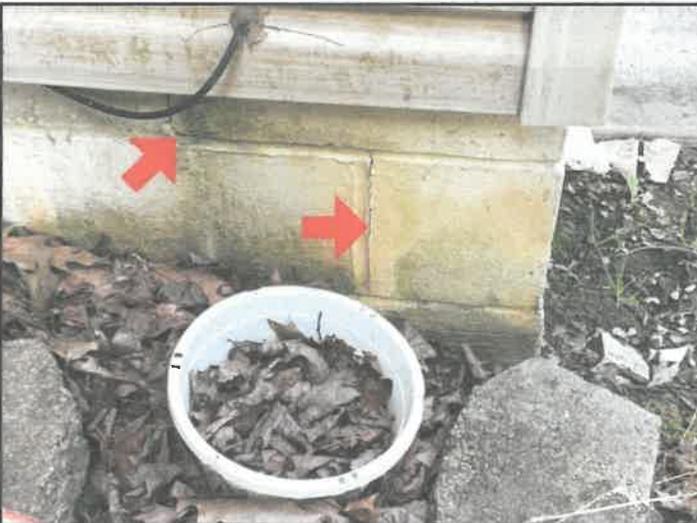
**33. Condition:** • Cracks

**Implication(s):** Chance of water damage to contents, finishes and/or structure | Weakened structure

Repair all cracks and monitor for any changes.

**Task:** Monitor / Repair

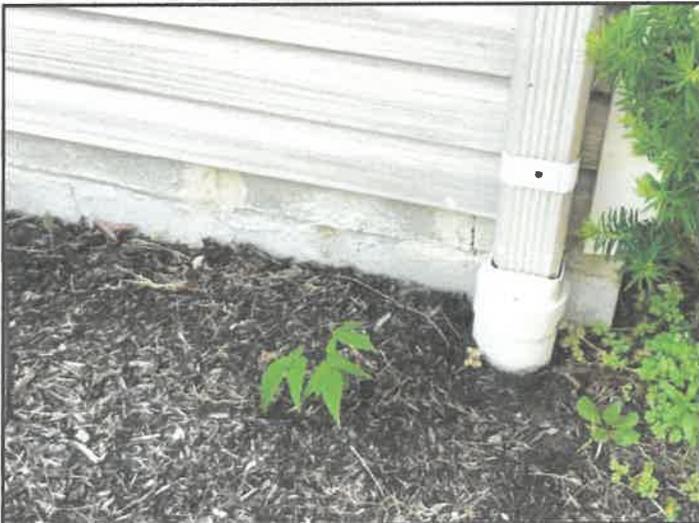
89. Prior repairs

**34. Condition:** • Prior repairs

**Location:** Basement

**Task:** Monitor

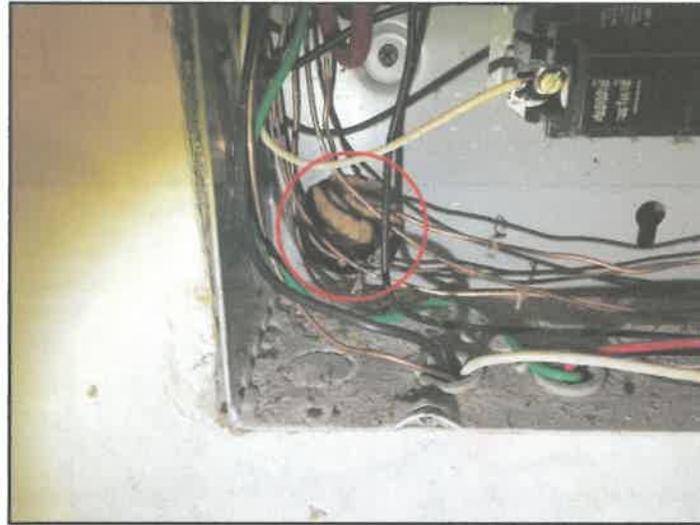
100. Unprotected openings

**37. Condition:** • Unprotected openings

**Implication(s):** Electric shock | Fire hazard

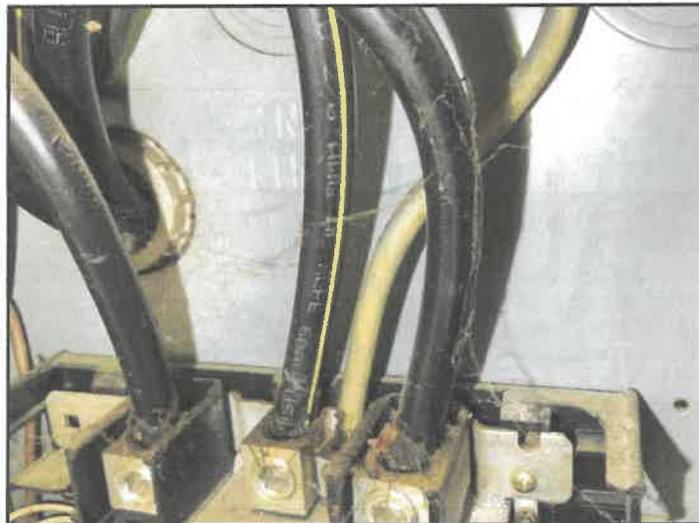
**39. Condition:** • Breakers / fuses too big

Appears the wires powering the 200-amp breaker are undersized. Recommend having a licensed electrician evaluate and make any needed repairs.

**Implication(s):** Equipment overheating | Fire hazard

**Location:** Main Panel

**Task:** Correct

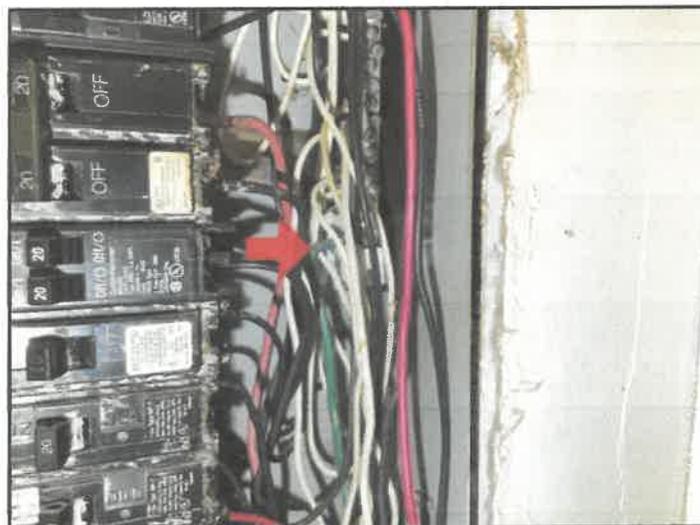
**104.** Neutral and ground wires bonded at subpanel

**41. Condition:** • Neutral and ground wires bonded at subpanel

Recommend having a licensed electrician separate neutrals and grounds in the sub-panel and ensure panel is properly bonded.

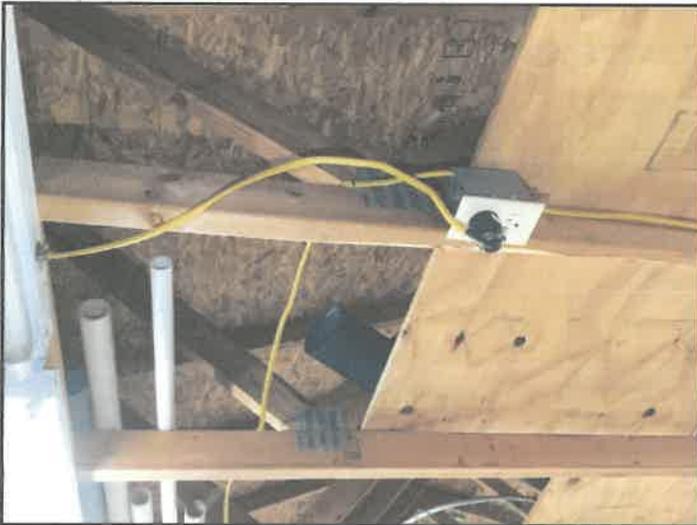
105. Extension cord used as permanent wiring

**42. Condition:** • Extension cord used as permanent wiring

**Implication(s):** Electric shock | Fire hazard

**Location:** Garage / Laundry room

Recommend removing extension cord and properly installing outlet / light fixture box.

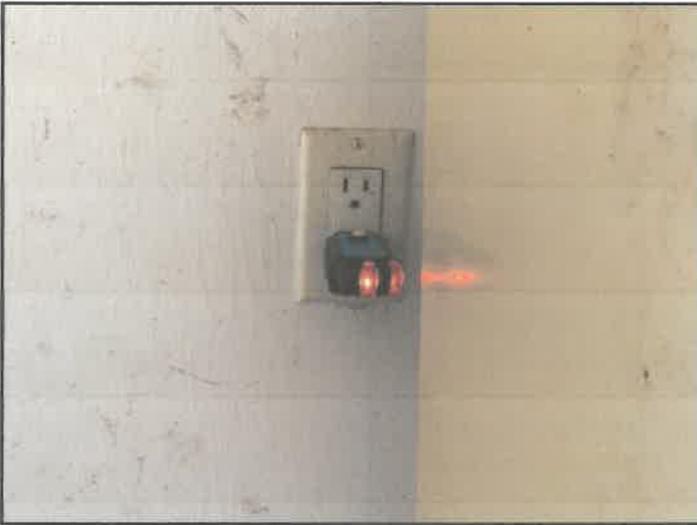
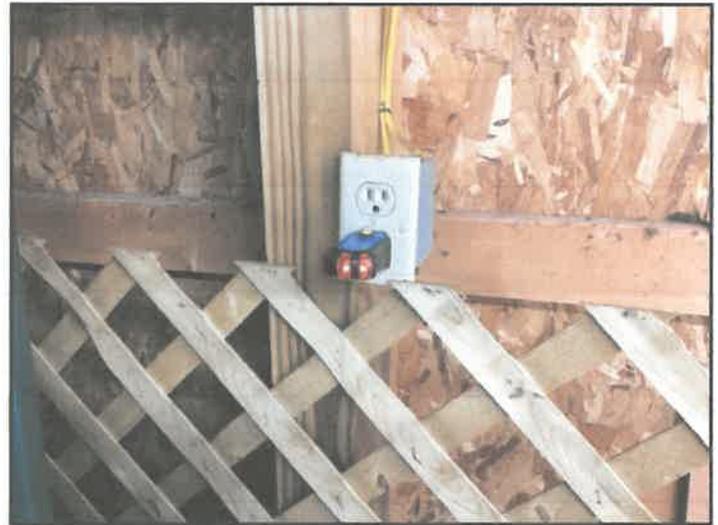
45. Condition: • GFCI needed

**Location:** Garage / Outgoing building

**Task:** Correct

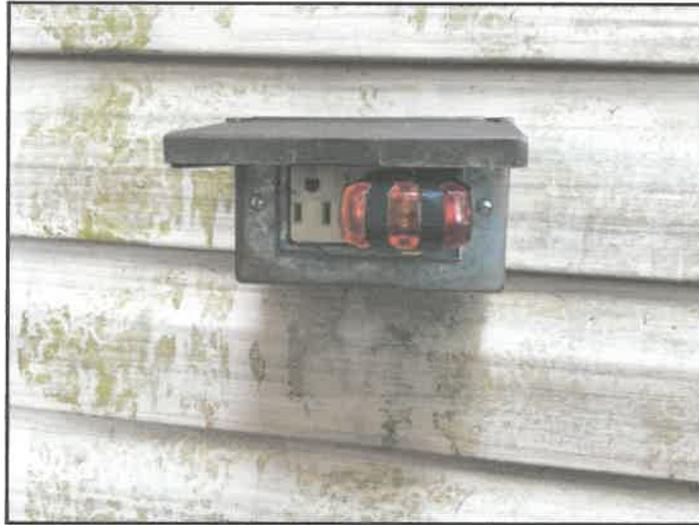
113. *Reversed polarity*

**47. Condition:** • Reversed polarity

GFCI outlet showed reversed polarity. Recommend having a qualified electrician evaluate and correct.

**Task:** Correct

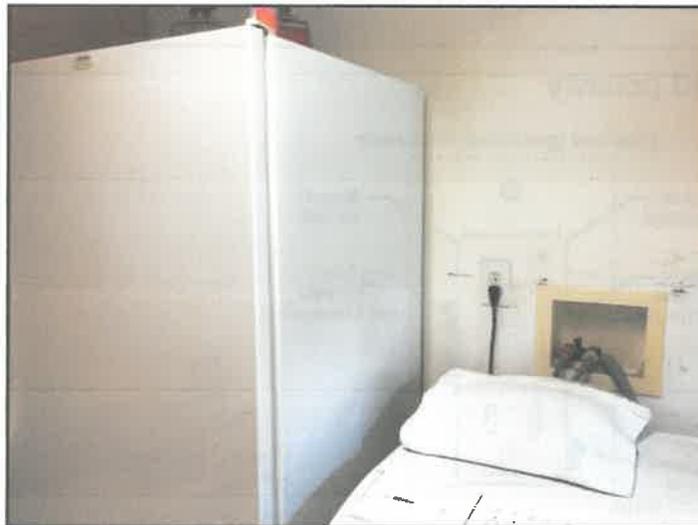
114. *Dedicated circuit needed*

**48. Condition:** • Dedicated circuit needed  
Refrigerator should be on a dedicated circuit.

**Location:** Laundry room

**Task:** Correct

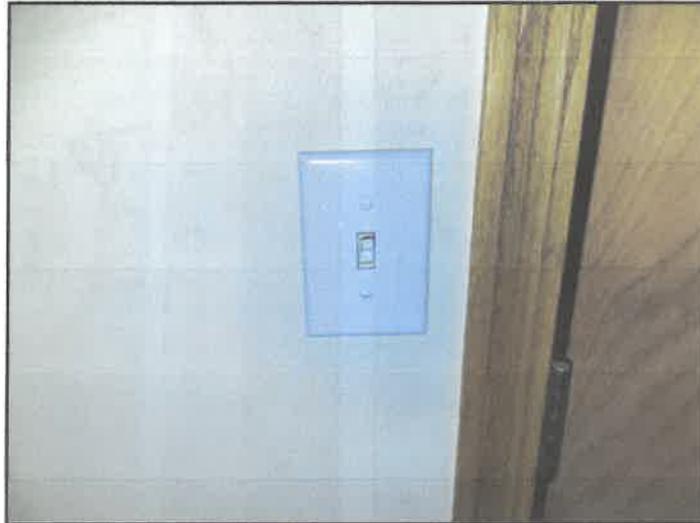
115. *Inoperative*

**49. Condition:** • Inoperative

**Implication(s):** Inadequate lighting / Nuisance

**Task:** Check with current owner

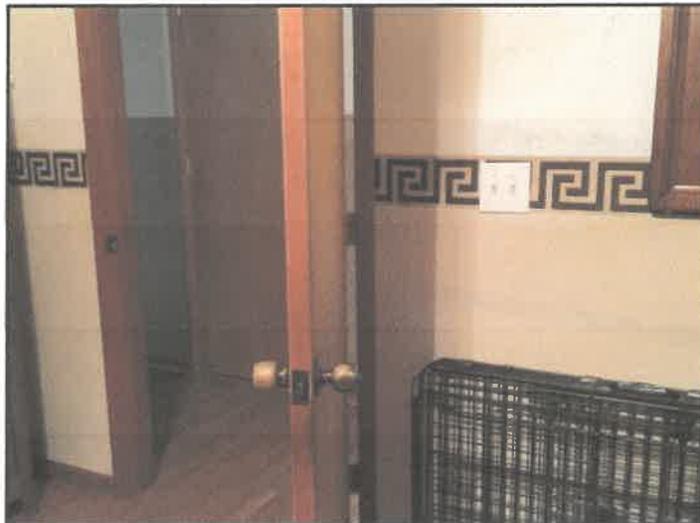
116. *Poor location*

**50. Condition:** • Poor location  
Switches are located behind the door.  
**Implication(s):** Nuisance  
**Location:** Bedroom  
**Task:** Improve

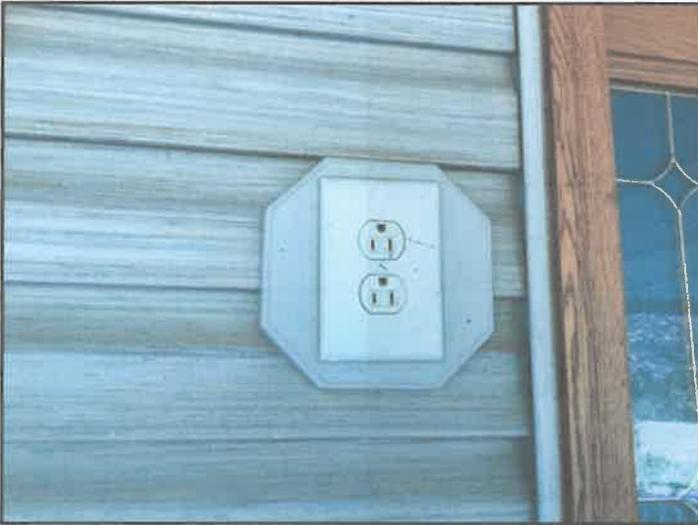
117. Missing

**51. Condition:** • Missing  
**Implication(s):** Electric shock  
**Task:** Replace

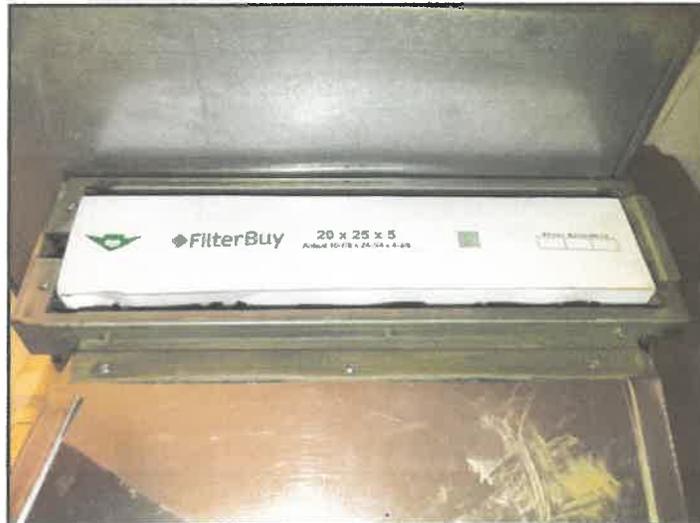
131.

59. Condition: • I was unable to remove the furnace filter at the time of inspection.

Location: Utility room

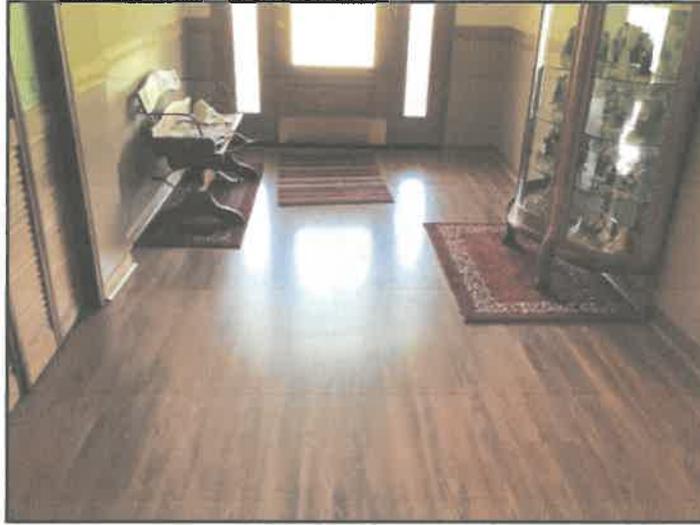
60. Condition: • No heat source

**132.** *No heat source*

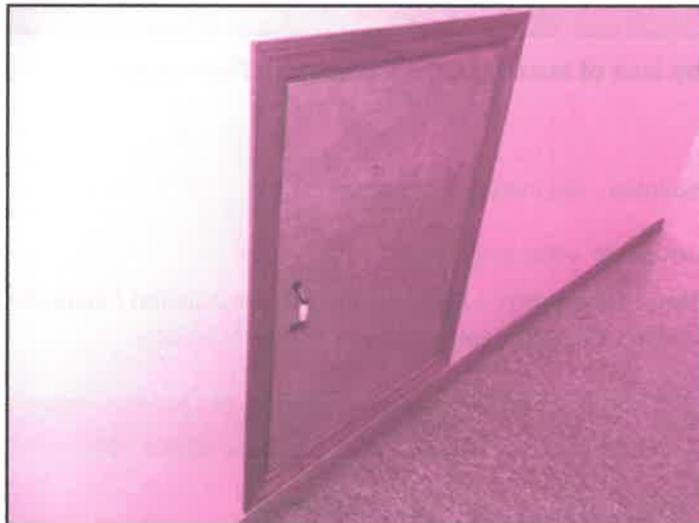
**62. Condition:** • Not insulated and/or weatherstripped

**Implication(s):** Chance of condensation damage to finishes and/or structure | Increased heating and cooling costs |

143. Not insulated and/or weatherstripped

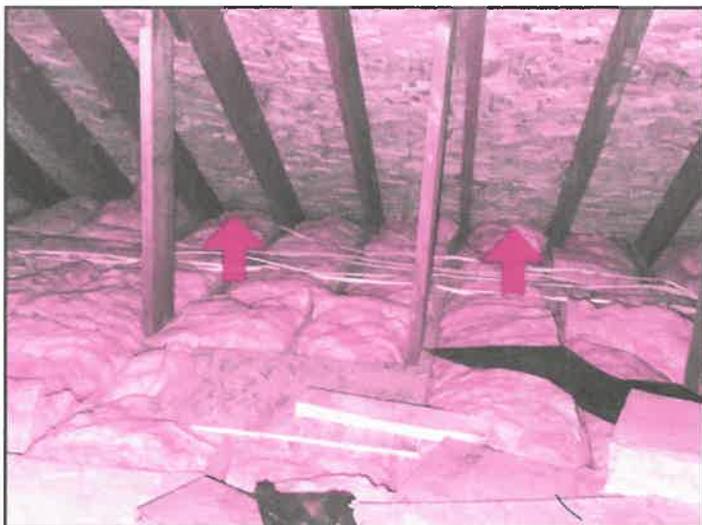
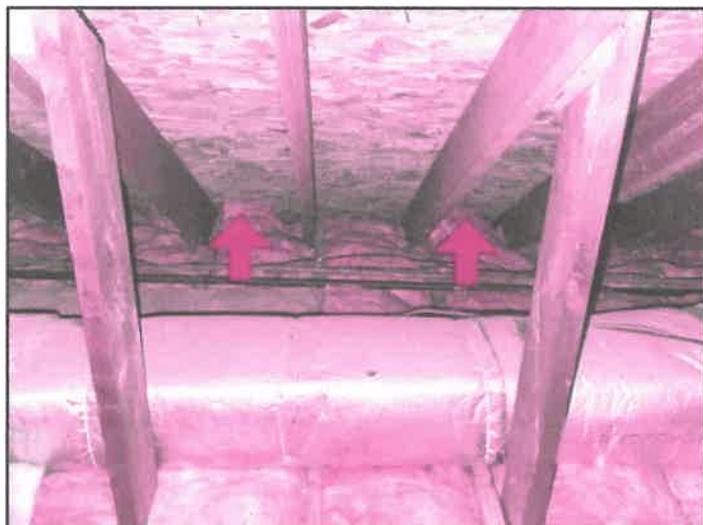
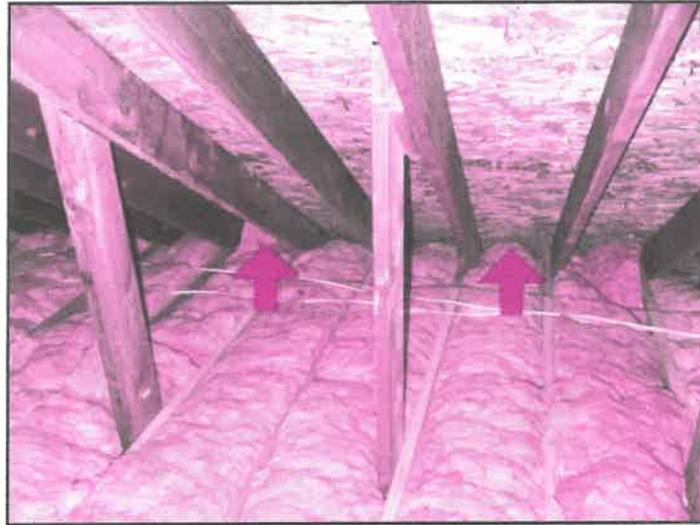
**63. Condition:** • Soffit vents blocked by insulation

**Implication(s):** Chance of condensation damage to finishes and/or structure / Mold growth

**Location:** Attic

144. Soffit vents blocked by insulation

145. Soffit vents blocked by insulation

**146.** *Soffit vents blocked by insulation*

Recommend installing baffles to prevent insulation from blocking soffit vents.

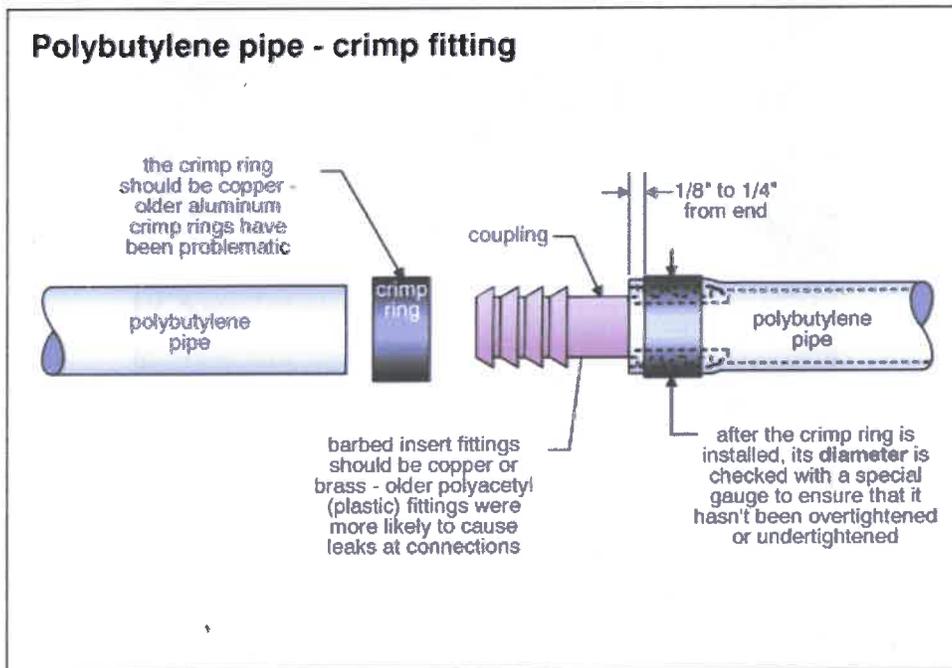
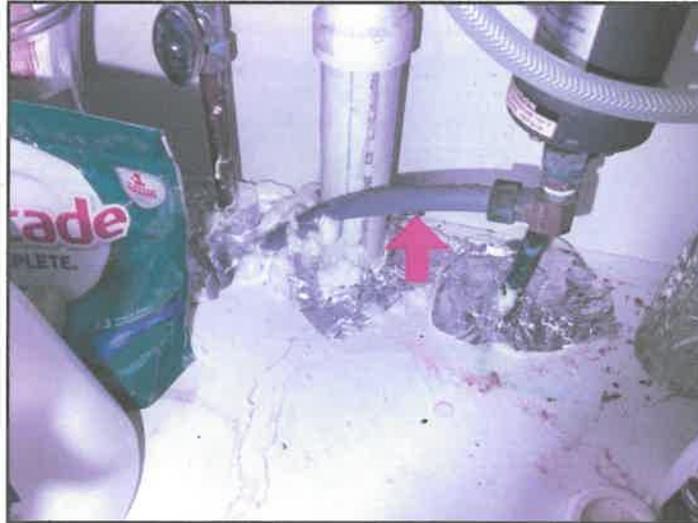
**65. Condition:** • [Polybutylene](#)

PB supply lines have been the center of class action lawsuits. Pipes are known to leak or fail without warning. It is often recommended to replace entire supply system when found. Recommend having licensed plumber further evaluate and make replacement recommendations.

**Implication(s):** Chance of water damage to contents, finishes and/or structure | Leakage

153. Polybutylene

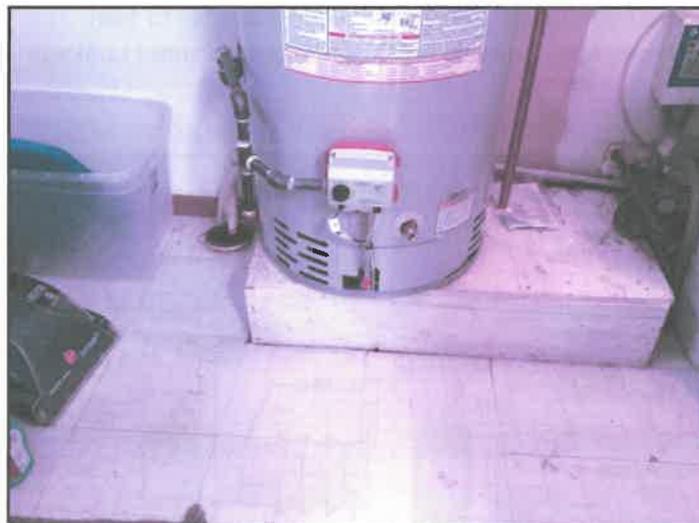
**66. Condition:** • Safety pan / Drain missing

**Implication(s):** Chance of water damage to contents, finishes and/or structure

154. Safety pan / Drain missing

A safety pan plumbed to a drain or a floor drain is recommended when tank is installed in or near finished areas.

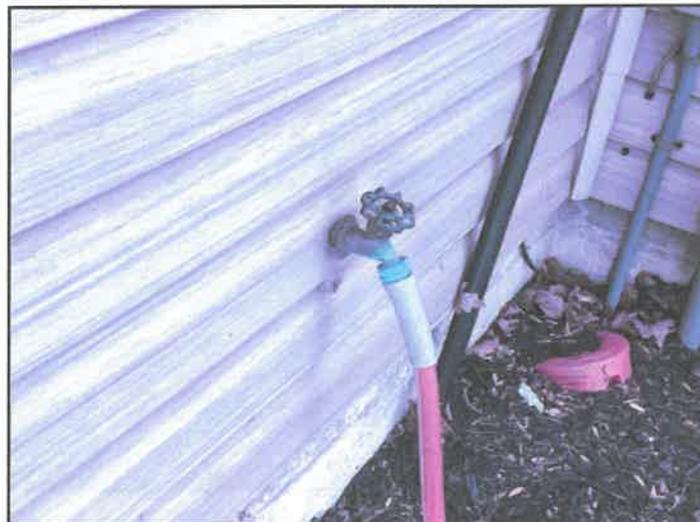
**68. Condition:** • Not Frost Free

**Implication(s):** Chance of water damage to contents, finishes and/or structure

**Location:** Throughout Exterior

156. Not Frost Free

Recommend replacing older style spigots with newer frost free styles when feasible.

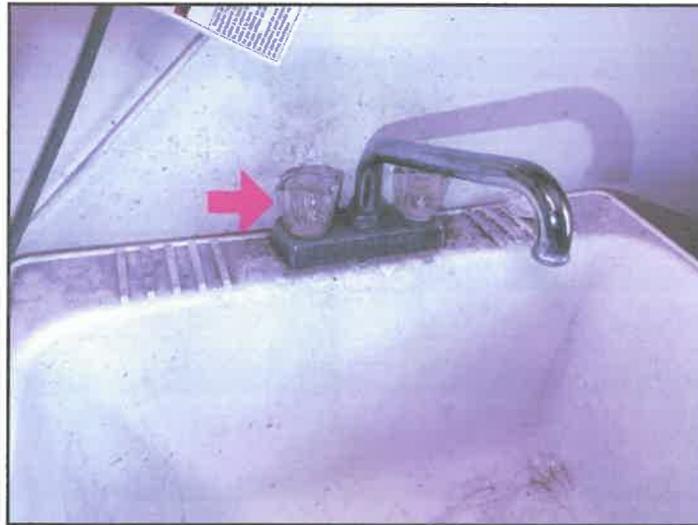
157.

**69. Condition:** • No hot water to the utility sink.

**Location:** Laundry room

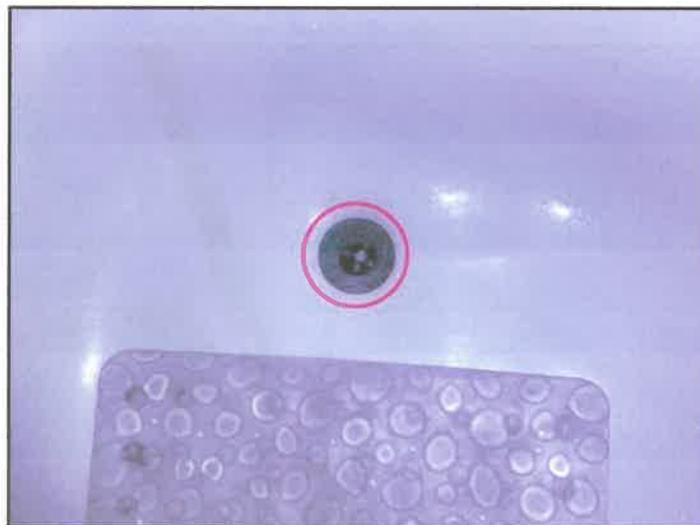
**70. Condition:** • Drain stop missing

**Location:** Bathroom

158. Drain stop missing

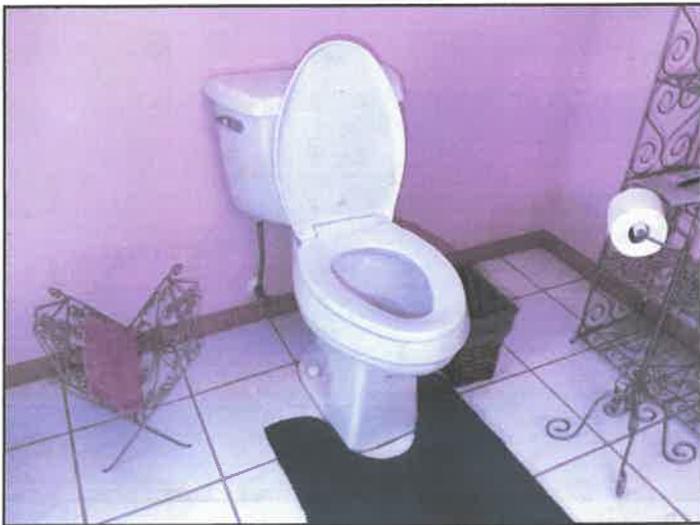
**71. Condition:** • **Loose**

**Implication(s):** Chance of water damage to structure, finishes and contents | Sewage entering the building | Possible hidden damage

159. Loose

Both toilets were very loose at the base. Recommend properly securing both toilets to prevent the toilets from leaking.

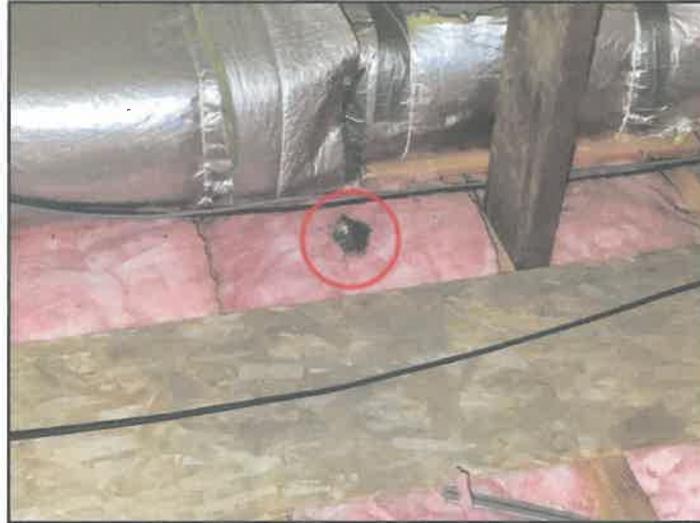
**72. Condition:** • Signs of animal or pest activity noted

Dead mouse noted in attic area.

**Implication(s):** Health hazard / Damage to structure or contents

**Location:** Attic

166. Signs of animal or pest activity noted

**Task:** Consult with exterminator

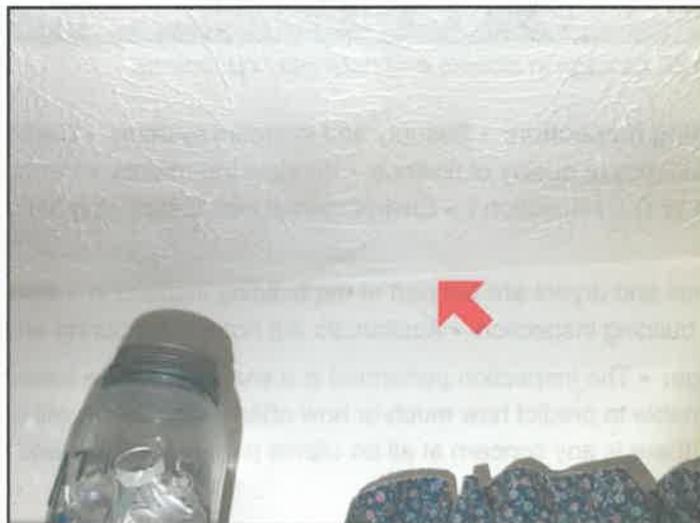
**73. Condition:** • Water stains

Water stains noted to ceiling/s. Area/s tested dry with moisture meter at the time of inspection.

**Implication(s):** Chance of water damage to contents, finishes and/or structure

**Location:** Kitchen

167. Water stains

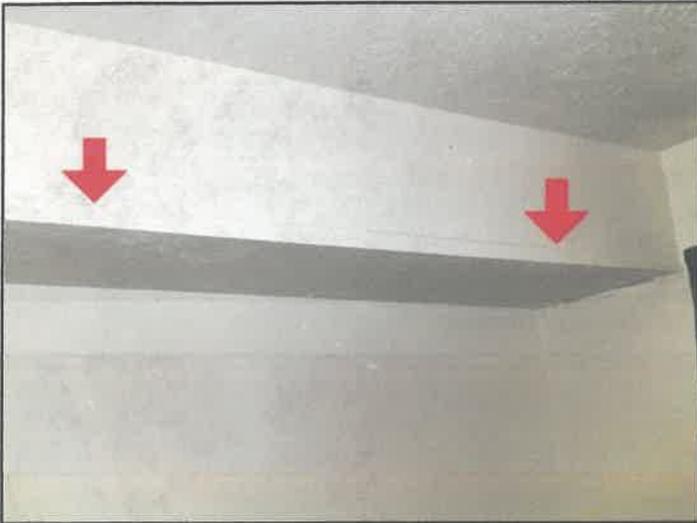
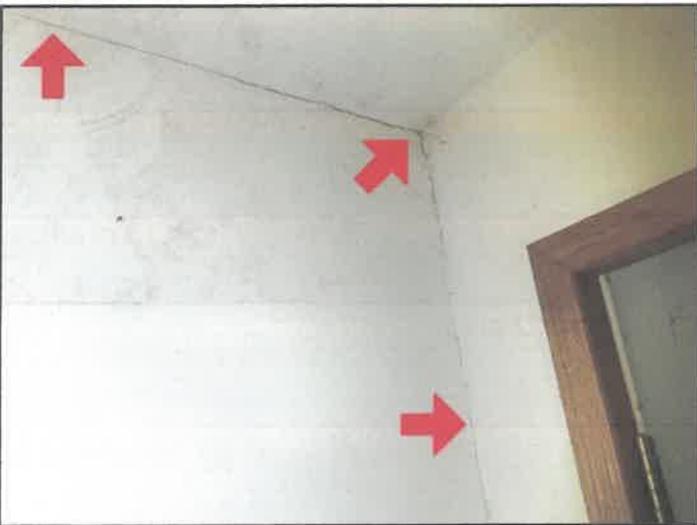
**74. Condition:** • Cracks

**Location:** Various

168. Cracks

170. Cracks

Repair all cracks.

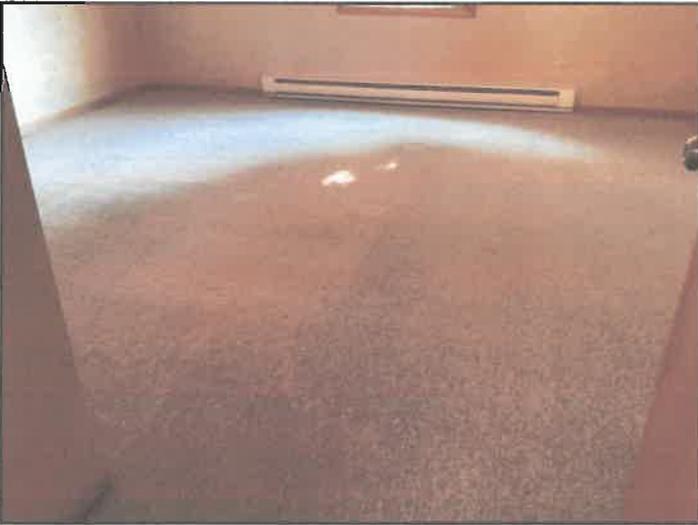
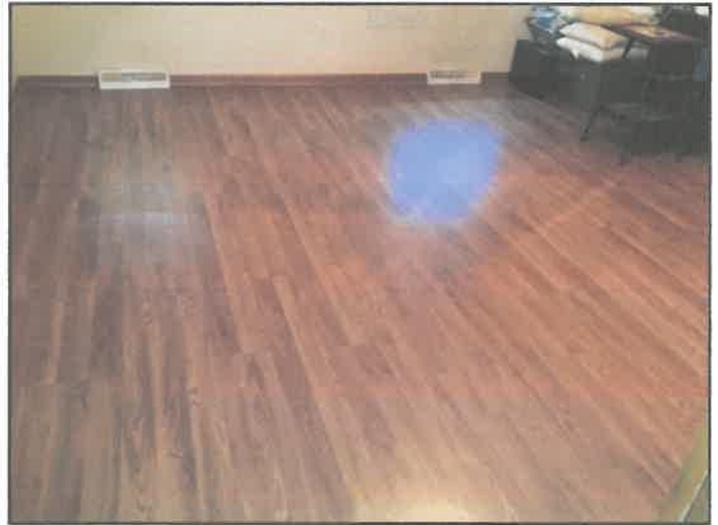
**75. Condition:** • Sloped / Uneven

172. Sloped / Uneven

173. Sloped / Uneven
