### Complaint Against the Valuation of Real Property

6. Parcel numbers from tax bill	Address of property
<u>07-021-10-009-21</u>	<u>1170 Greenbriar DR. Rock Creek, Ohio 44084 (Austinburg TWP)</u>

1170 Greenbriar Dr, Rock Creek, OH June 19, 2023

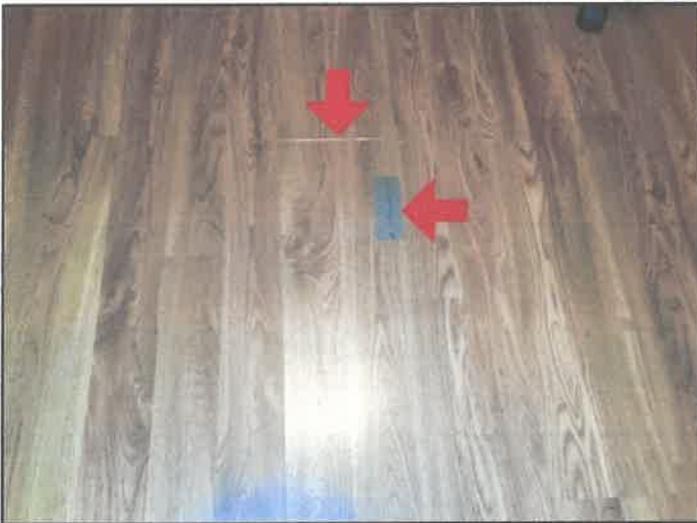
177. Damaged

76. Condition: • Damaged

Implication(s): Trip or fall hazard

Location: Interior-Bedroom / Living room

Task: Repair or replace

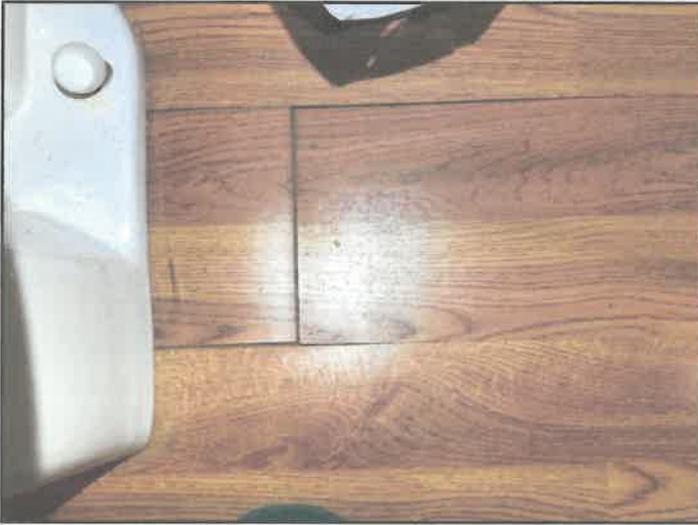
179. Exposed tongues

77. Condition: • Exposed tongues

Location: Interior-Bathroom

Task: Repair or replace

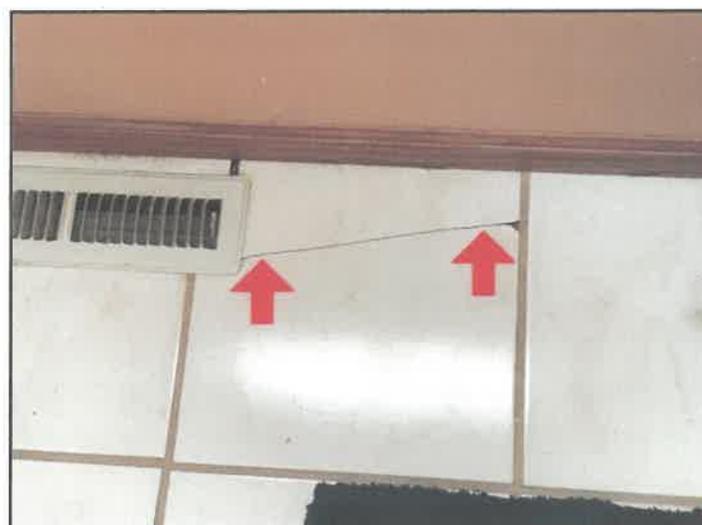
182. Tiles cracked or broken

**78. Condition:** • Tiles cracked or broken

**Implication(s):** Further material deterioration / Physical injury

**Task:** Replace

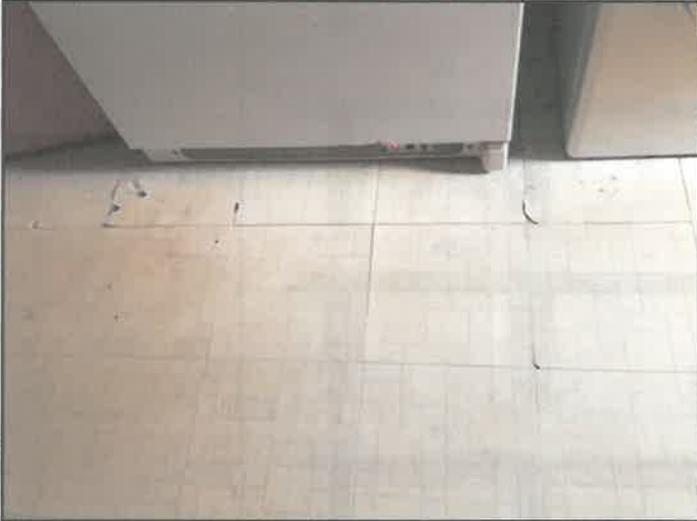
183. Damage

**79. Condition:** • Damage

**Implication(s):** Material deterioration | Trip or fall hazard

**Location:** Laundry room

**Task:** Replace

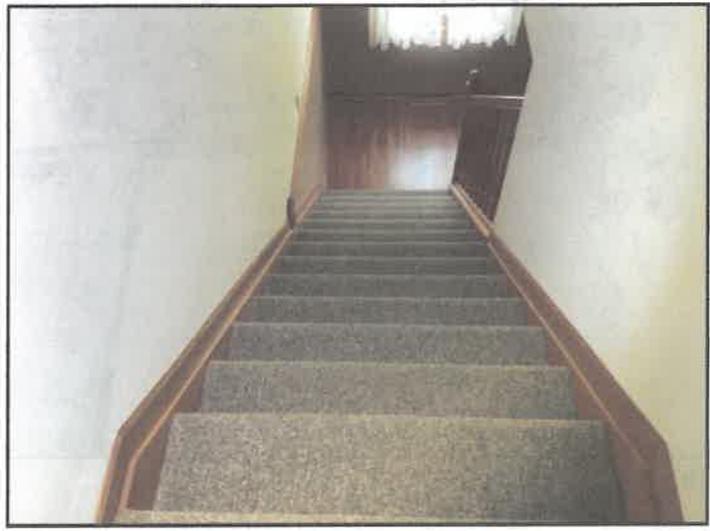
185. Missing

**80. Condition:** • Missing

**Implication(s):** Fall hazard

**Location:** Staircase

**Task:** Replace / Install

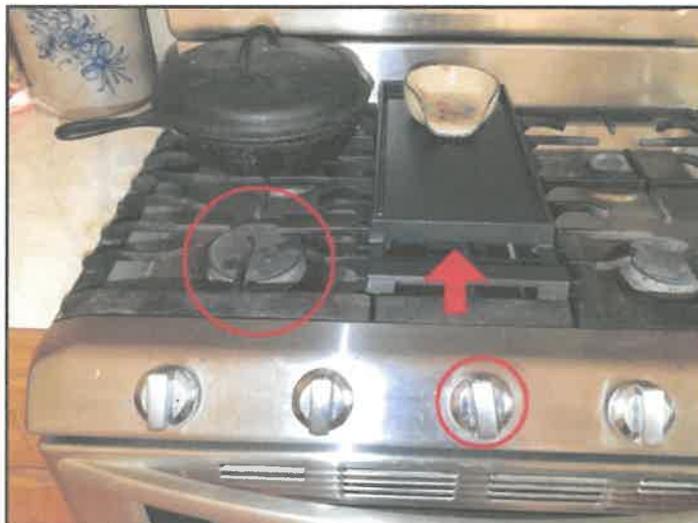
186. *Burner inoperative*

81. Condition: • Burner inoperative

**Location:** Kitchen

**Task:** Repair or replace

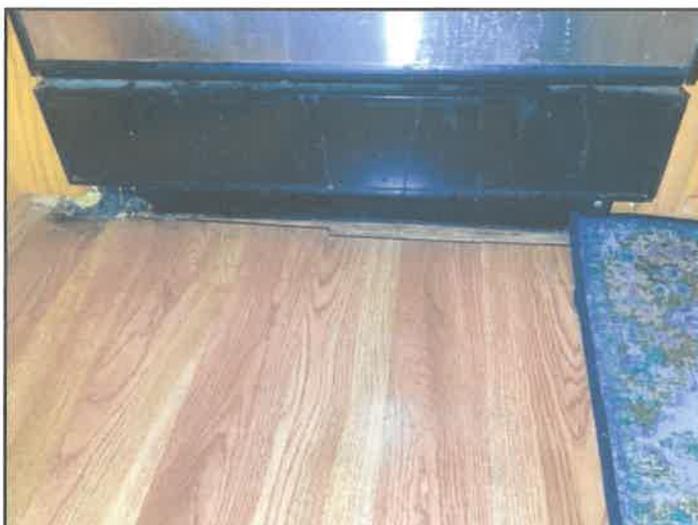
187.

**82. Condition:** • Floor was not installed under the dishwasher. This may make it difficult to remove when needed.

**Location:** Kitchen

**Task:** Improve
